# Inspection Report

## Wilper Estate

**Property Address:**  
507 Hope St  
Monroe City MO 63456

## Integrity Home Inspection

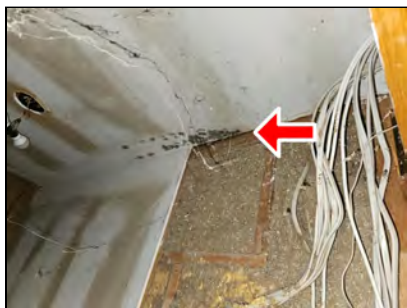
Stairway to basement.

Signs of possible fungi growth (mold) is present. A mold inspection/testing was not requested and this is a courtesy observation. Therefore the findings are limited and not conclusive. Mold spores are present in all buildings. Mold could be also present in any unobserved areas We did not inspect, test or determine if this growth is or is not a health hazard. Long term contact with mold can damage some surfaces and building materials. The underlying cause is moisture. An air sample test can be taken to determine what types of mold and at what level of spore count exists in the building. A swab sample will only indicate the type of mold preset at the test site. Please let us know if you would like us to conduct either of these test for you. More information on Mold can be found at: <http://www.epa.gov/mold/>.

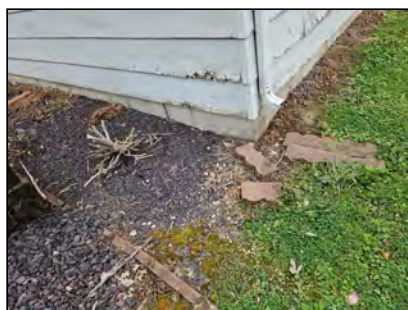
Nw corner

(1) Downspouts are dumping too close to foundation. Suggest getting water away from foundation by 5'. Water settling by the foundation could cause settling of the foundation or could find its way into the basement/crawlspace or lower level of the home.

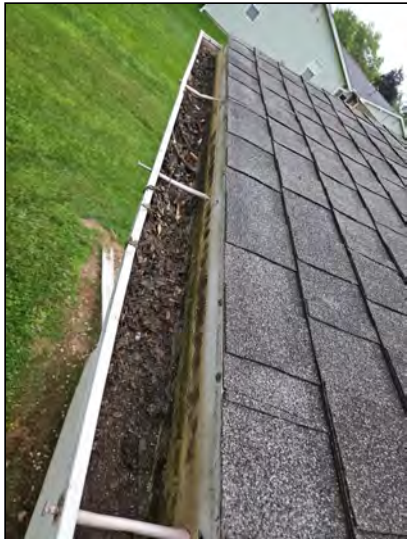
(2) Gutter is pulling away on the front of the home and rainwater has the ability to run behind the gutter. Additionally debris was observed in the guttering.

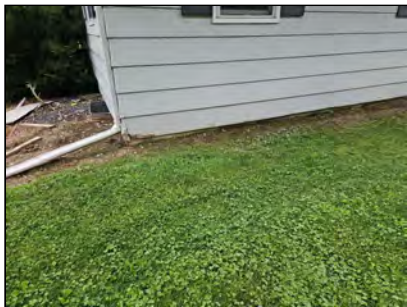
Ne corner

Deterioration of the siding was observed around the entire home.

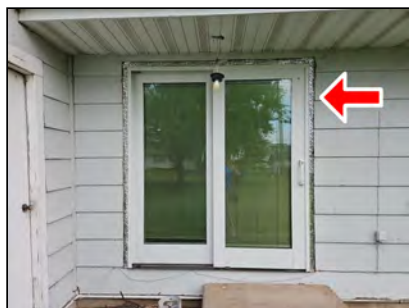
A sliding door has been installed on the rear of the home but it's not been finished out.

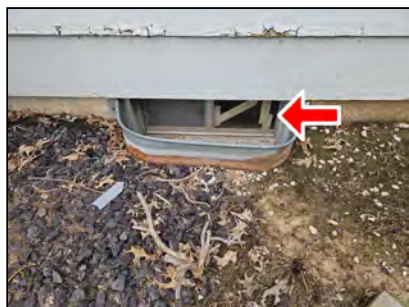
Cracked glass in a East basement window was observed.

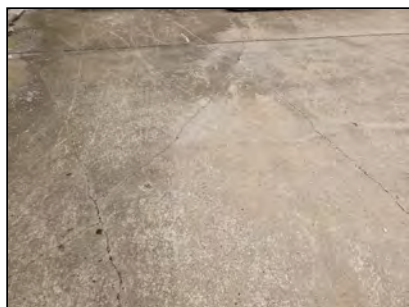
(1) Cracks common with older concrete was observed. Sealing the cracks and separations could help keep moisture from intruding and extend the life of the concrete before replacement. Leveling of the concrete should be considered if there is a difference of over 1/2" as this could be a trip hazard.

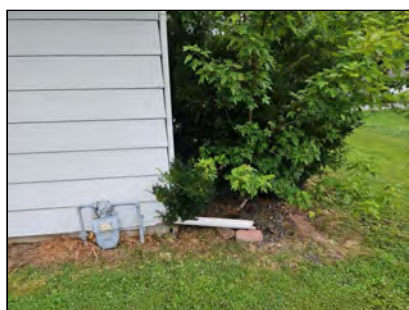
East side of the home

(2) Small trees/shrubs are beginning to grow next to the foundation. Suggest removal before the trees have a chance to cause damage.

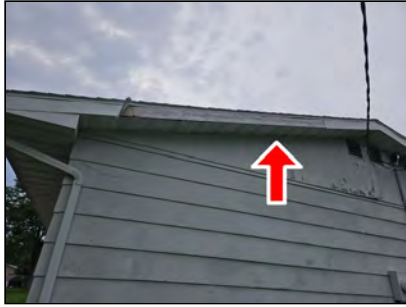
Aluminum fascia is missing from the West Gable.

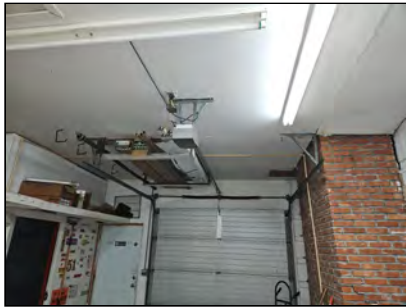
The garage door opener did not operate using the controls by the door to the home.

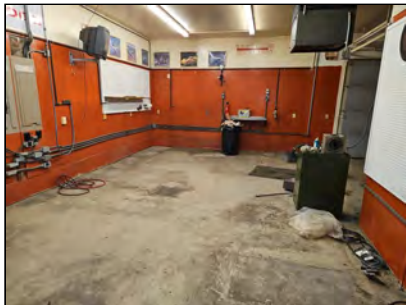
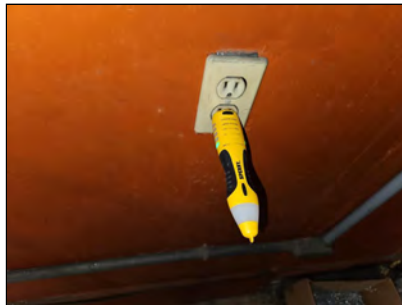
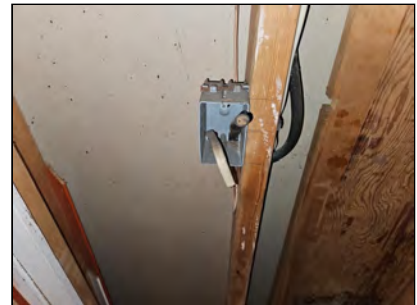
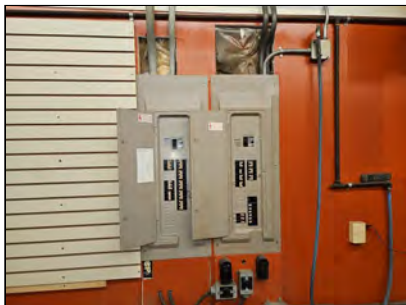
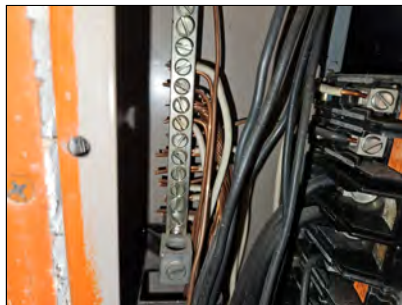
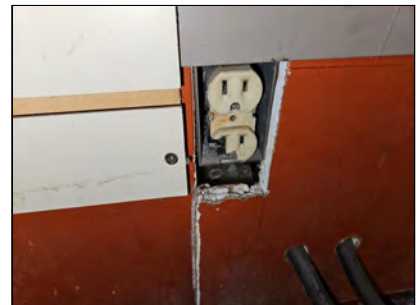
Improperly discontinued electrical circuits, damaged receptacles, and a lack of GFCI protection were observed in the garage. These conditions may present shock, fire, and safety hazards. Recommend further evaluation of the garage electrical system and correction of all identified deficiencies by a qualified licensed electrician.

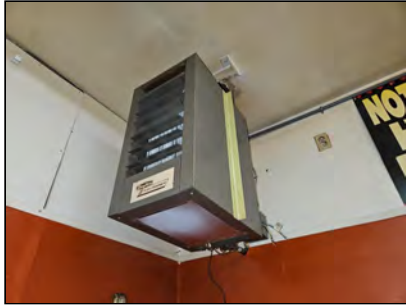
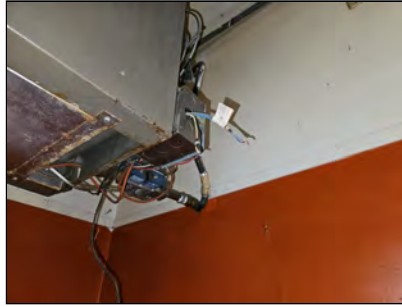
The furnace was not operated. Exposed wires are sticking through the junction box. Recommend evaluation prior to usage.

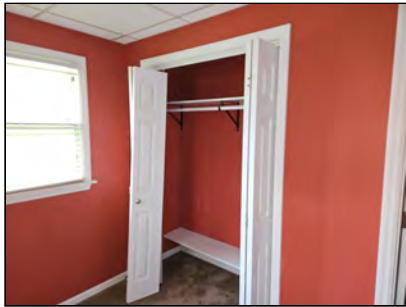
The closet doors in the Southeast bedroom are off track.

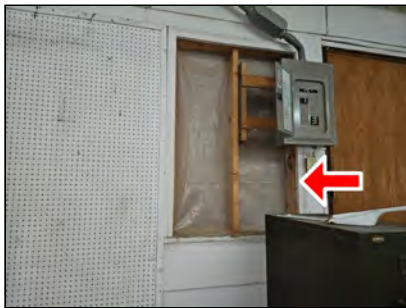
A window has been removed on the west side of the dining room but has not been properly completed out on the garage side. Should they fire occur in the garage this would be a weak point in the wall.

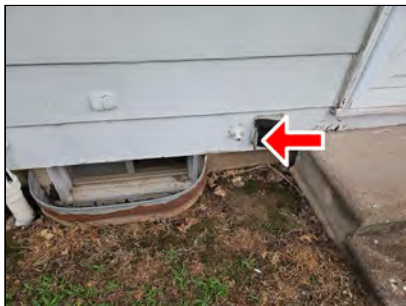
(1) The hose bib on the rear of the home is missing its handle and could not be operated.

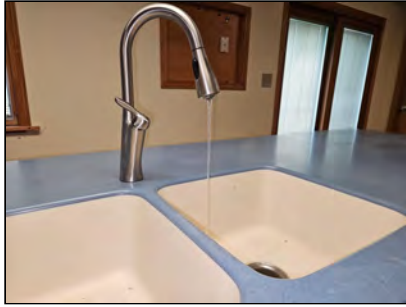
(2) The hot water side of the kitchen faucet head shows slow water flow.

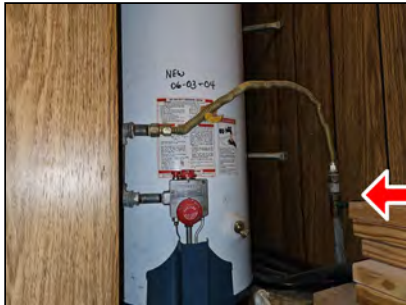
The gas was turned off to the water heater and it could not be operated. Please see comments about brass corrugated connectors.

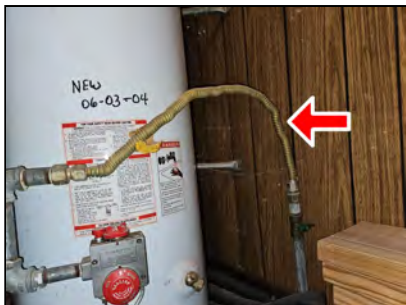
An older type appliance connector was observed. Suggest replacement. From NICOR GAS CO: Appliance connectors are corrugated metal tubes used to connect gas appliances to fuel gas supply pipes in our home or business. Some older brass connectors have a serious flaw in how their tubing was joined to their end pieces. Over time, the end pieces can separate from the tubing and cause a serious gas leak, explosion or fire. To our knowledge, these dangerous uncoated brass connectors have not been made for more than 20 years, but many of them are still in use. The older these connectors get, the greater the possibility of failure. Although not all uncoated connectors have this flaw, it is very difficult to tell which ones do. Therefore, any uncoated brass connector should be replaced immediately with either a new plastic-coated brass or a new stainless steel connector. Connectors can wear out from too much moving, bending or corrosion. Connectors should always be replaced whenever the appliance is replaced or moved from its location. If you believe that you have an older connector in your home, have a qualified contractor inspect the connector and replace it if necessary. Do not attempt to check connectors yourself. Moving the appliance, even slightly, whether to clean behind it or to inspect its gas connector, can cause the complete failure of one of these older weakened connectors, possibly resulting in a deadly fire or explosion. Be sure to follow these appliance connector safety guidelines: • Make sure that connectors are installed where no one will step, sit, lean or place a heavy object on them • Never have a connector installed through a wall, floor or ceiling • An appliance connector should not be more than six feet long • Each appliance should have a shut-off valve installed on the house piping before the connector

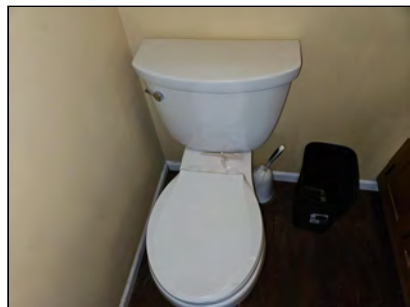
(1) The toilet in the master bathroom is broken.

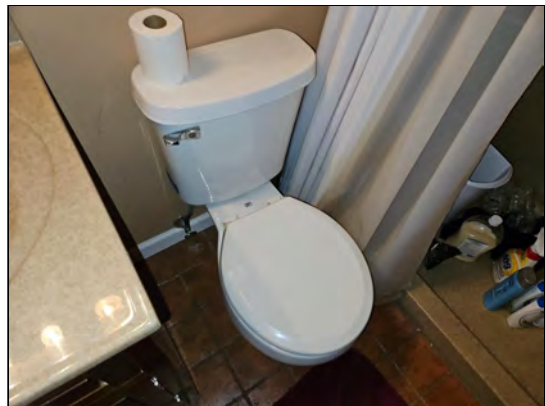
hallway toilet

(2) The toilet had a loose connection to the floor. Suggest corrective measures be taken. Additionally, it appears that the water to the toilet has been turned off

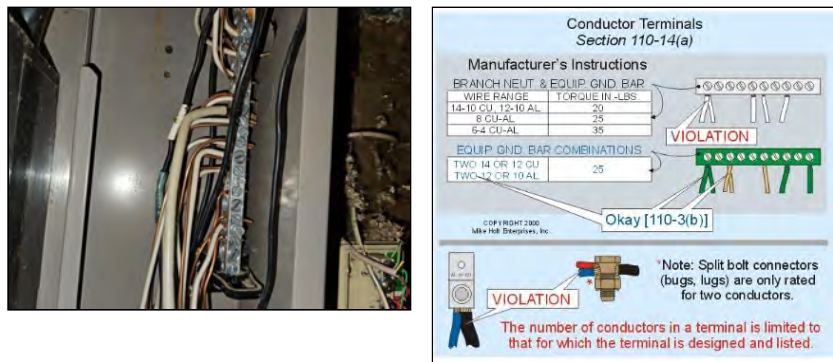
double tap ill.

Double tapping in the panel was observed. Current requirements state Neutrals & Neutral /Ground combinations should not share the same connection hole/screw. Although many electricians do not follow this rule and local municipal inspectors "OK" this infraction, it is still considered unsafe. Suggest corrective measures be considered in the near future. It has been required by manufacturer's instructions and Underwriters Laboratories Standard 67 for panelboards for some time. See this link for a narrative description of the reason for single neutral wire - single screw.

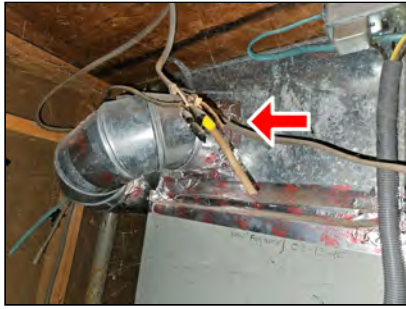
Furnace

Connections or wiring termination made outside of junction boxes and/or boxes without covers were observed. Suggest corrective action be taken. Some locations identified are noted in the accompanying photos.

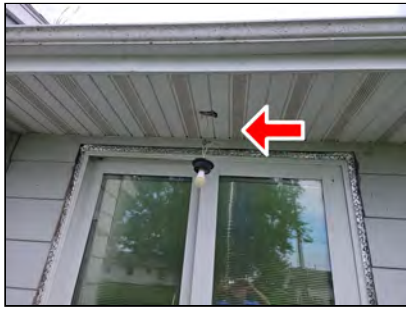
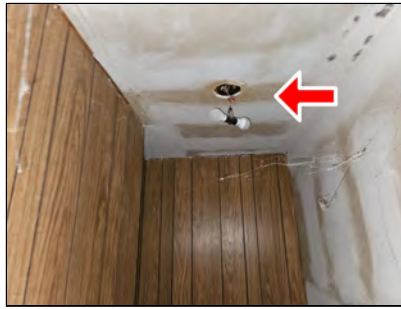
(1) A light fixture on the rear of the home and the basement stairway has not been properly installed.

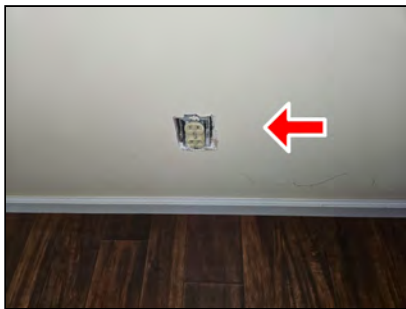
Dining room

(2) Cover(s) are missing from receptacle(s) and/or switch(es). Suggest covers be installed for safety.

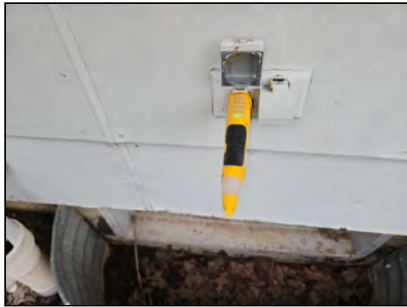
exterior rear of home

No GFCI requirements existed prior to 1971. The common accepted practice is to upgrade the receptacles to GFCI as renovations occur. The following dates indicate when the requirement for certain areas required GFCI. Exterior - 71'; Bathroom - 75'; Garage - 78'; Jetted or Hot tub - 81'; Kitchen (within 6' of the sink edge) & Unfinished basements - 87'. In 1996, all Kitchen counter top area and all bathroom receptacles must have GFCI protection. Areas that lack GFCI protection are noted in the photos. Not every deficient receptacle is photographed. A qualified electrician should be consulted to further evaluate and determine which receptacles should be upgraded. Suggest upgrading when possible. Some locations or areas are indicated in the accompanying photos.

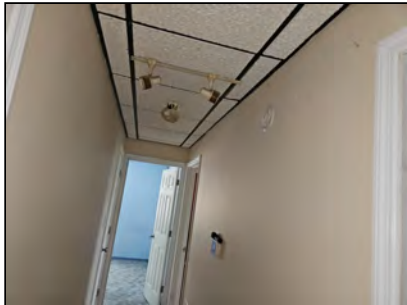
Smoke detectors are missing or disconnected in the home.

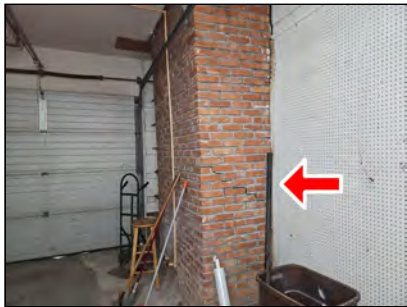
The base of the chimney has settled in the garage and a large crack is present. Recommend corrective measures as needed.

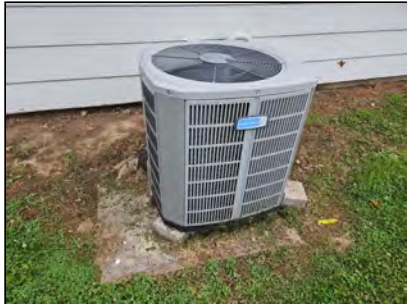
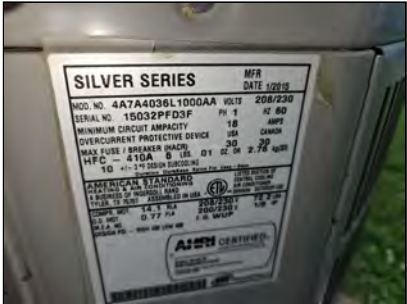
The AC did not operate when tested.

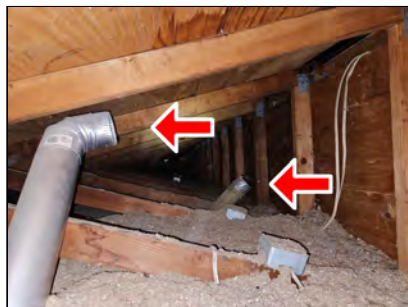
outside venting

The vent for the bathroom does not vent to the outside. Venting into the attic can cause moisture build up which can damage insulation and possibly promote mold growth.

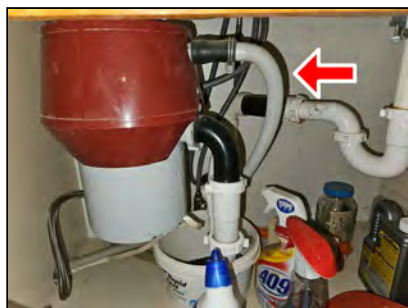
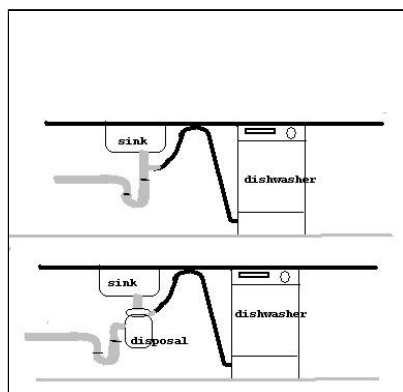
highloopimage

The drain for the dishwasher does not "high loop" above the tub. Without a high loop, waste water could back up into the dishwasher. A few dishwasher models have a high loop built in to the side making an additional high loop unnecessary. The dishwasher would likely have to be removed to verify. FYI

The dishwasher is missing part of its control panel.

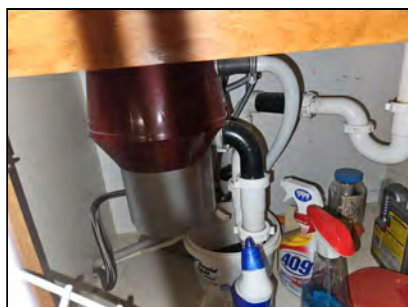
The disposal did not operate when the switch was turned on.

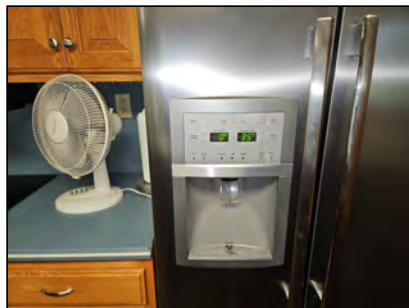
The water in the refrigerator door did not operate.
