# Property Condition Report

160 Hickory Ln  
Eolia, MO 63344

Prepared for: Pamela Duff

Prepared by: Missouri Property Inspections  
PO Box 160  
Cottleville, Mo 63338  
Chris Lucke A.C.I. 251932  
(636) 528-1554

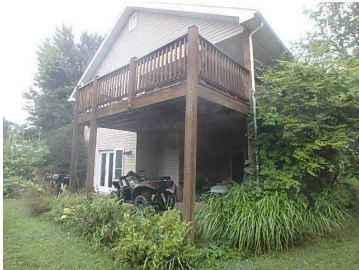
Deck: *Treated wood, Stained wood - Recommend stain/seal to preserve deck material.*

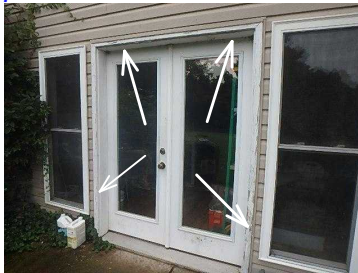
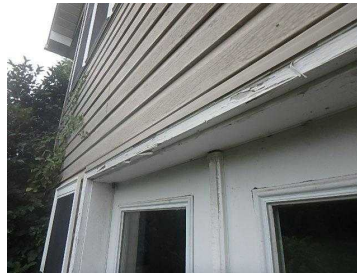
Trim: Wood - Several areas of the wood trim is cracked and peeling. I recommend scraping & painting all exterior wood trim components to preserve wood trim.

1. Trim: Wood - Several areas of the wood trim is cracked and peeling. I recommend scraping & painting all exterior wood trim components to preserve wood trim.

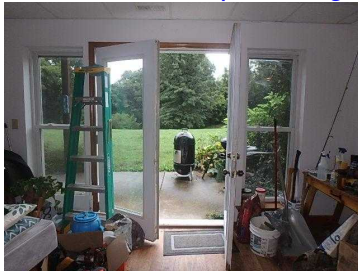
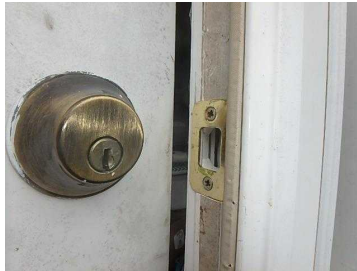
Patio Door: French door - Deadbolt does not align to the latch plate. I recommend repairing as needed.

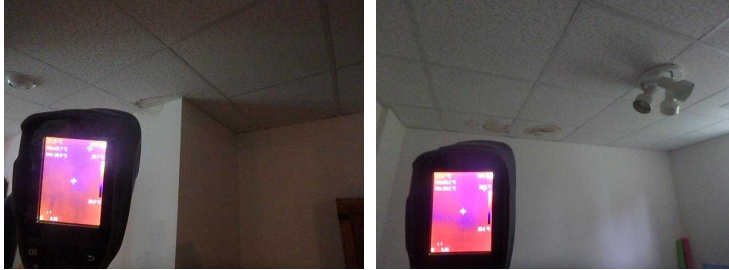
Moisture Penetration: *None observed at time of inspection. Previous water stains observed in kitchen, lower bedroom, lower fireplace area, and primary closet - stains appear to be old and not the result of active leaks. Stains tested OK with moisture meter, also no anomalies observed with thermal camera despite running water faucets and heavy rains during the previous 24 hours. No water intrusion observed during inspection.*

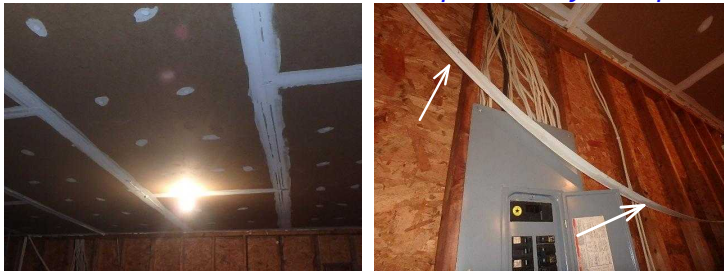
3. *Acceptable* Door Operation: *Mechanized*  
4. *Acceptable* Door Opener: *Lift Master*  
5. *Acceptable* Service Doors: *Metal*  
6. *Marginal* Ceiling: *Unpainted Drywall - Loose or missing tape on tape joints was observed. I recommend repairs by a qualified contractor.*

2. Attached Garage Ceiling: Unpainted Drywall - Loose or missing tape on tape joints was observed. I recommend repairs by a qualified contractor.

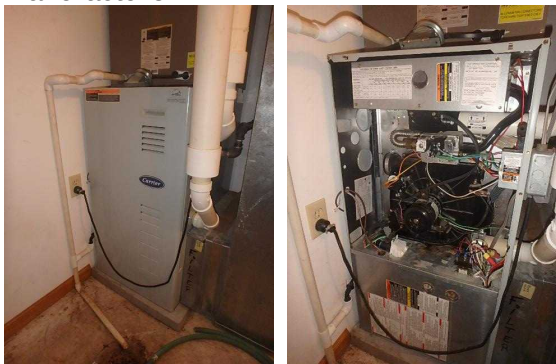
7. *Marginal* Design Life *20 Years* - *The unit is beyond its design life of (20) years. It was operational at the time of inspection. I recommend further evaluation by a qualified HVAC contractor if needed.*

3. Basement Heating System Design Life 20 Years - The unit is beyond its design life of (20) years. It was operational at the time of inspection. I recommend further evaluation by a qualified HVAC contractor if needed.

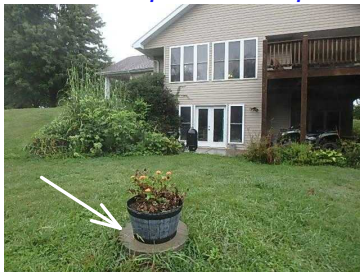
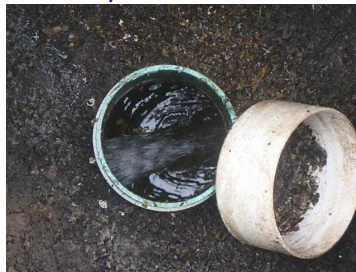
17. *Marginal* Sewage: *Septic* - *Appears functional and serviceable. However, the septic system does not meet current state standards. See the separate State septic inspection report for additional information.*

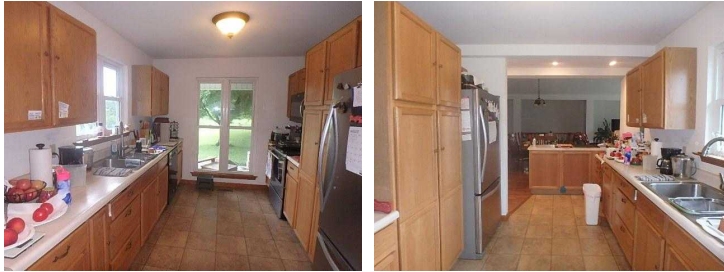
Ceiling: *Painted Drywall - Water stains present. Refer to the attic section of this report (Page 11; line 7) for further comments regarding water stains.*

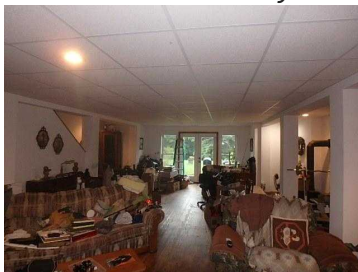
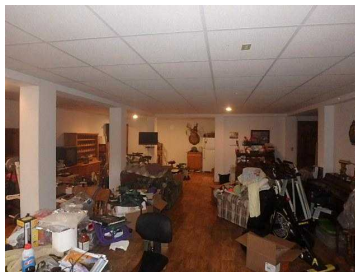
Ceiling: *Suspended ceiling - Water stains present*  
Walls: *Painted Drywall*

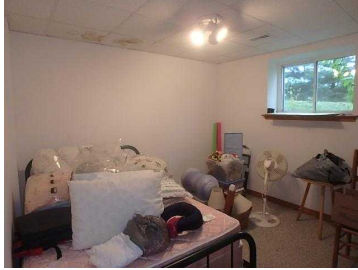
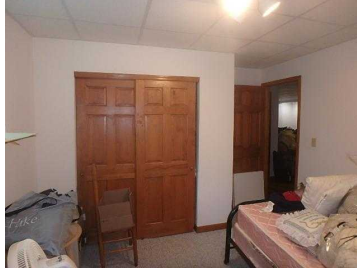
Closet: *Large*  
Ceiling: *Suspended ceiling - Water stains present*  
Walls: *Painted Drywall*

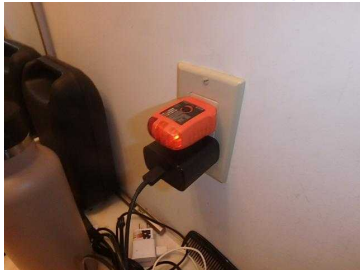
Electrical: 110 VAC - *Non-GFCI outlet. I recommend GFCI circuit/outlet be installed by a qualified electrician.*

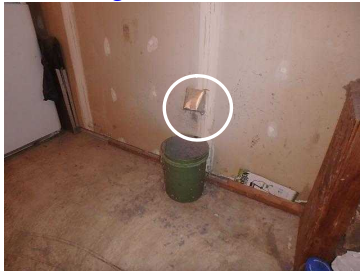
- 3. *Acceptable* Floor: *Vinyl floor covering*
- 4. *Acceptable* Doors: *Wood*
- 5. *Acceptable* Electrical: *110 VAC outlets and lighting circuits*
- 6. *Acceptable* HVAC Source: *Central Air*
- 7. *Acceptable* Laundry Tub: *Stainless Steel*
- 8. *Acceptable* Laundry Tub Drain: *PVC*
- 9. *Acceptable* Washer Hose Bib: *Rotary*
- 10. *Acceptable* Washer and Dryer Electrical: *110-240 VAC*
- 11. *Acceptable* Dryer Source *Electric - 4-prong 220VAC*
- 12. *Defective* Dryer Vent: *Vent to garage - [Dryer vents into the garage. I recommend venting to the exterior.](#)*

5. Main Floor Laundry Room/Area Dryer Vent: *Vent to garage - Dryer vents into the garage. I recommend venting to the exterior.*
