Inspection Report

Property Address:
26523 Route N
Monroe City MO 63456

Integrity Home Inspection

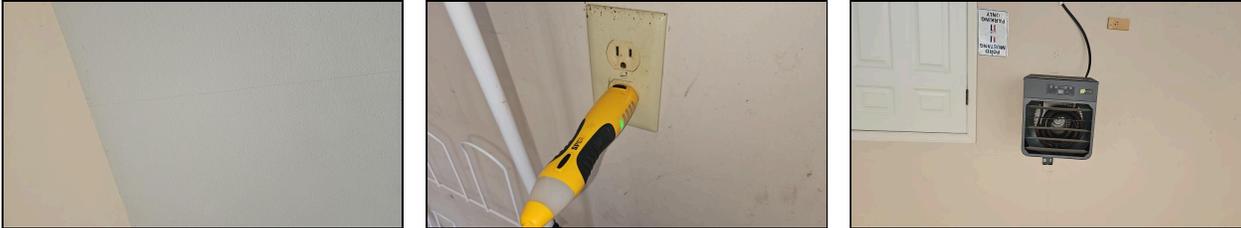
No GFCI requirements existed prior to 1971. The common accepted practice is to upgrade the receptacles to GFCI as renovations occur. GFCI protection was required starting in 1978 for garages. No GFCI protection was observed in the garage. Suggest upgrading in the near future.

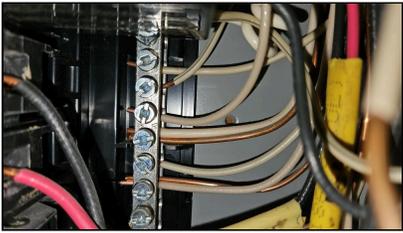
Conductor Terminals
Section 110-14(a)

Double tapping in the panel was observed. Current requirements state Neutrals & Neutral /Ground combinations should not share the same connection hole/screw. Although many electricians do not follow this rule and local municipal inspectors "OK" this infraction, it is still considered unsafe. Suggest corrective measures be considered in the near future. It has been required by manufacturer's instructions and Underwriters Laboratories Standard 67 for panelboards for some time. See this link for a narrative description of the reason for single neutral wire - single screw.

The number of conductors in a terminal is limited to that for which the terminal is designed and listed.

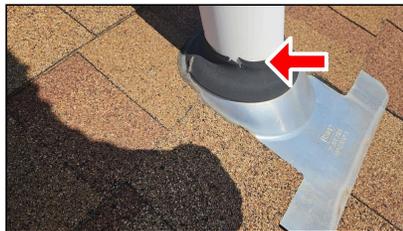
The roof boot(s) are deteriorating around the plumbing vent stacks. During a rain, water could enter the building. Suggest replacement.

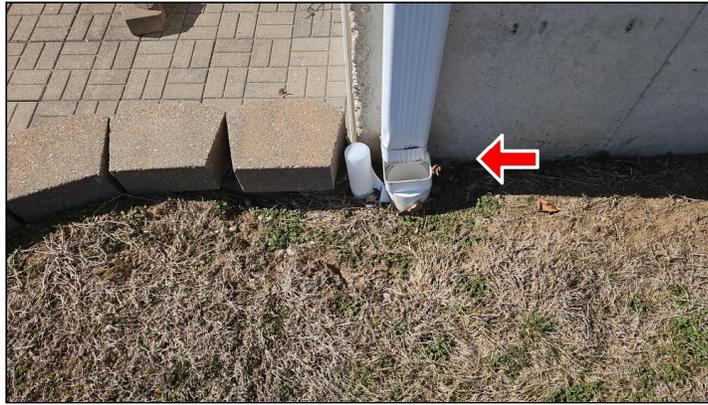
Se corner

Downspouts are disconnected from the underground drains (likely due to settling). Water could leak out of the open connection and cause water to run down along the foundation. Water settling by the foundation could cause settling of the foundation or could find its way into the basement/crawlspace or lower level of the building.

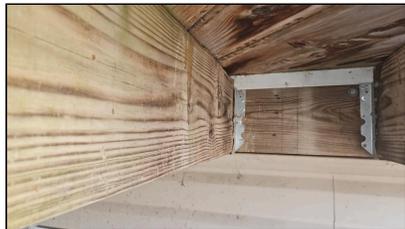
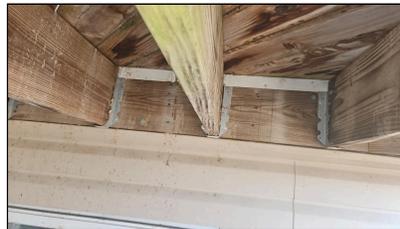
joist hangers

(1) Joist hangers used in the construction of the deck are not properly installed. Roofing nails, drywall screws & deck screws should not be used and every available nail hole should be filled with a proper hanger rated fastener.

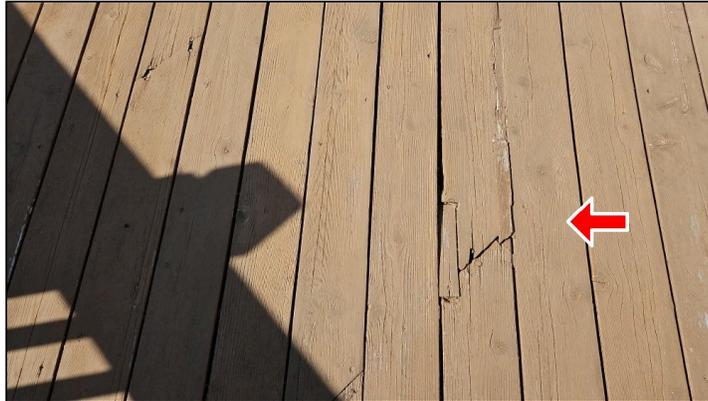
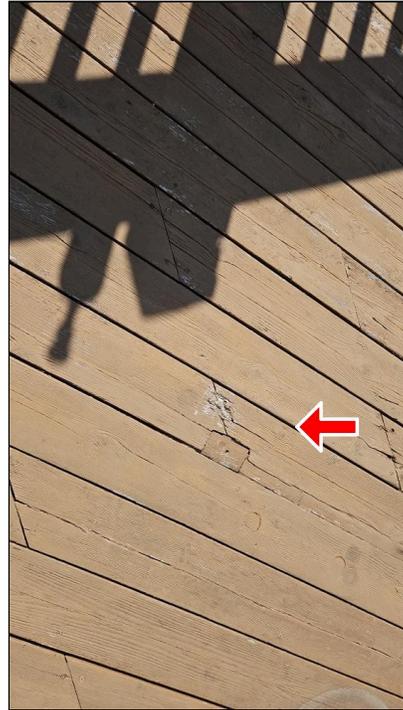
(2) Damage was observed in a few locations on the deck.

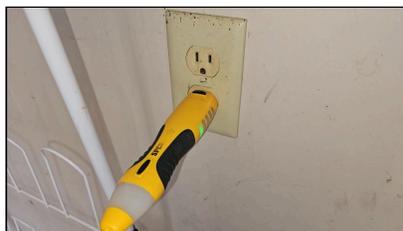
No GFCI requirements existed prior to 1971. The common accepted practice is to upgrade the receptacles to GFCI as renovations occur. GFCI protection was required starting in 1978 for garages. No GFCI protection was observed in the garage. Suggest upgrading in the near future.

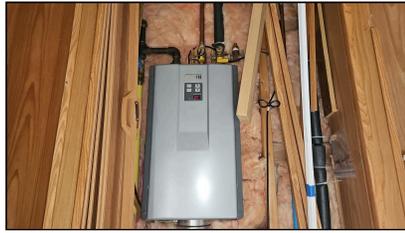
The T&P (Temperature and Pressure) valve on water heater needs a 3/4 pipe to extend within 6 inches

of floor for safety. (PVC is not approved for hot water use). I recommend repair by a qualified person.

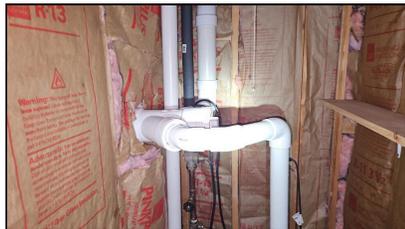
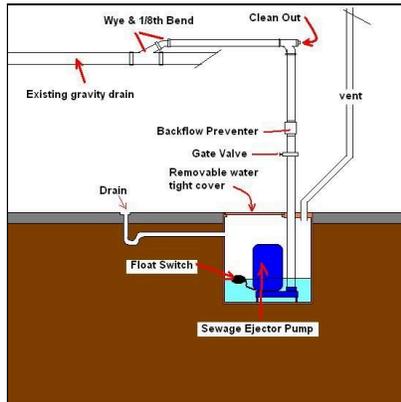
Illustration Injector Pump

The Injector pump is not properly connected to the home's waste system. The drain enters horizontally. The accepted configuration is to have the discharge drop in from from above. Although incorrect, the current configuration is working.

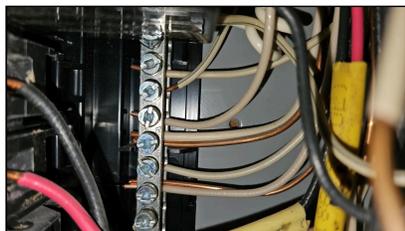
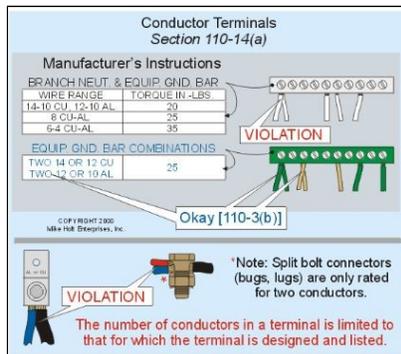
double tap ill.

Double tapping in the panel was observed. Current requirements state Neutrals & Neutral /Ground combinations should not share the same connection hole/screw. Although many electricians do not follow this rule and local municipal inspectors "OK" this infraction, it is still considered unsafe. Suggest corrective measures be considered in the near future. It has been required by manufacturer's instructions and Underwriters Laboratories Standard 67 for panelboards for some time. See this link for a narrative description of the reason for single neutral wire - single screw.

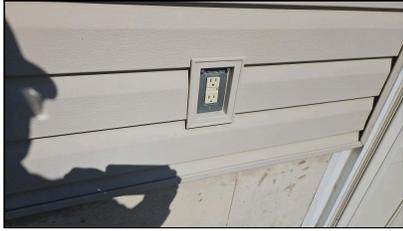
(1) The moisture resistant cover is missing from the receptacle on the south side of the home.

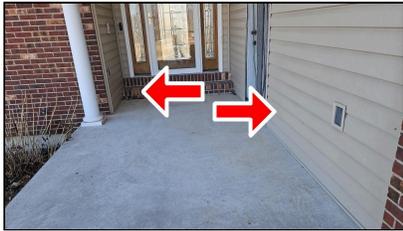
(2) The two covers on the front porch receptacle are broken.

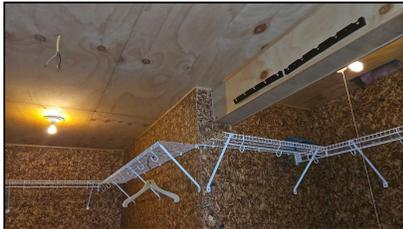
(3) Bare electrical wires and an improperly installed light were observed in the downstairs Cedar closet.

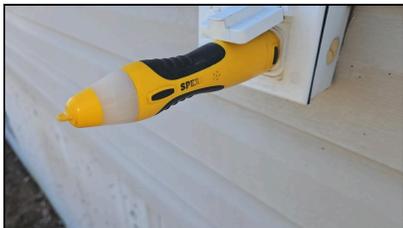
Ne corner of the home

No GFCI requirements existed prior to 1971. The common accepted practice is to upgrade the receptacles to GFCI as renovations occur. The following dates indicate when the requirement for certain areas required GFCI. Exterior - 71'; Bathroom - 75'; Garage - 78'; Jetted or Hot tub - 81'; Kitchen (within 6' of the sink edge) & Unfinished basements - 87'. In 1996, all Kitchen counter top area and all bathroom receptacles must have GFCI protection. Areas that lack GFCI protection are noted in the photos. Not every deficient receptacle is photographed. A qualified electrician should be consulted to further evaluate and determine which receptacles should be upgraded. Suggest upgrading when possible. Some locations or areas are indicated in the accompanying photos.
