## Property Inspection Report

LOCATED AT:  
16508 Hailey Ct  
Tyler, TX 75703

INSPECTED ON:  
Wednesday, February 11, 2026

Inspector, Dominic Cacciapaglia 22932  
B2K Inspections

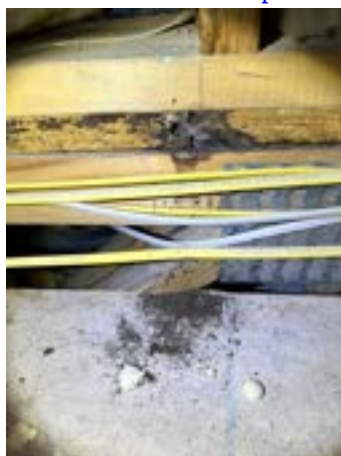
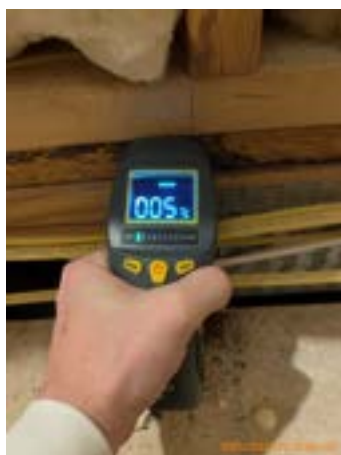
18: Inspector noted staining on framing members and subfloor in the left side attic above the main house (near the access door).

Appears to be from previous leakage at the toilet near this area.

Not wet at time of inspection. No evidence of active leakage

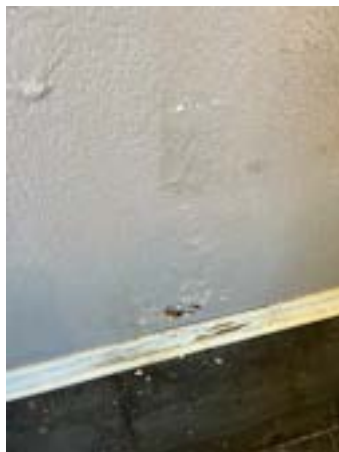
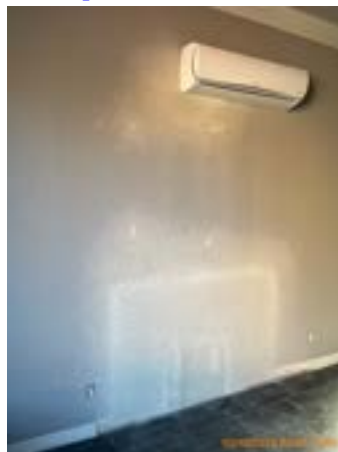
21: Wall in man cave showed signs of previous moisture damage on first day of inspection (subsequent to previous leakage of the mini split on this wall).

The wall was repaired during the second day of inspection (not subcontractors of B2K).

Repair work appears to be satisfactory.

No evidence of active leak at time of inspection.

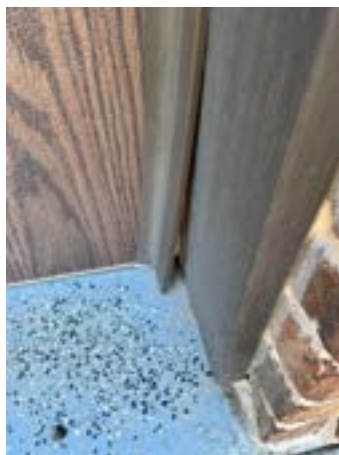
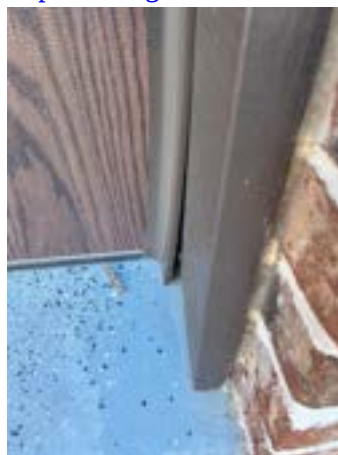
23: Lower ends of some weather strips coming loose near the overhead garage doors

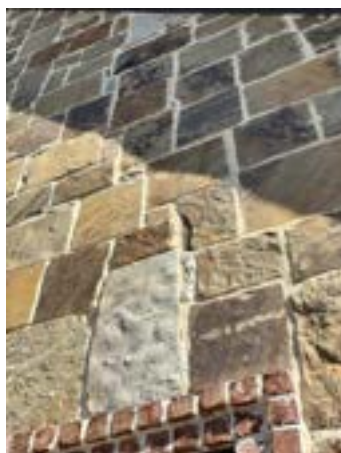
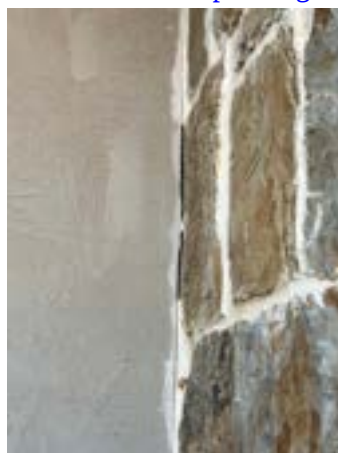
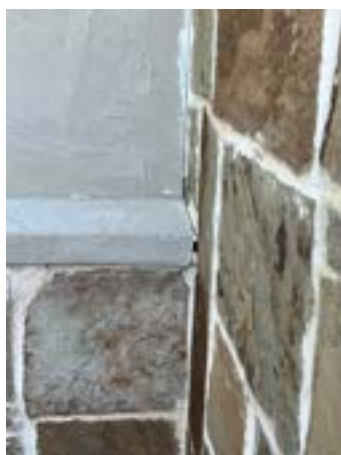
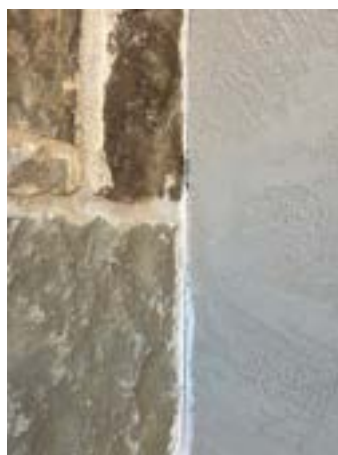
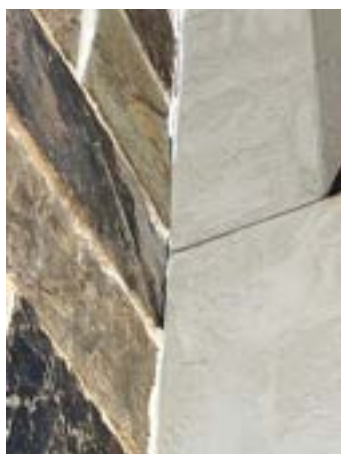
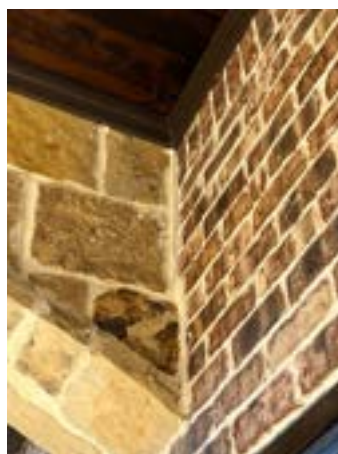
24: Minor cracks noted in areas. Grout could use repointing in these areas

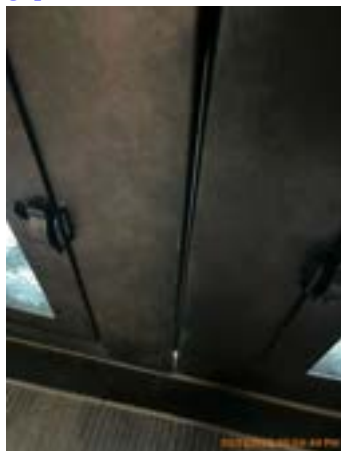
28: Front door doesn't seal tightly against weatherstripping when closed. Light seen through gap.

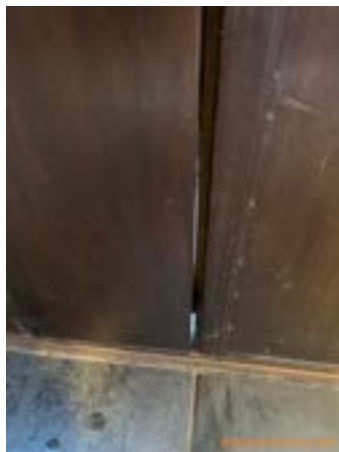
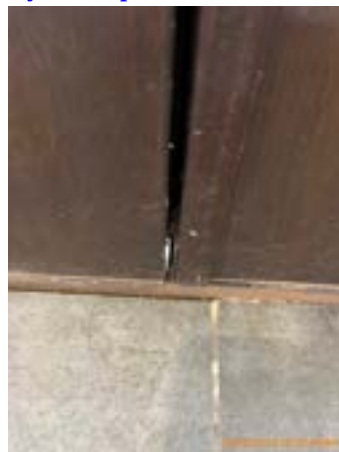
(Man cave, upstairs bedroom, detached garage etc).

We recommend all doors seal tightly to keep outside moisture/air out

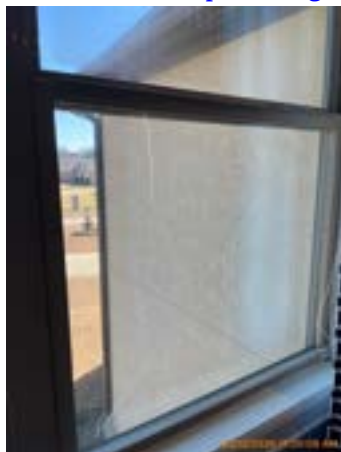
36: Window in upstairs right side bedroom has broken glazing

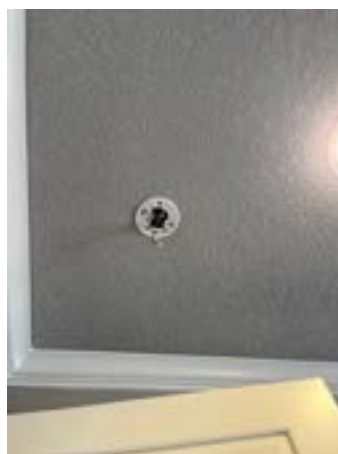
94: Smoke detectors not present in all areas required. (Mounts present, but detectors missing in two upstairs bedrooms)

One is required in each bedroom. One in each hallway adjacent to each sleeping area and at least one on each floor if more than one story. Alarm system connected detectors and heat detectors do not count toward the minimum.

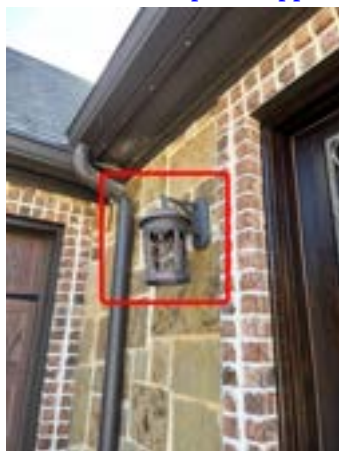
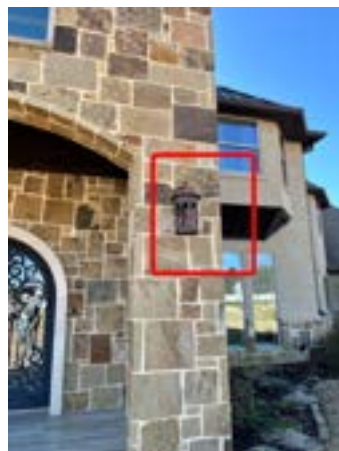
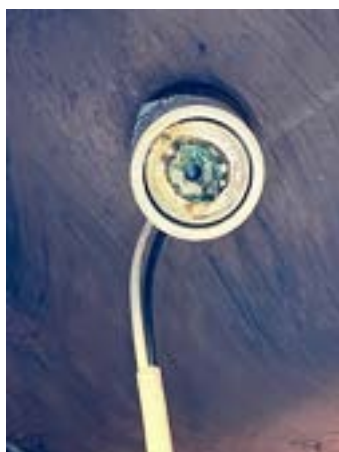
**100:** Some exterior lights were inoperative. Likely need new bulbs.

Fixture at front porch appears it has the base of a broken bulb stuck in the socket

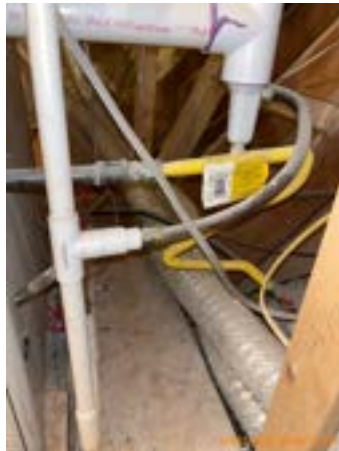
**124:** The fuel piping does not include a 'T' extension to collect condensation and debris, as is considered good practice. In the course of future upgrading or repair, a 'drip leg' should be added to the gas piping just ahead of the connector.

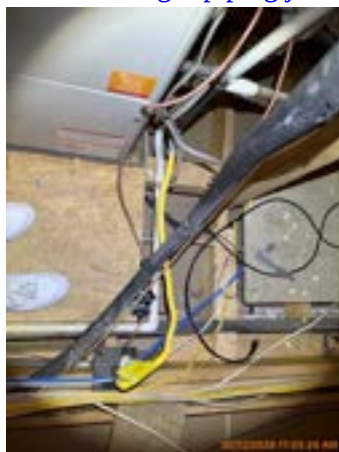
**142:** The fuel piping does not include a 'T' extension to collect condensation and debris, as is considered good practice. In the course of future upgrading or repair, a 'drip leg' should be added to the gas piping just ahead of the connector.

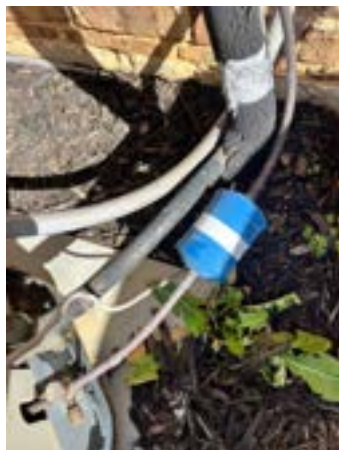
and missing from portions of the refrigerant lines in areas. We  
insulation be replaced to increase energy efficiency.

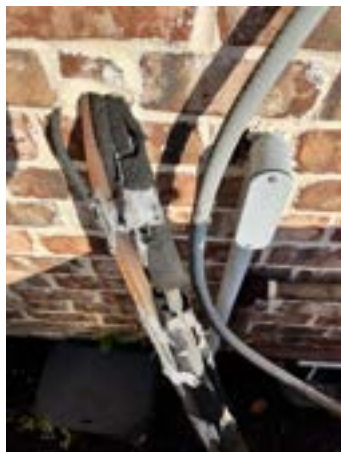
and missing from portions of the refrigerant lines in areas. We  
insulation be replaced to increase energy efficiency.

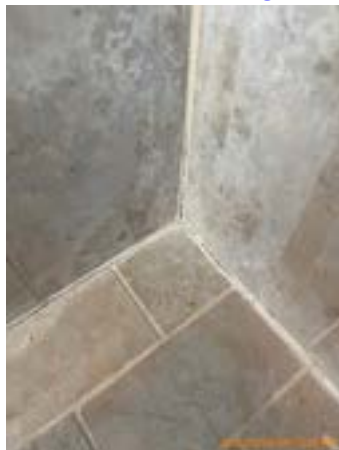
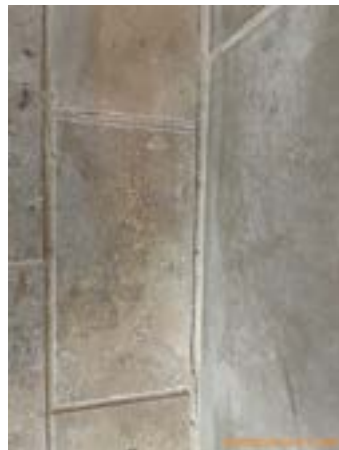
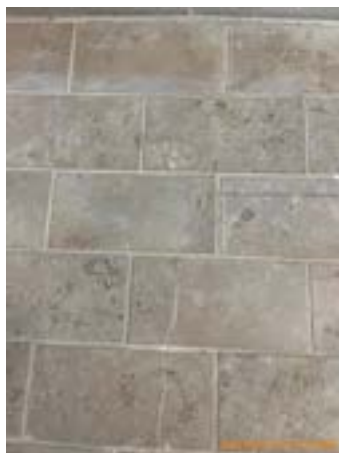
**234:** Minor cracks in grout and some cracked tiles noted in master shower

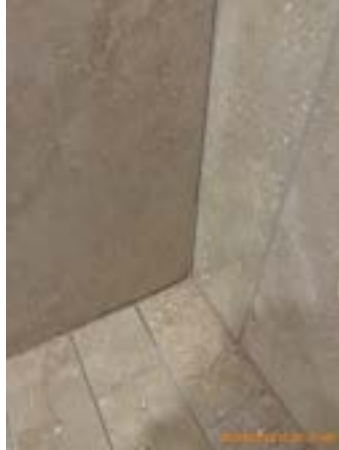
235: Minor cracks in grout of upstairs middle bedroom shower

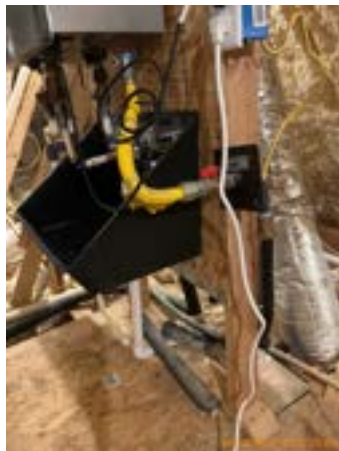
**247: GAS SHUT-OFF VALVE:** The gas piping does not include a sediment trap/drip leg installed downstream of the shutoff valve to collect condensation and debris. In the course of future upgrading or repair, a 'drip leg' should be added to the gas piping just ahead of the connector.

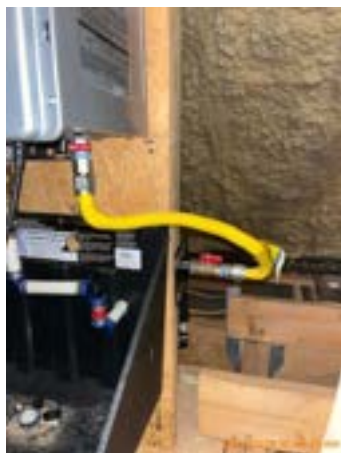
**264: GAS SHUT-OFF VALVE:** The gas piping does not include a sediment trap/drip leg installed downstream of the shutoff valve to collect condensation and debris. In the course of future upgrading or repair, a 'drip leg' should be added to the gas piping just ahead of the connector.

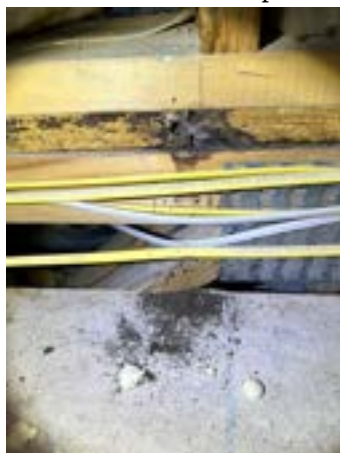
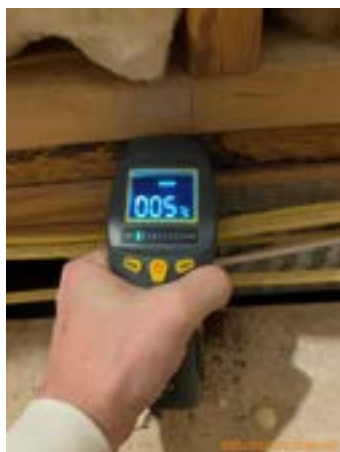
Not wet at time of inspection. No evidence of active leakage

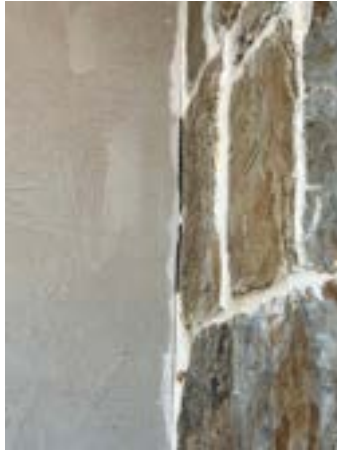
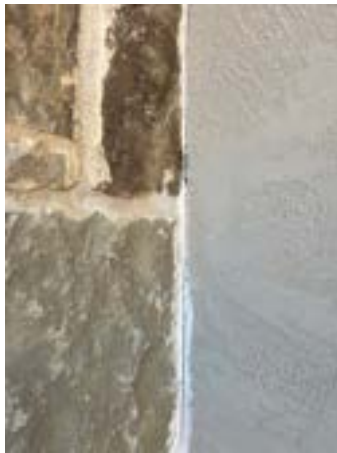
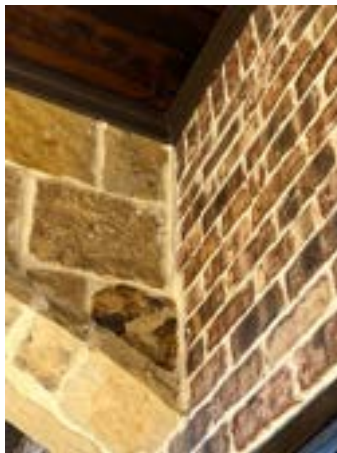
s-24: Minor cracks noted in areas. Grout could use repointing in these areas

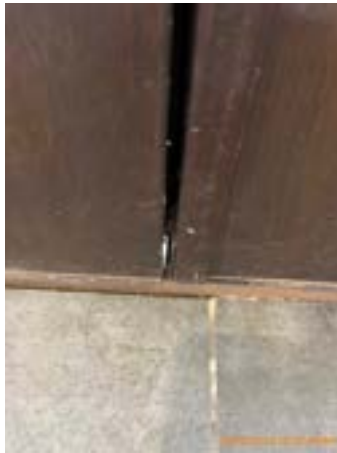
**s-31:** Multiple exterior doors have minor gaps where light can be seen through weather stripping (Man cave, upstairs bedroom, detached garage etc).  
We recommend all doors seal tightly to keep outside moisture/air out

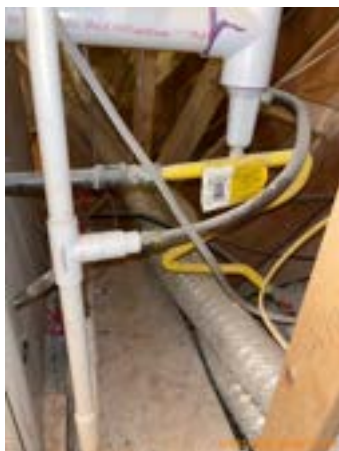
**s-124:** The fuel piping does not include a 'T' extension to collect condensation and debris, as is considered good practice. In the course of future upgrading or repair, a 'drip leg' should be added to the gas piping just ahead of the connector.

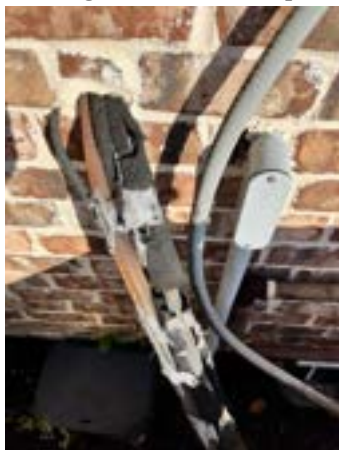
s-203: Insulation is deteriorated and missing from portions of the refrigerant lines in areas. We recommend that all missing insulation be replaced to increase energy efficiency.

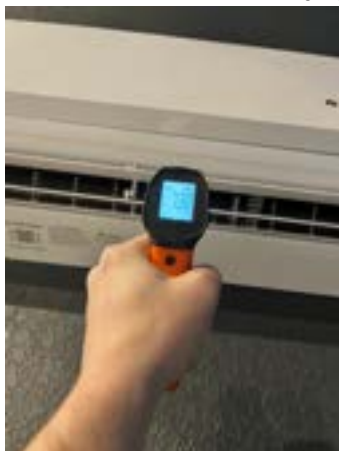
s-204: When set to cool, air blew from mini split but was not cooling  
Recommend evaluation by specialist

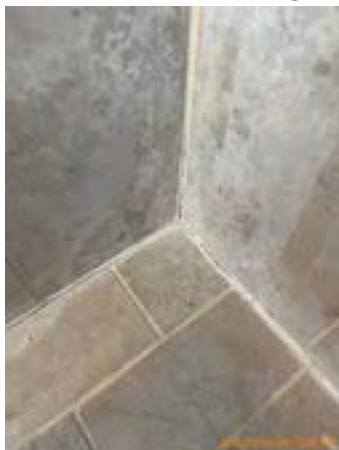
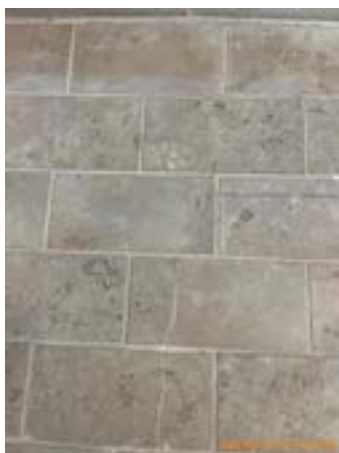
s-234: Minor cracks in grout and some cracked tiles noted in master shower

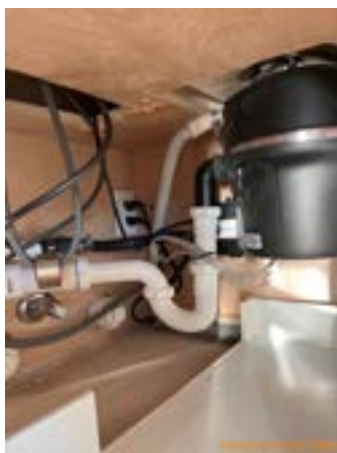
s-281: Dishwasher lacks air gap or backflow loop or the loop is not elevated high enough. This is considered a deficiency.

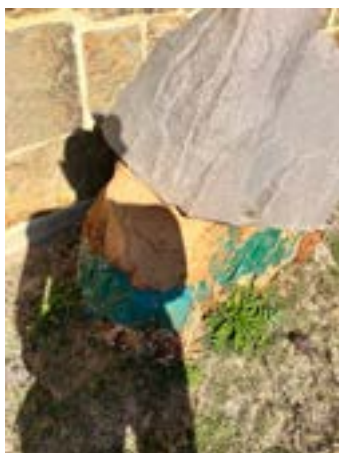
**s-305:** Cover for backflow preventer was completely filled with dirt (maybe from ants).  
Dirt should be cleared so valves are made accessible
