**Service:** Full Home Inspection

**Prepared for:** Joan Dandridge

Site Address: 6053 Collins Road, Ellis Grove, IL, 62241

Service Date And Time: July 21, 2026 At 09:00 AM

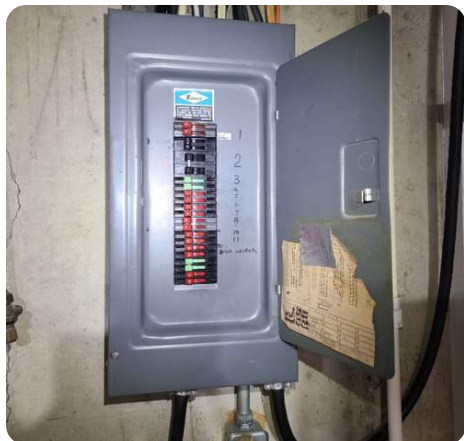
The electrical service is provided by a Zinsco brand main panel, which is a known safety concern in the home inspection industry. These panels are notorious for design flaws where the circuit breakers can fail to trip, overheat, or even fall out of place, creating a significant fire and shock hazard. Due to the high risk of internal arcing and component instability, the dead front cover was not removed during this inspection. It is strongly recommended that a licensed electrician replace this panel with a modern, safe alternative to ensure the property's electrical integrity.

- **Manufacturer:** Zinsco (Sylvania/GTE-Sylvania)
- **Status:** Noted Safety Hazard
- **Recommended Action:** Full Replacement by Licensed Electrician

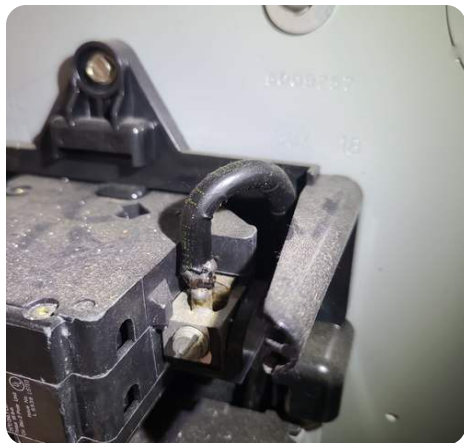
The insulator on the feeder conductor in the subpanel is melted, indicating a potential overheating issue. This could lead to electrical hazards and should be addressed promptly. It is recommended to have a licensed electrician evaluate and repair the melted insulator to ensure safe operation of the electrical system.

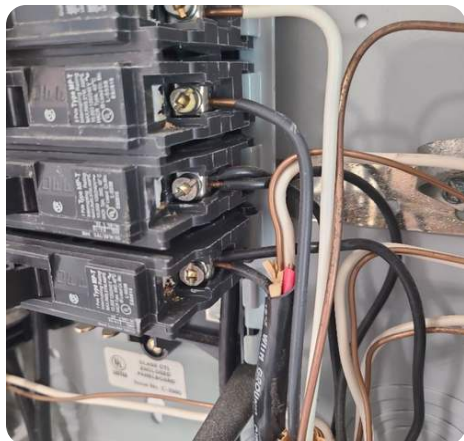
### 5 Double Tapped Breaker

The double tapped breaker issue involves two wires being connected to a breaker designed for a single wire. This can lead to overheating, creating a fire hazard. It is recommended to have a qualified electrician evaluate and repair this issue by installing a separate breaker for each wire to ensure safety and proper function of the electrical panel.

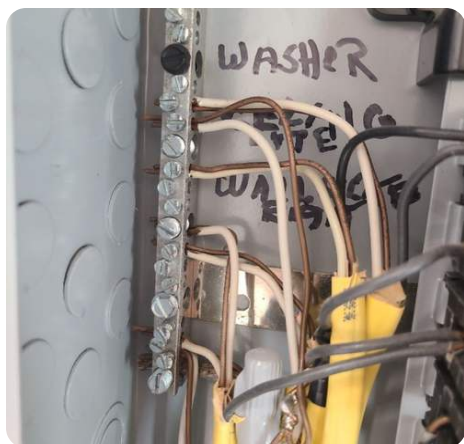
#### 6 Double-Tapped Neutral

Double-tapped neutral was observed at the sub-panel where two neutral wires are connected to a single terminal slot. This could result in poor connections, and overheating, and poses a potential fire hazard. It is advised to contact a qualified electrician to address this issue for the safety and optimal performance of the electrical system.

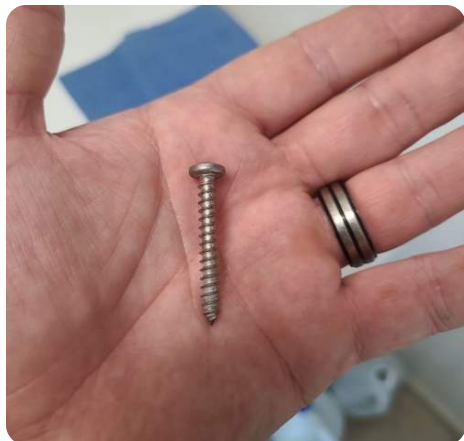
#### 7 Pointed Screws In Subpanel

The subpanel was found to have pointed screws. Pointed screws are not recommended for subpanels as they may pierce the insulation of wires, leading to potential safety hazards. It is recommended to replace them with proper screws to ensure the safety and integrity of the electrical system. A licensed electrician should evaluate and replace the screws as needed.

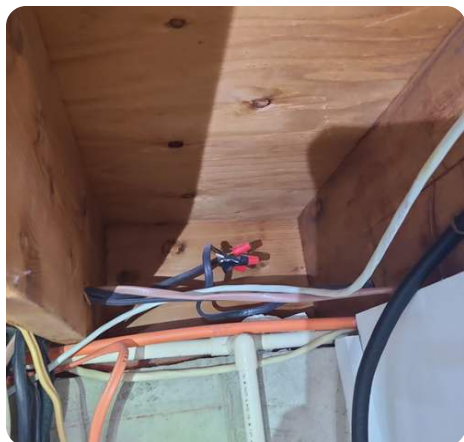
The inspector noted exposed electrical splices on the property. It is recommended to contact a qualified professional to make the necessary repairs.

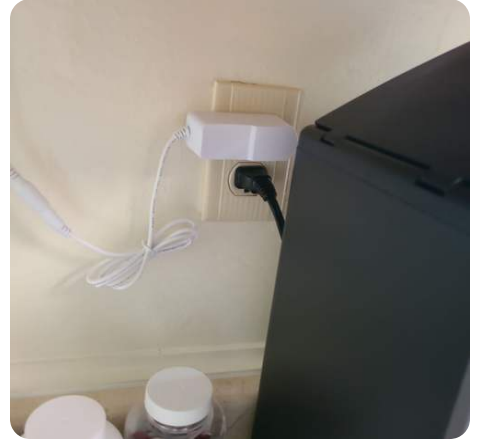
**10 Missing GFCI Protection (Kitchen Counter)**

Kitchen countertops require Ground-Fault Circuit Interrupter (GFCI) protection for electrical receptacles. GFCI protection was not found for some counter-level receptacles, indicating a potential electrical shock hazard. We recommend that a qualified electrician evaluate the circuits and install proper GFCI protection to improve safety.

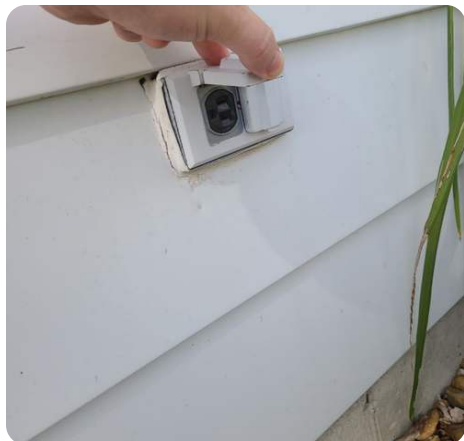
**12 Missing GFCI Protection (Exterior)**

The GFCI (Ground Fault Circuit Interrupter) protection is absent for the exterior electrical outlets. GFCI outlets are essential for safeguarding against electric shock risks, particularly in wet or damp locations like the exterior. It is advised to install GFCI outlets for safety and to meet electrical codes. Contact a qualified electrician to assess and set up the required GFCI protection.

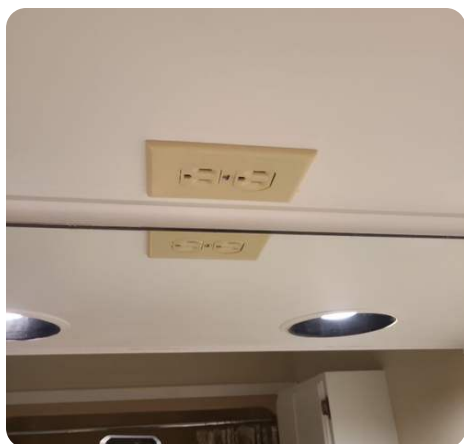
**13 Missing GFCI Protection (Bathroom)**

All receptacles in the bathroom lack GFCI (Ground-Fault Circuit Interrupter) protection, which is a safety concern in locations with exposure to water. GFCI protection is a standard safety feature that helps prevent electrocution. Recommend a qualified electrician evaluate and upgrade the bathroom receptacles to meet current safety standards.

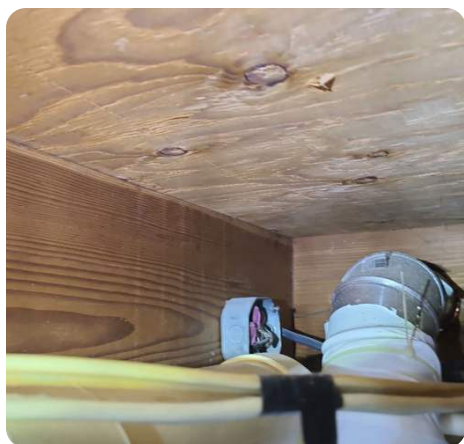
**14 Open Junction Box**

An open junction box containing exposed wire connections was observed within the home at the time of the inspection. Junction box covers offer protection to the wire connections, limits debris and rodent access, while containing any potential arcing within the box. It is recommended that an approved cover be installed by a qualified professional.

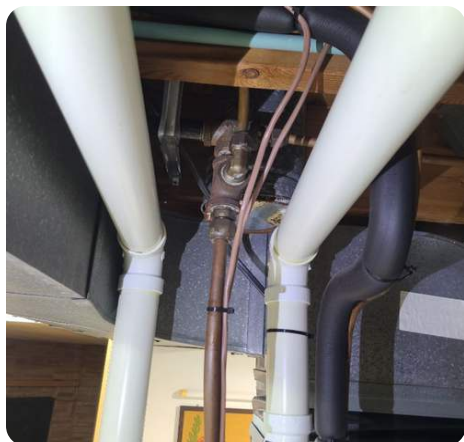
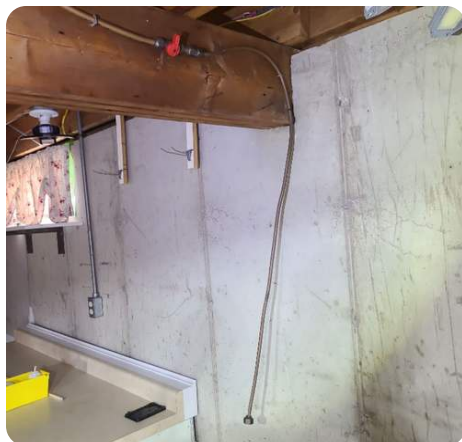
The copper propane gas line is not recommended for gas supply as it may not be approved for gas distribution. It is recommended to have a licensed plumber evaluate and replace the copper gas line with an appropriate material for gas supply, such as black steel or CSST piping.

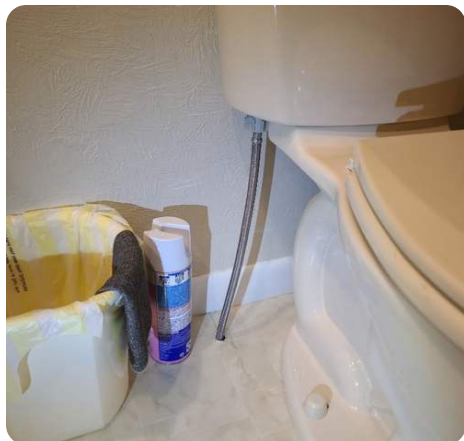
### 17 Missing Shut Off Valve For Toilet

The toilet is missing a shut-off valve, which is essential for turning off the water supply to the toilet when needed. It is recommended to have a qualified plumber install a shut-off valve to ensure proper functionality and maintenance of the toilet.

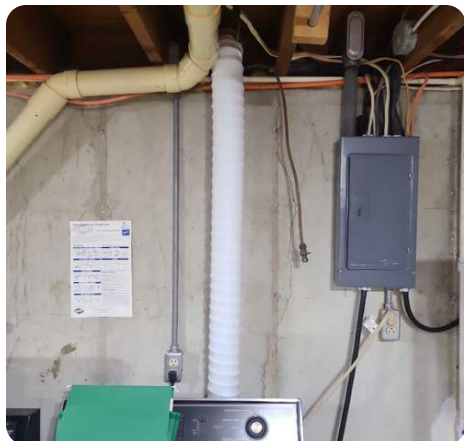
### 19 Improper Dryer Vent Material

The dryer vent system is constructed with improper material. It is recommended to use only rigid or flexible metal venting material for the dryer exhaust. Improper materials such as plastic or foil can be a fire hazard due to their flammability. The issue should be addressed promptly by a qualified HVAC technician to ensure proper ventilation and reduce the risk of fire.

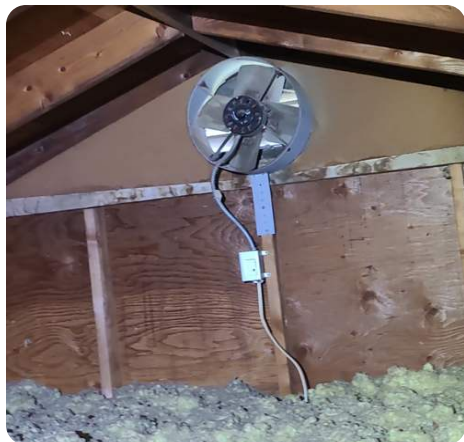
The powered vent fan in the attic is not functioning. It is recommended to evaluate and repair the fan to ensure proper ventilation in the attic. Proper attic ventilation helps in preventing moisture buildup and prolongs the life of the roof. A qualified electrician or HVAC technician can assess and repair the powered vent fan to maintain good air circulation.

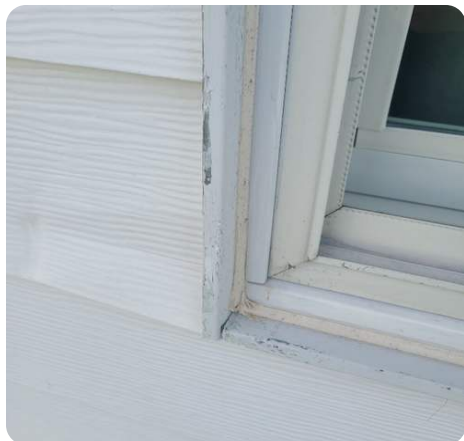
### Wooden Window Trim Painting Recommendation

The wooden window trim requires painting to protect it from weather damage and prolong its lifespan. It is recommended to evaluate the current condition, scrape off any loose paint, sand the surface for better adhesion, apply a primer, and then paint with a suitable exterior paint. Ensuring proper preparation and using high-quality paint will help maintain the integrity of the trim.

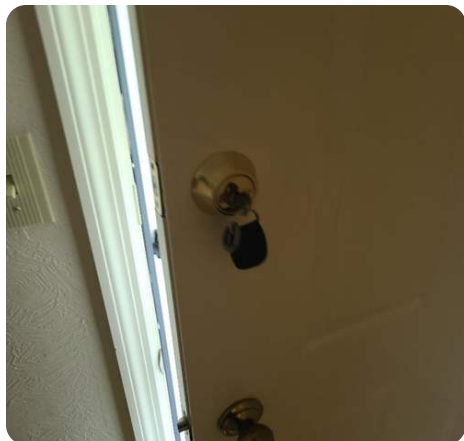
The double-keyed deadbolts, which require a key to unlock from both sides, can pose a fire safety hazard by restricting quick egress during an emergency. It is recommended to replace them with single-keyed deadbolts or other safe locking mechanisms. A qualified locksmith can evaluate and perform the necessary replacement.

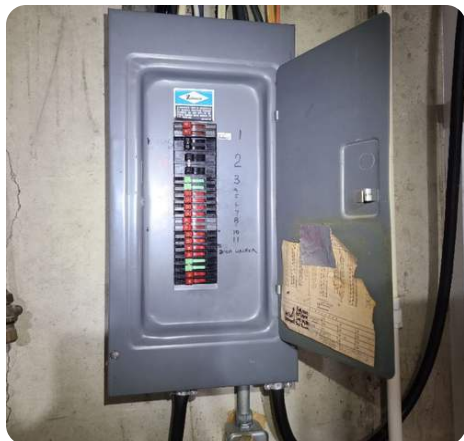
- **Manufacturer:** Zinsco (Sylvania/GTE-Sylvania)
- **Status:** Noted Safety Hazard
- **Recommended Action:** Full Replacement by Licensed Electrician

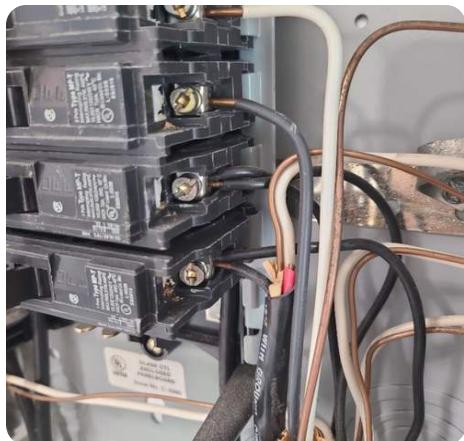
The double tapped breaker issue involves two wires being connected to a breaker designed for a single wire. This can lead to overheating, creating a fire hazard. It is recommended to have a qualified electrician evaluate and repair this issue by installing a separate breaker for each wire to ensure safety and proper function of the electrical panel.

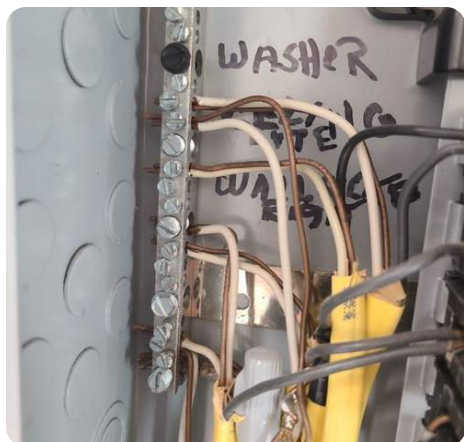
#### Double-Tapped Neutral

Double-tapped neutral was observed at the sub-panel where two neutral wires are connected to a single terminal slot. This could result in poor connections, and overheating, and poses a potential fire hazard. It is advised to contact a qualified electrician to address this issue for the safety and optimal performance of the electrical system.

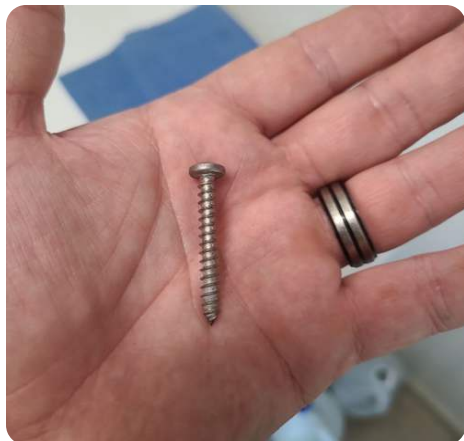
#### Pointed Screws In Subpanel

The subpanel was found to have pointed screws. Pointed screws are not recommended for subpanels as they may pierce the insulation of wires, leading to potential safety hazards. It is recommended to replace them with proper screws to ensure the safety and integrity of the electrical system. A licensed electrician should evaluate and replace the screws as needed.

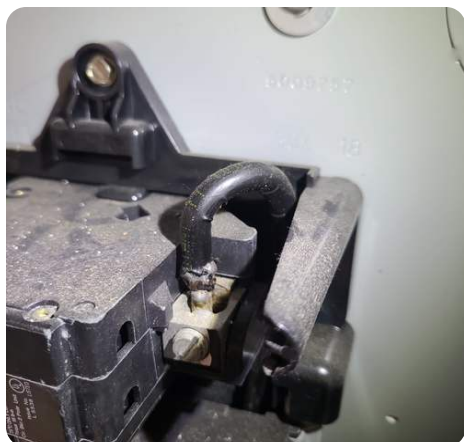
#### Melted Insulator On Feeder Conductor In Subpanel

The insulator on the feeder conductor in the subpanel is melted, indicating a potential overheating issue. This could lead to electrical hazards and should be addressed promptly. It is recommended to have a licensed electrician evaluate and repair the melted insulator to ensure safe operation of the electrical system.

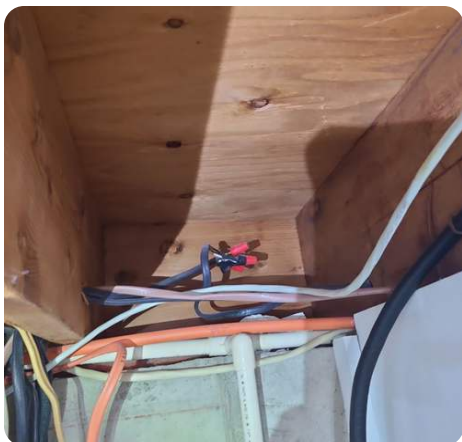
The inspector noted exposed electrical splices on the property. It is recommended to contact a qualified professional to make the necessary repairs.

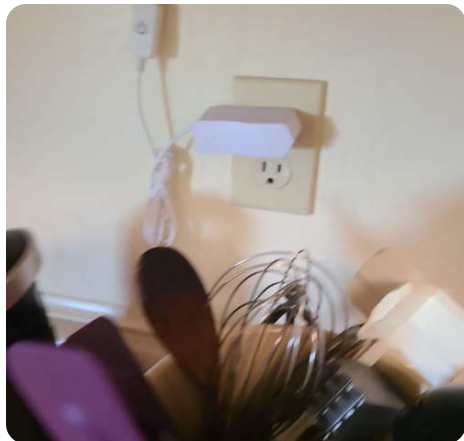
Kitchen countertops require Ground-Fault Circuit Interrupter (GFCI) protection for electrical receptacles. GFCI protection was not found for some counter-level receptacles, indicating a potential electrical shock hazard. We recommend that a qualified electrician evaluate the circuits and install proper GFCI protection to improve safety.

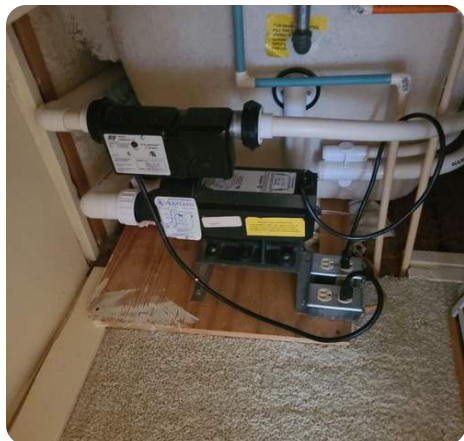
### Missing GFCI For Jetted Tub

A jetted tub is missing Ground Fault Circuit Interrupter (GFCI) protection. It is recommended to have a qualified electrician install a GFCI outlet near the tub for improved safety. GFCIs help protect against electric shocks in areas where water is present. Evaluate and repair by installing a GFCI outlet to ensure proper electrical safety measures are in place.

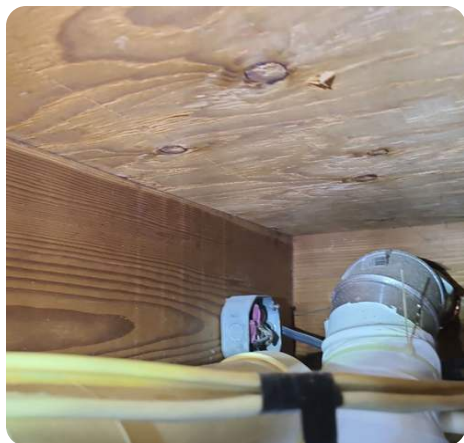
An open junction box containing exposed wire connections was observed within the home at the time of the inspection. Junction box covers offer protection to the wire connections, limits debris and rodent access, while containing any potential arcing within the box. It is recommended that an approved cover be installed by a qualified professional.

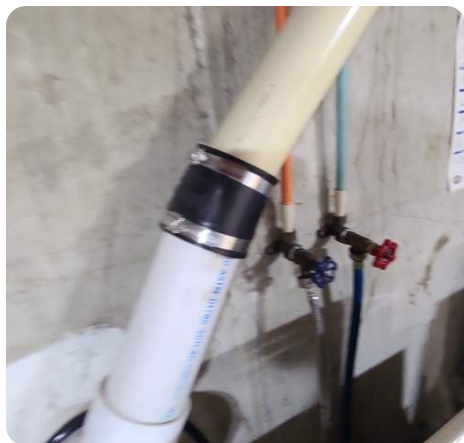
#### Fernco Adapter On Drain Line Issue

The Fernco adapter on the drain line is not an approved plumbing fitting. This can lead to leaks and potential drainage issues. It is recommended to have a qualified plumber evaluate and replace the Fernco adapter with the appropriate plumbing fittings to ensure proper drainage and prevent future issues.

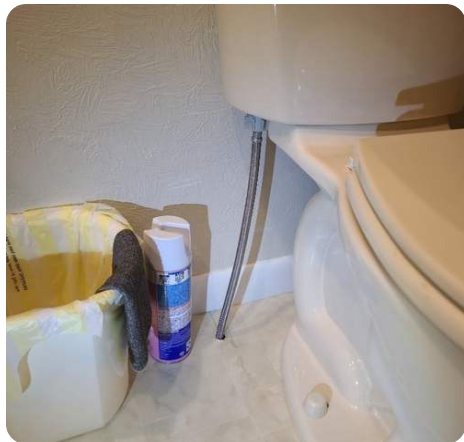
#### Missing Shut Off Valve For Toilet

The toilet is missing a shut-off valve, which is essential for turning off the water supply to the toilet when needed. It is recommended to have a qualified plumber install a shut-off valve to ensure proper functionality and maintenance of the toilet.
