# Inspection Report

**Property Address:**  
16153 Monroe Rd 743  
Paris MO 65275

**Integrity Home Inspection**

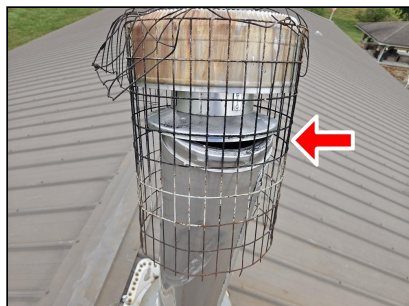
Chimney Cap is loose and not properly secured.

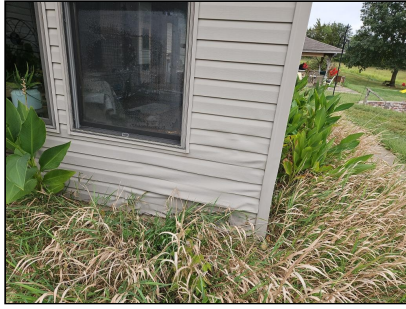
The siding at the southwest corner of the sun porch is thermally damaged.

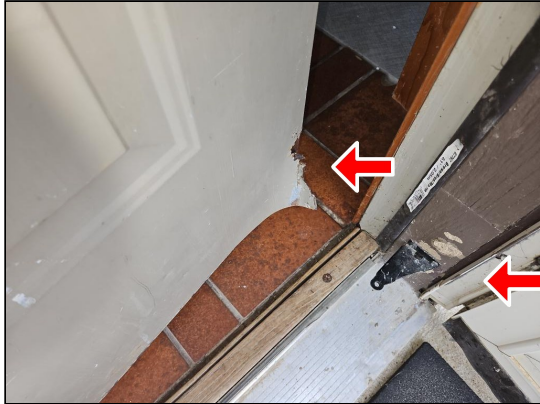
(1) Southeast exterior door is damaged at the bottom. Additionally the snow radar is missing its closer.

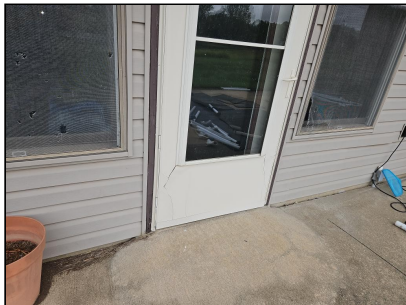
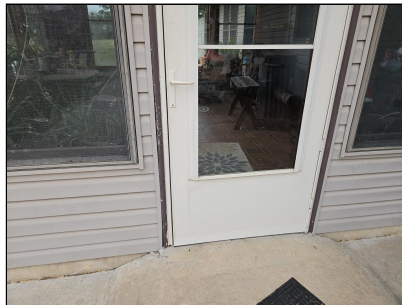
(2) The vinyl storm door on the Southside of the home and the sun porch door is cracked and deteriorating.

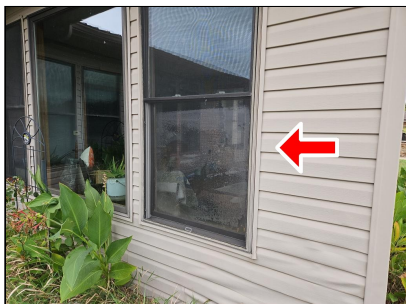
Westside Sun porch

Window(s) were observed with fogging or stains between the glass. This is often an indication of a broken seal separating the panes of glass or a breakdown of coating on the glass. Replacement of glass as desired.

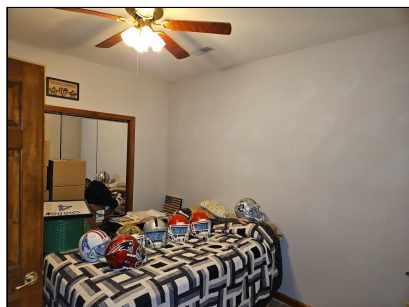
North bedroom

Typical Of berm homes, The north Bedroom Does not have an External Source for egress.

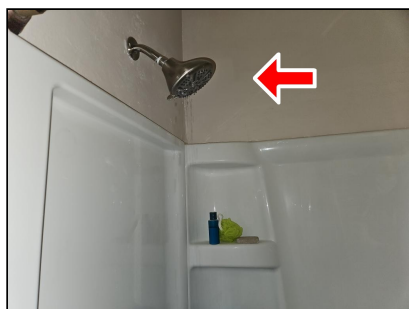
The shower in the East bathroom did not have any pressure at the shower head

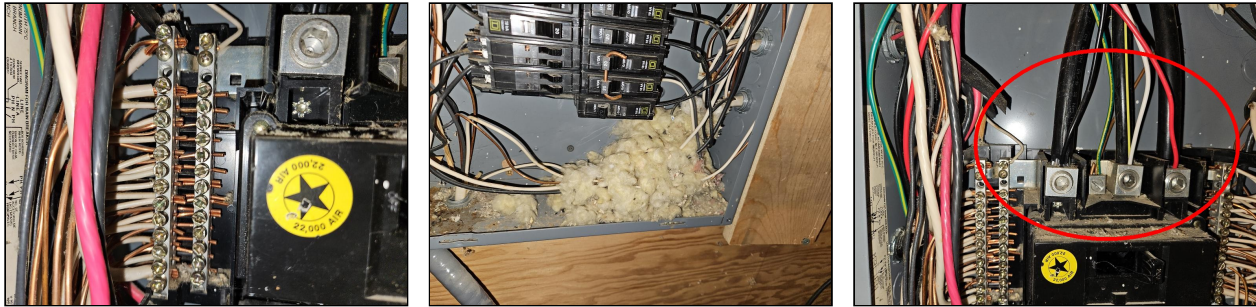
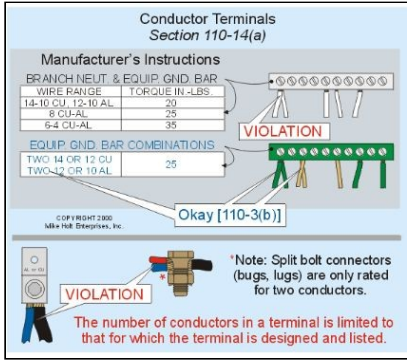
Double tapping in the panel was observed. Current requirements state Neutrals & Neutral /Ground combinations should not share the same connection hole/screw. Although many electricians do not follow this rule and local municipal inspectors "OK" this infraction, it is still considered unsafe. Suggest corrective measures be considered in the near future. It has been required by manufacturer's instructions and Underwriters Laboratories Standard 67 for panelboards for some time. See this link for a narrative description of the reason for single neutral wire - single screw.

It appears that a mouse has made a nest inside the electric panel period

Bootlegging off of the main lugs was observed. This is extremely unsafe.

double tap ill.

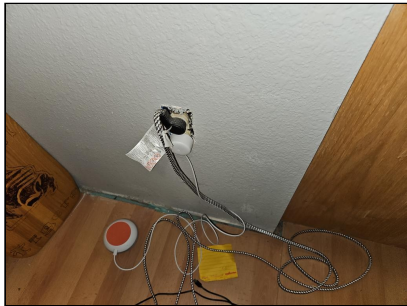
Office area

Cover(s) are missing from receptacle(s) and/or switch(es). Suggest covers be installed for safety.

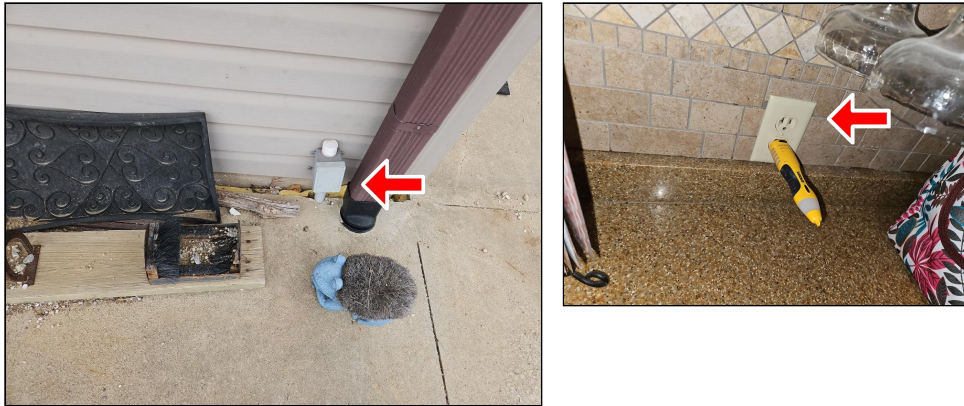
(1) The GFCI receptacles on the south side of the home did not have power. Additionally comma The receptacle To the right of the sink did not have power.

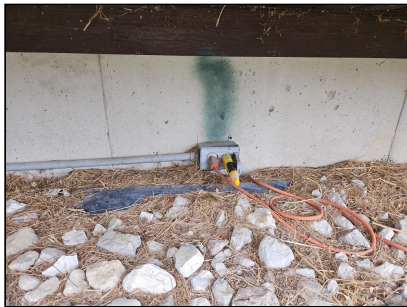
Exterior north side

(2) The receptacle on the North side of the home Was not GFCI protected.

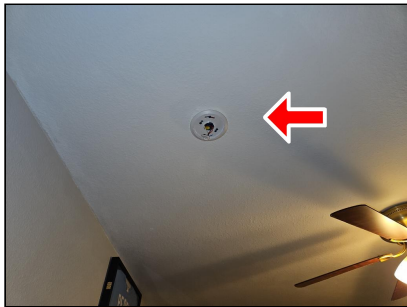
Smoke detector is missing in the north bedroom period

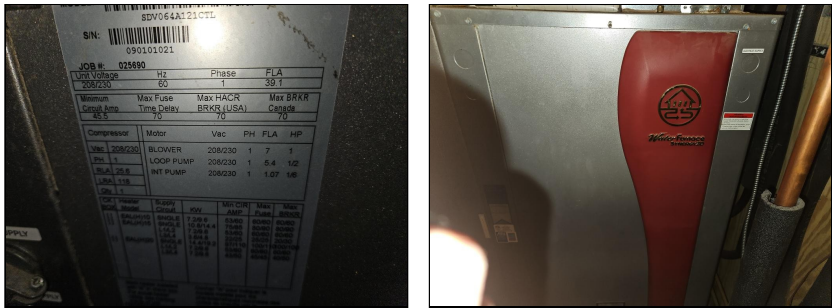
(1) The Heat pump & emergency heat were tested and the emergency heat did not produce heat . Geo thermal circulation pump/loop systems are not evaluated as this is outside the scope of a home inspection. A qualified hvac technician can provide this service to you if desired. As a matter of maintenance, it is advised to have the system maintained and serviced a minimum of once a year.

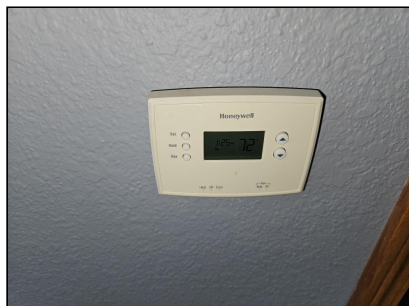
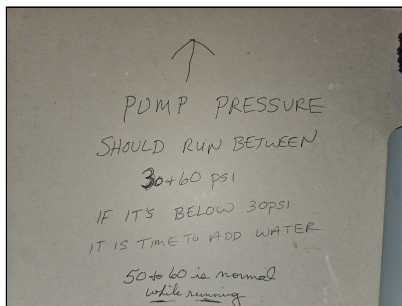
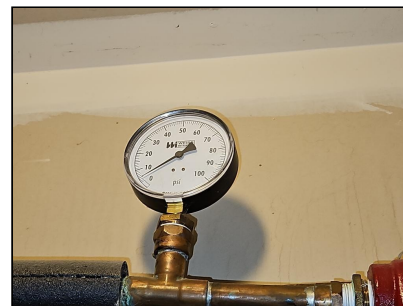
(2) The home has an in-floor heating system. It appears that a 115 gal State Electric water heater supplies the heat for this system. The system was not operated. Recommend evaluation and testing by qualified HVAC tech.

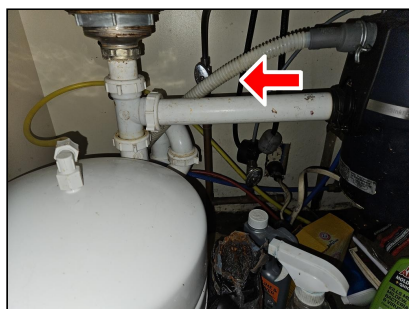
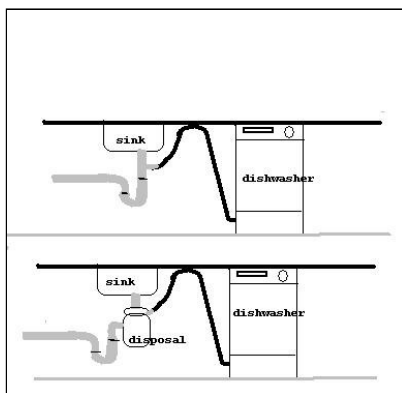
highloopimage

The drain for the dishwasher does not "high loop" above the tub. Without a high loop, waste water could back up into the dishwasher. A few dishwasher models have a high loop built in to the side making an additional high loop unnecessary. The dishwasher would likely have to be removed to verify. FYI
