Home Inspection Report

PROPERTY INSPECTED:
2175 Quaethem Drive
Wildwood, MO 63005

Date of Inspection: 03/23/2026

Inspection No. 551034-13856

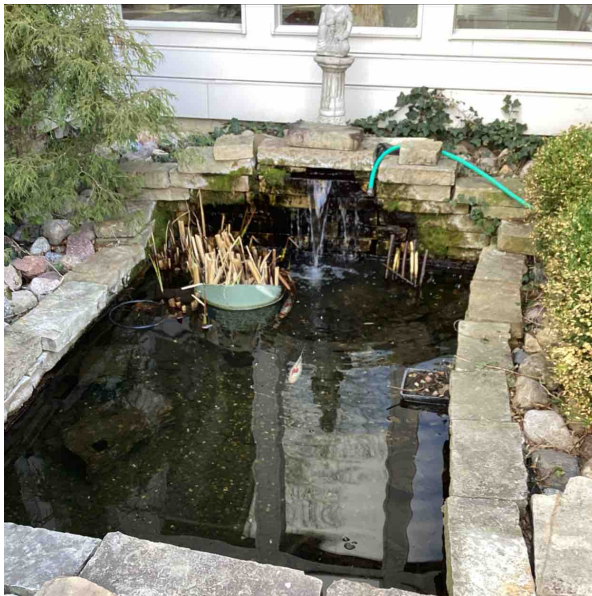
2.2.1 Ponds and associated components are beyond the scope of this inspection. Recommend further evaluation by a qualified contractor as needed and demonstration of operations/controls by home owner, if applicable. **(Exterior Front)**

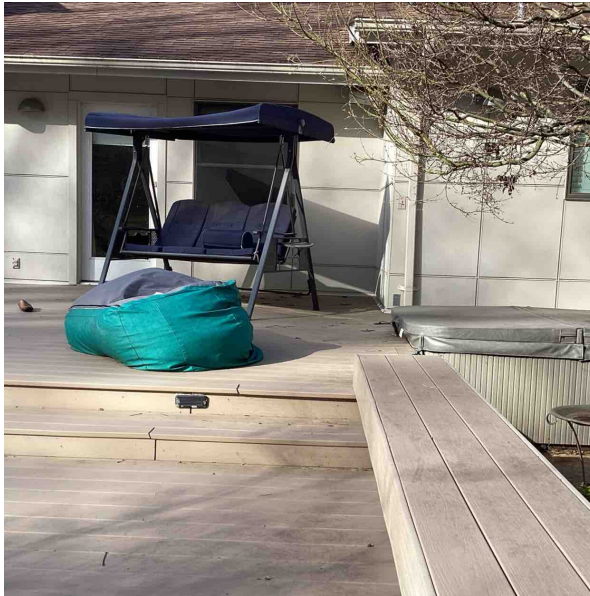
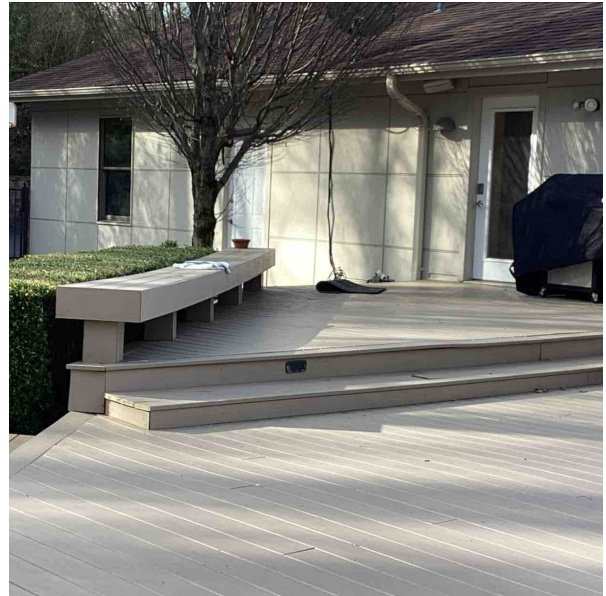
(Exterior Back)

3.9.3 **Sagging noted in the composite deck surface indicating issues with the structure, recommend further evaluation and correction as needed by a qualified contractor. (Exterior Back)**

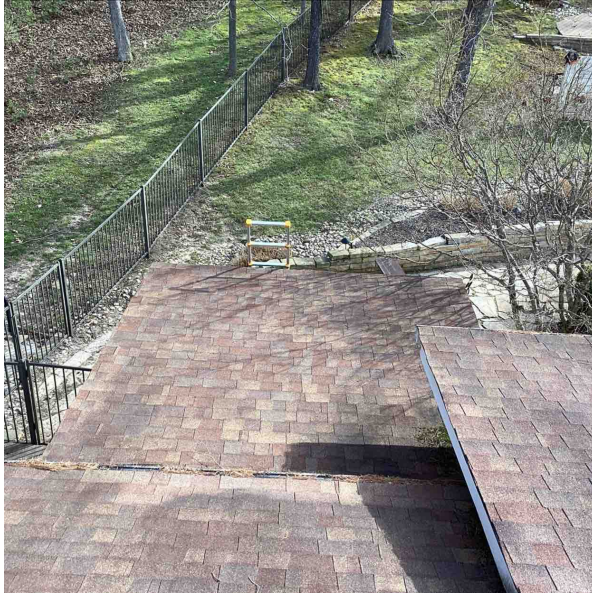
4.4.2 Less than a 4/12 slope was identified. Some manufacturers limit shingle use on low sloped roofs, or require extra protective measures installed. Consult with the seller and/or roofing contractor regarding any documentation on the installation, any associated warranties.

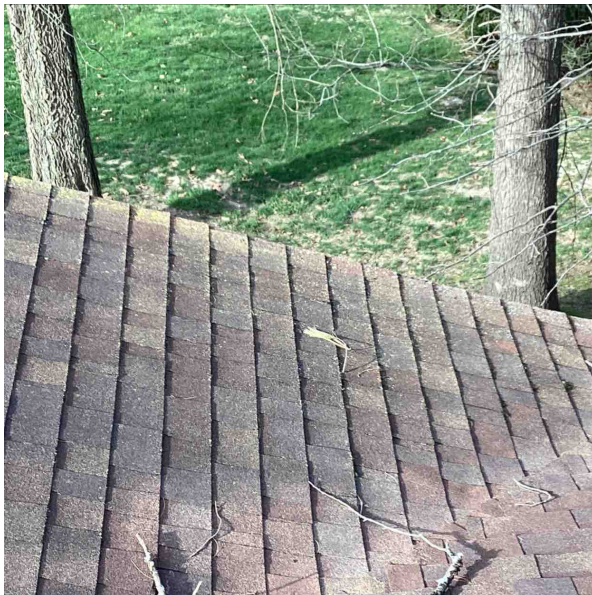
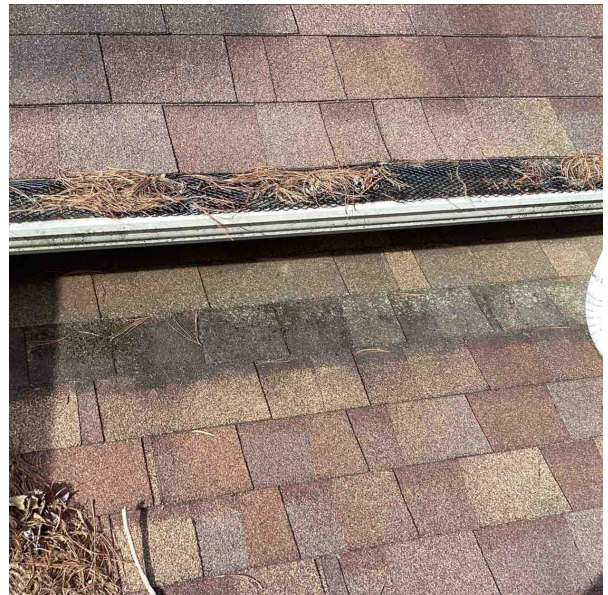
4.4.4 There are branches, sticks and leaves on roof. Remove tree debris off roof to prevent accelerated shingle deterioration and damage.

4.4.5 Staining present on the roof covering is an indication of an algae or fungal growth which can prematurely age the shingle, but is of minimal concern. A qualified contractor can clean the roof covering if desired.

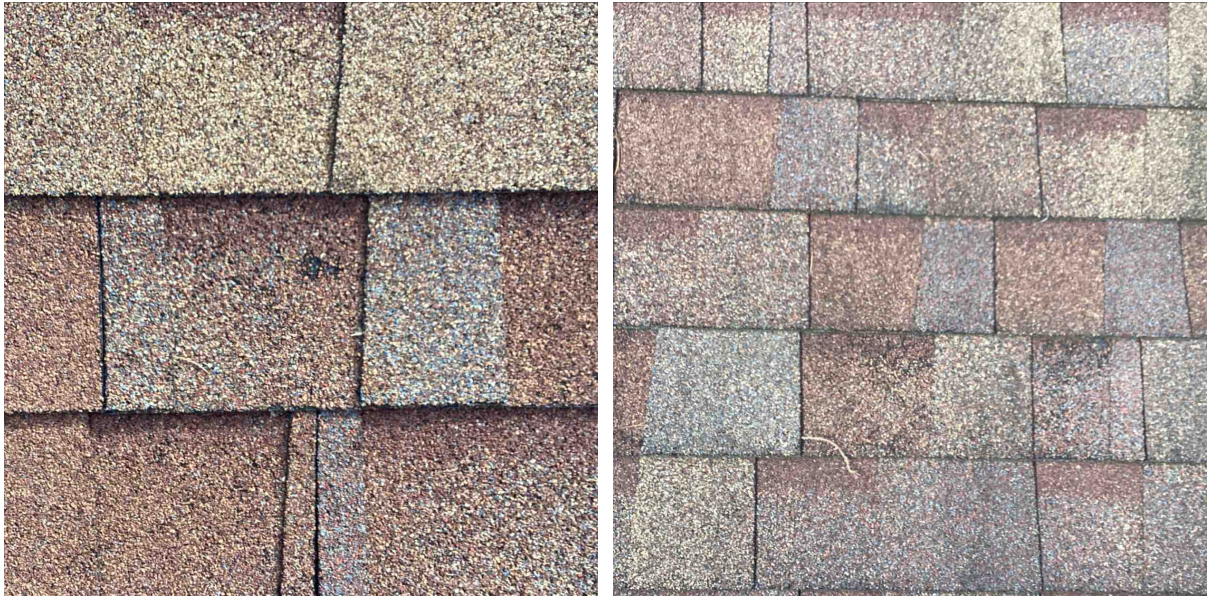
4.4.6 Evidence of hail and / or heat related damage. This type of wear may prematurely age the shingles but no repair or replacement is warranted in my opinion.

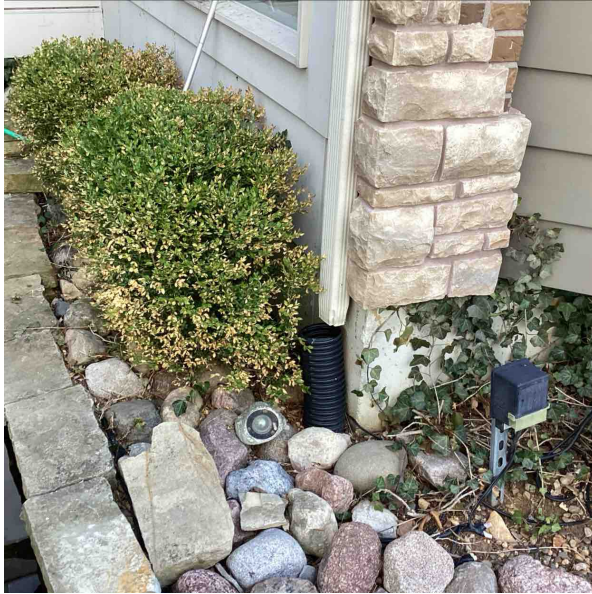
(Exterior Front)

4.6.5 Downspout disconnected from underground drain tile. Recommend repairs to ensure proper drainage away from the structure.

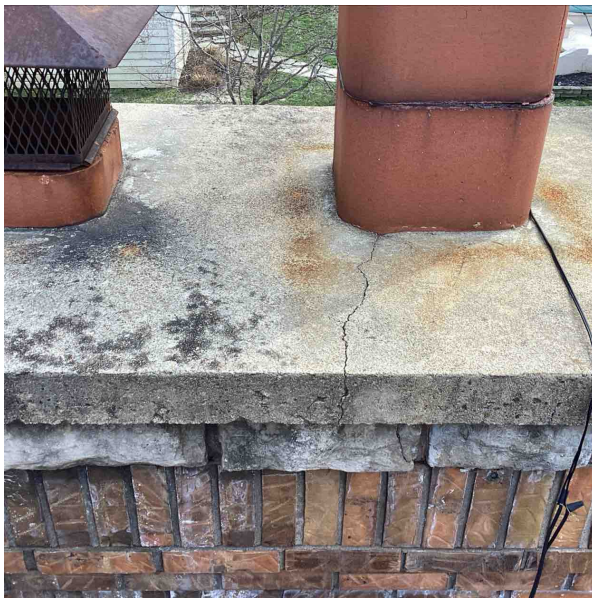
4.7.2 Recommend sealing cracks in the chimney crown to limit moisture entry and further damage.

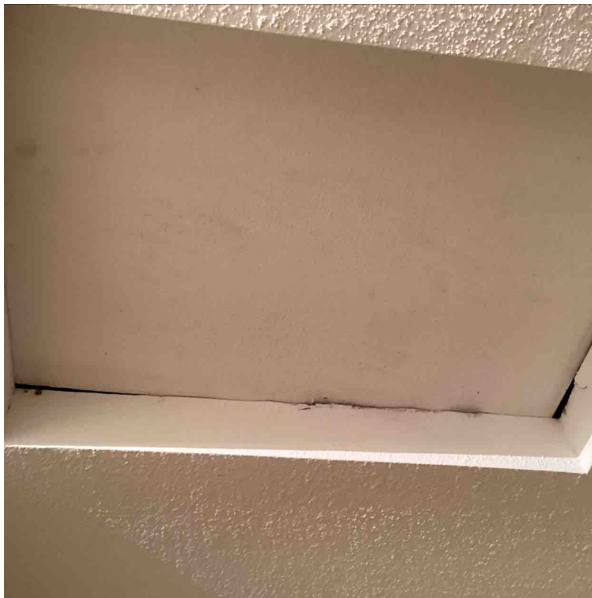
5.2.2 Attic hatch cover does not completely cover the hatch opening, creating a breach of the fire barrier. Replace cover with a properly fitted cover to ensure a proper fire barrier. (Primary Bedroom)

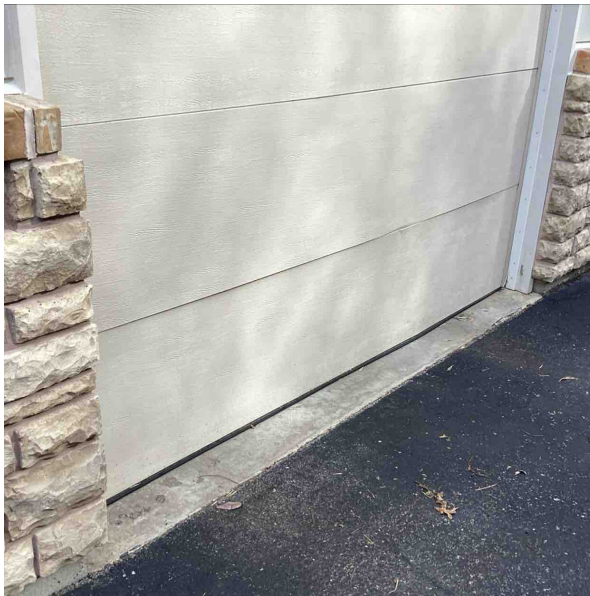
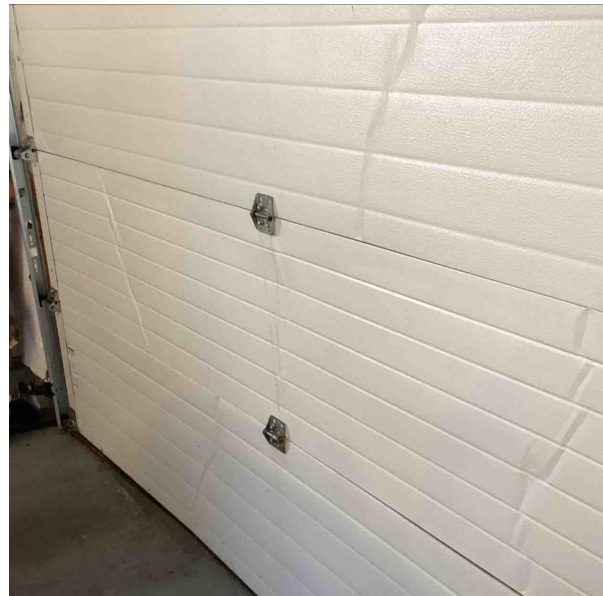
6.5.3 Minor damage noted to garage door does not appear to affect the operation. Monitor and repair as needed. **(Garage)**

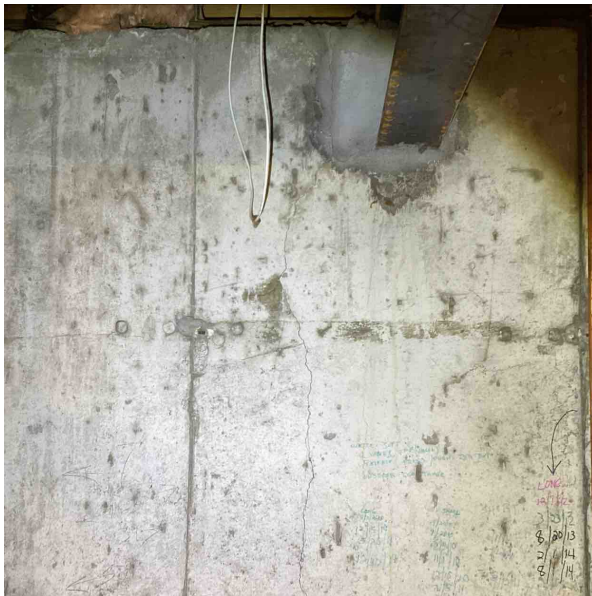
7.3.3 Minor cracks apparent in the foundation are very common and likely relate to drying of the concrete and / or minor amounts of settlement. Monitor for additional activity (e.g. cracking, moisture entry) and repair as needed. **(Mechanical/Utility Room)**

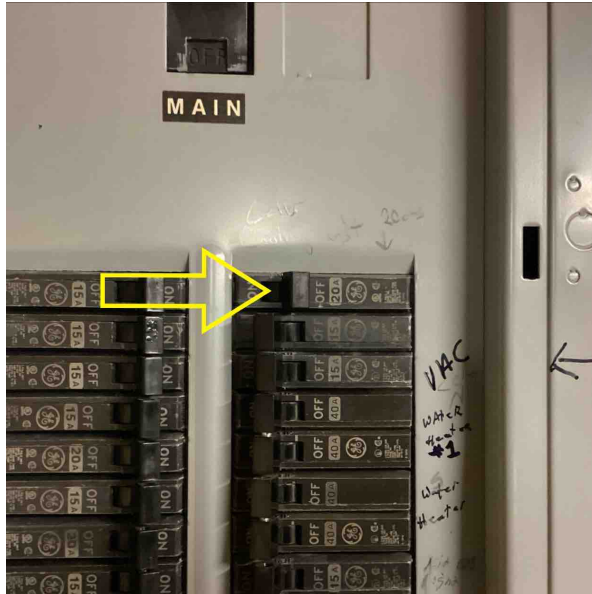
8.6.5 Breaker(s) were noted in the off position. Breakers are not turned on during an inspection due to risk of damage if they are off for a reason. Inquire with the seller and/or have them evaluated by an electrician as needed to ensure proper operation and loads. **(Mechanical/Utility Room)**

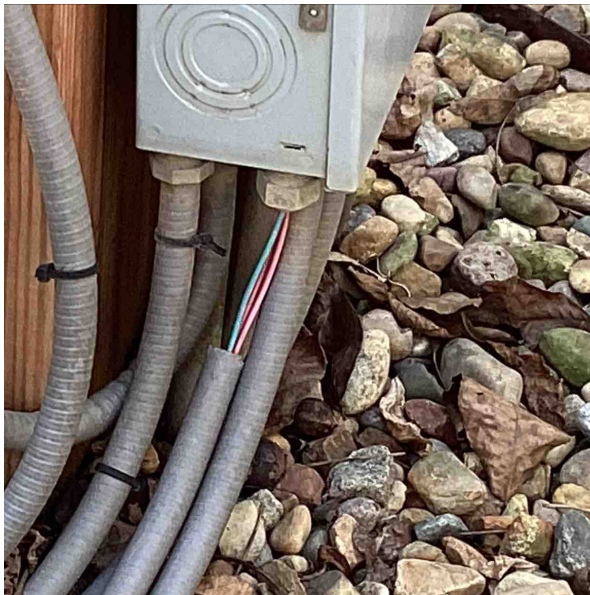
8.9.2 **Have a qualified contractor secure loose wiring for safety. (Exterior Back)**

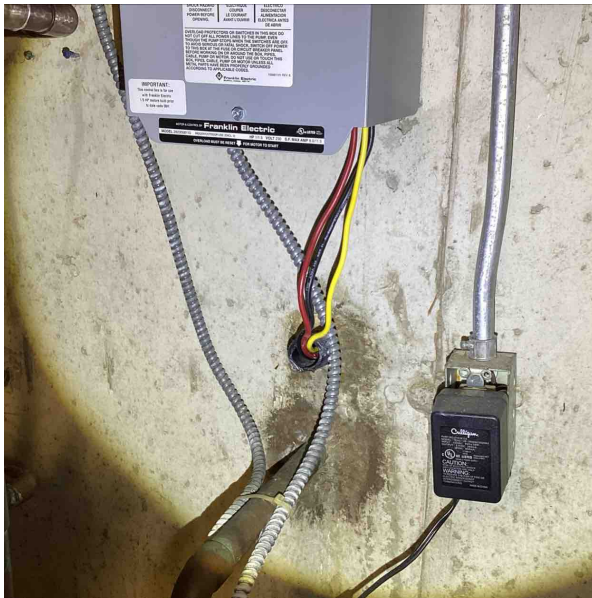
8.9.3 All unprotected exterior wiring should be placed in proper conduit to prevent possible wire damage and associated electrical safety concerns. (Mechanical/Utility Room)

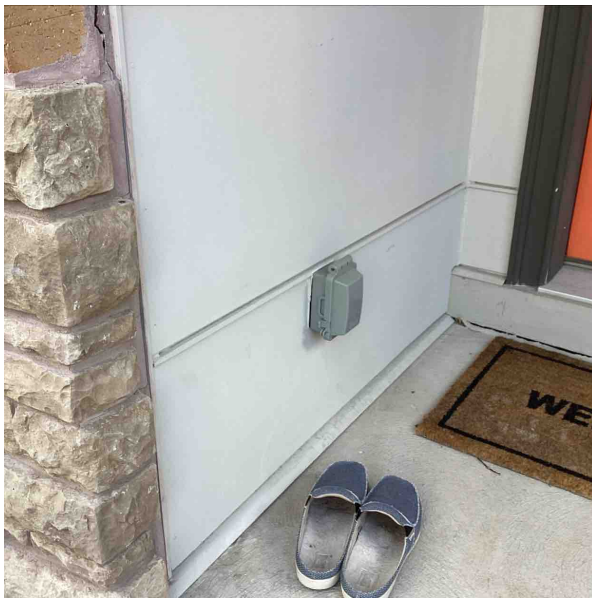
8.10.2 **Defective GFCI receptacle(s) identified. Receptacle(s) will not trip/reset. Recommend replacement by a qualified electrician. (Exterior Front)**

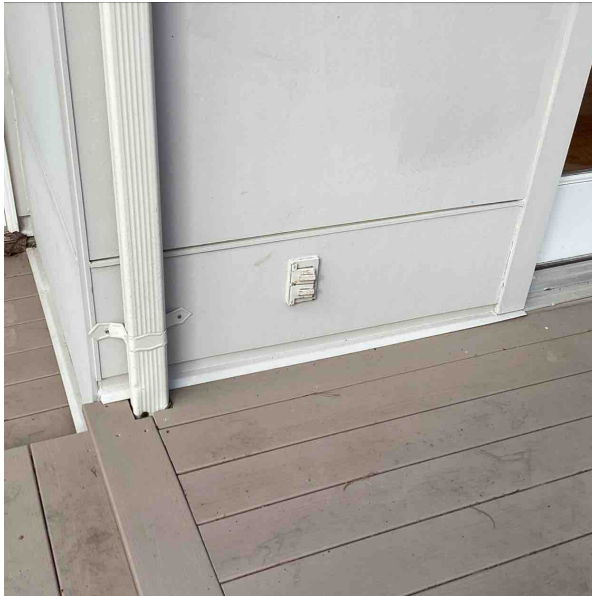
8.10.3 Have a qualified contractor upgrade the weather protected exterior receptacle cover(s) as needed to provide proper protection if components will be plugged in on a regular basis.

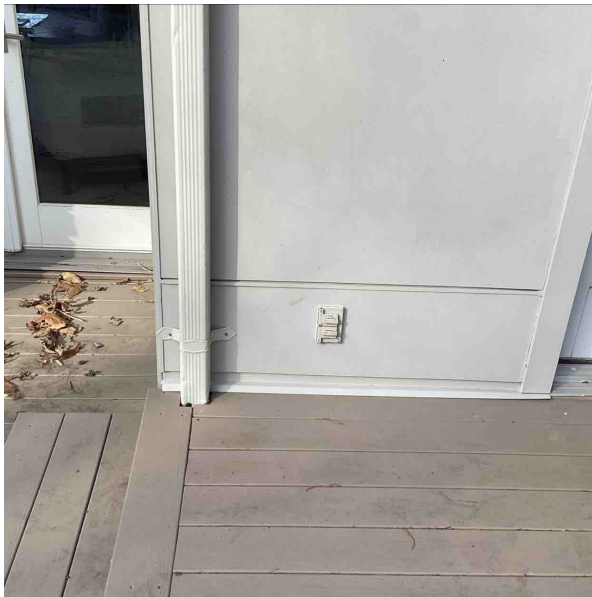
8.10.4 Have a qualified electrician install/ensure GFCI protection on all exterior receptacles for safety.

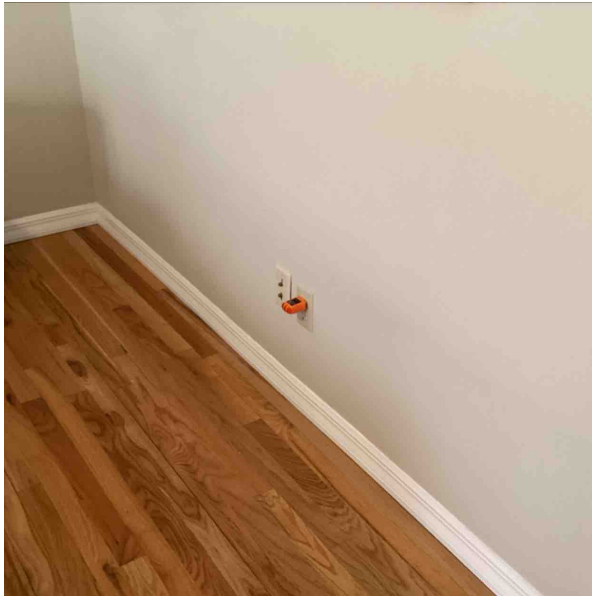
8.10.5 **Non-powered receptacle(s) identified at the time of inspection. Recommend further investigation and repair by a qualified contractor to ensure proper operation. (Primary Bedroom)**

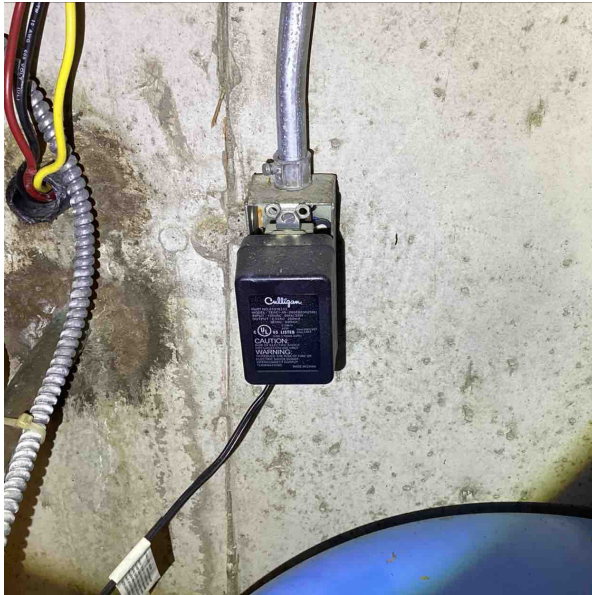
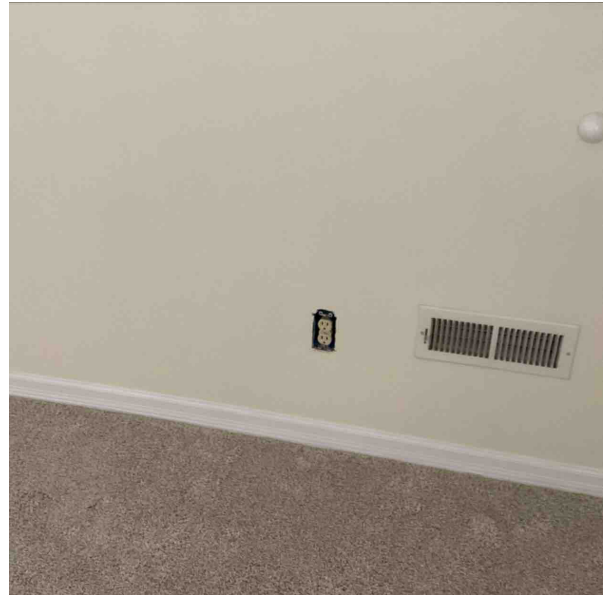
8.10.6 **Replace damaged receptacle covers to limit potential shock hazards. (Basement)**

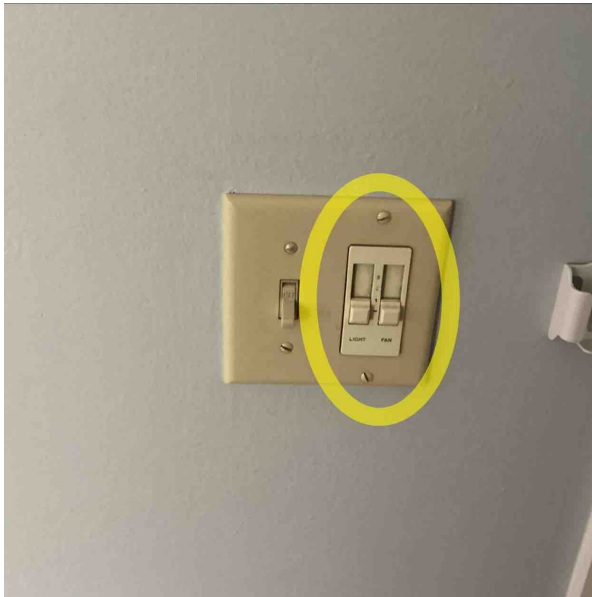
- Back Left Bedroom
- Front Left Bedroom

8.11.3 **Wall switches are prohibiting normal operation of the ceiling fans. Recommend further evaluation and and correction as needed as needed to ensure proper operation.**

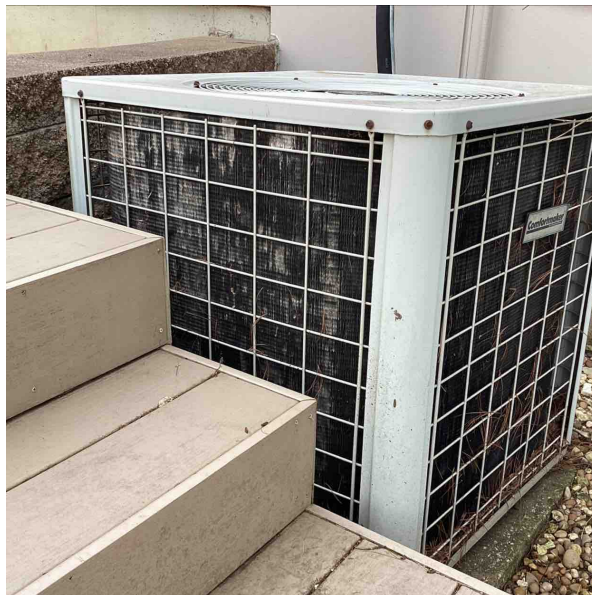
9.5.3 The heat pump has exceeded its typical life expectancy. You may want to consider getting a home protection plan and/ or budget for the eventual replacement. (Exterior Left)

9.5.4 The condenser fins are damaged. Have a qualified HVAC contractor evaluate to determine of scope of repairs needed for improved operation. (Exterior Left)

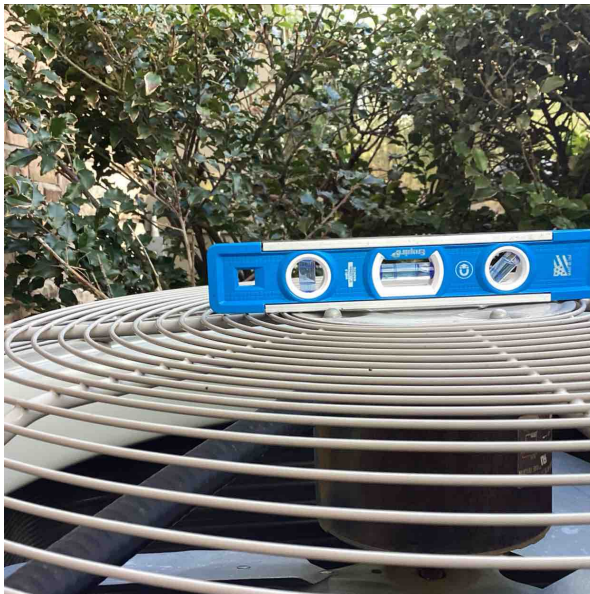
9.6.4 Have a qualified contractor level the condenser unit to limit premature wear and damage to the unit. (Exterior Front)

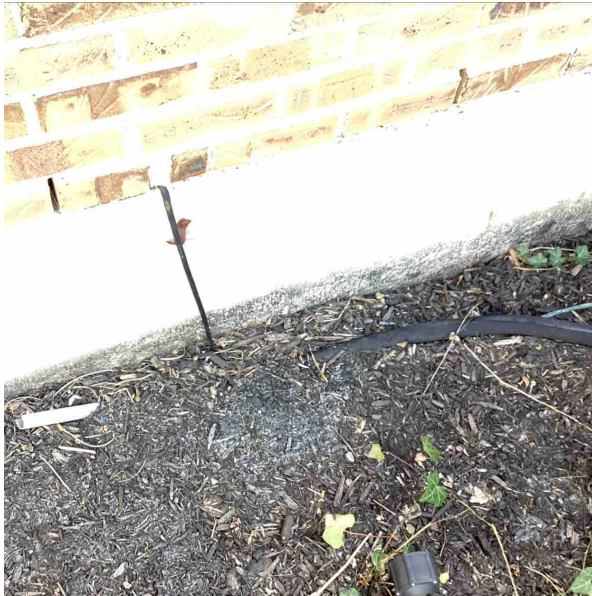
9.6.5 Air conditioner line set are buried under ground. Recommend correction by qualified contractor..
(Exterior Front)

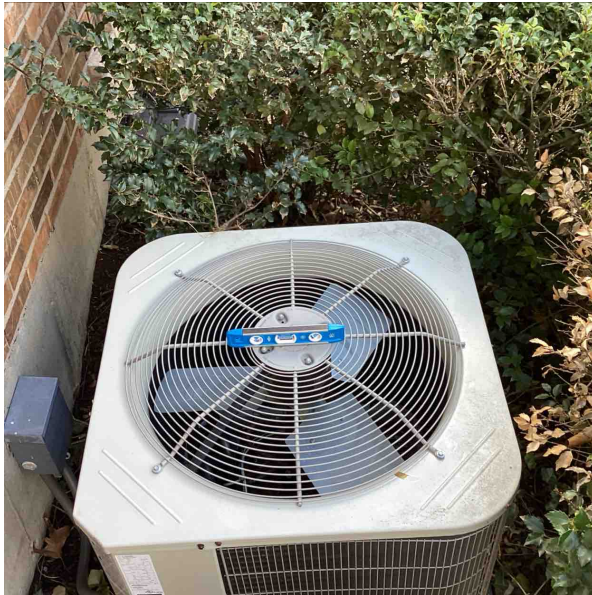
9.6.6 Trim vegetation away from condenser to ensure proper operation and efficiency. (Exterior Front)

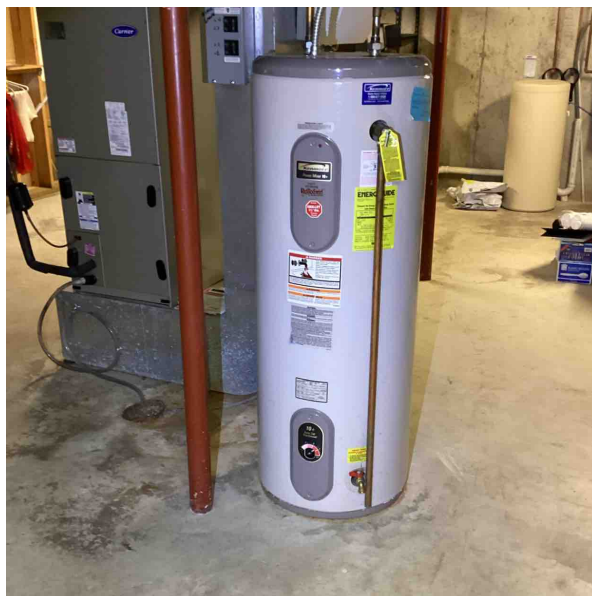
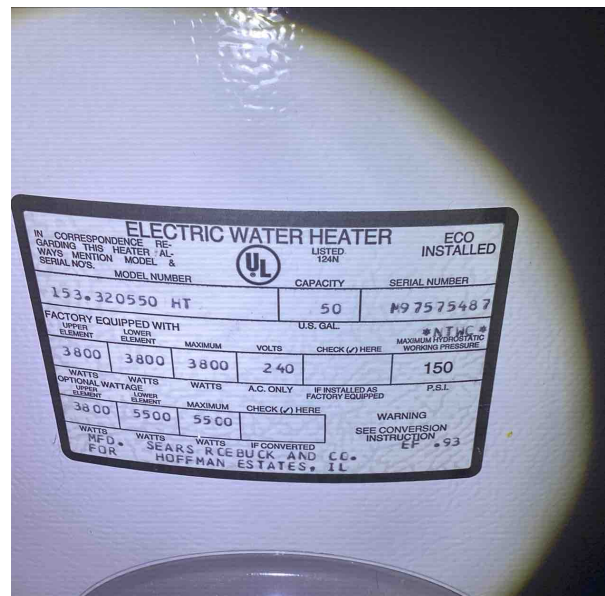
10.6.6 Water heater has exceeded the typical life expectancy. Water heater was operational. Consider a home protection plan and/or budget to replace. **(Mechanical/Utility Room)**

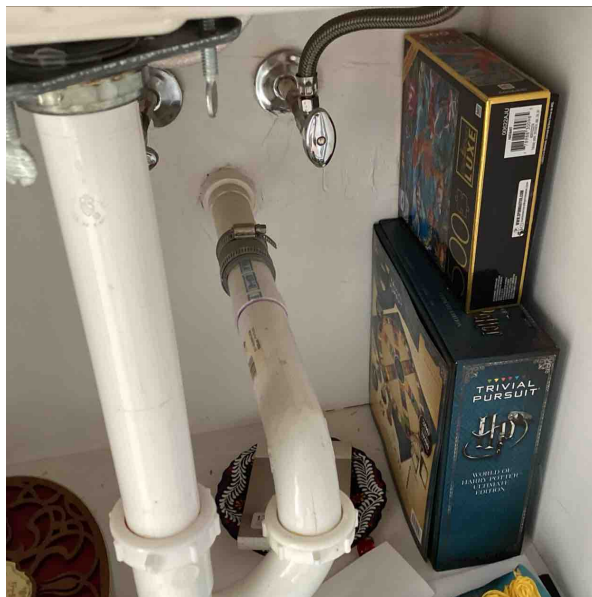
10.8.2 Rubber clamp connectors under sinks are prone to leaks. Recommend corrections as needed to limit potential leakage and related damage.

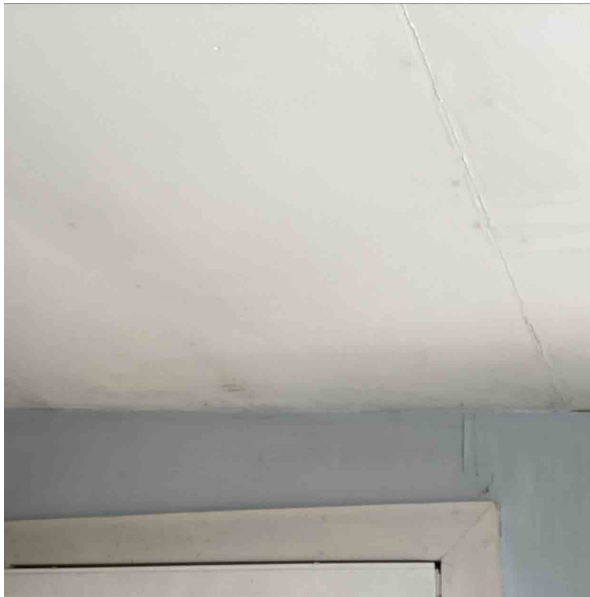
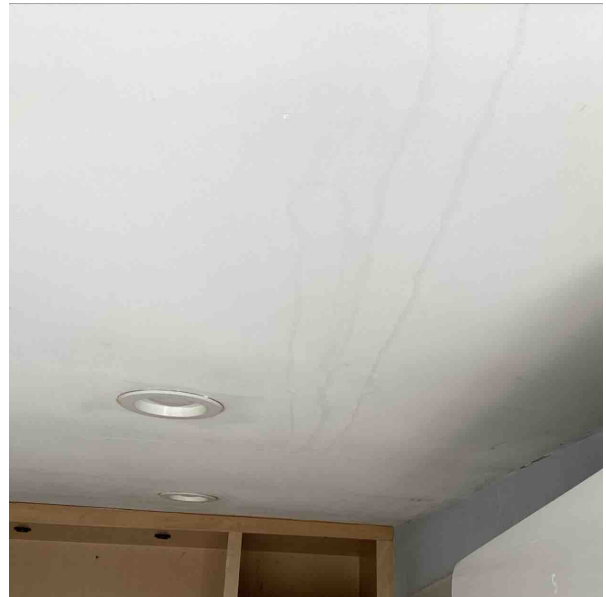
11.4.4 **Moisture staining/surface damage identified had elevated levels of moisture when tested at the time of inspection. Have a qualified contractor further investigate into the source of moisture and repair as needed to limit further activity and associated damage. Have any materials and areas cleaned/repaired/replaced as needed. (Art Room)**

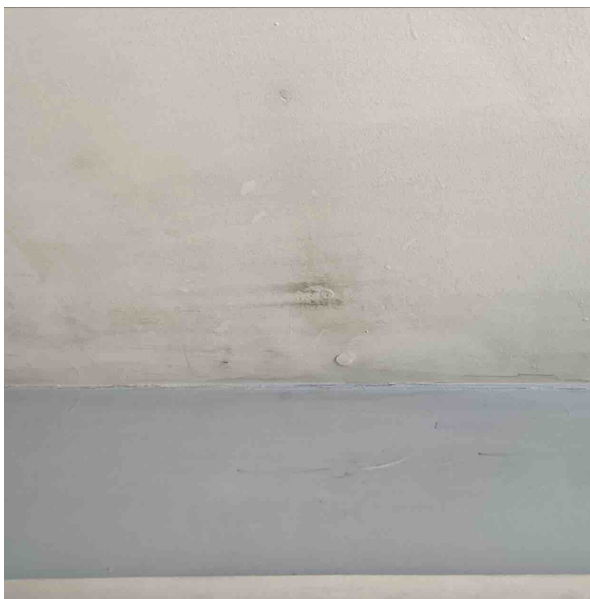
11.4.5 **Visible evidence of suspected mold / mildew related growth was present in isolated areas. Consult a qualified contractor to remove damaged material to allow further evaluation and clean / treat / remove as needed. Additionally, measures should be taken to limit potential future activity. Please review the following EPA web site regarding mold identification, hazards, and remediation (www.EPA.gov/mold). Defer to the mold report if applicable. (Art Room)**

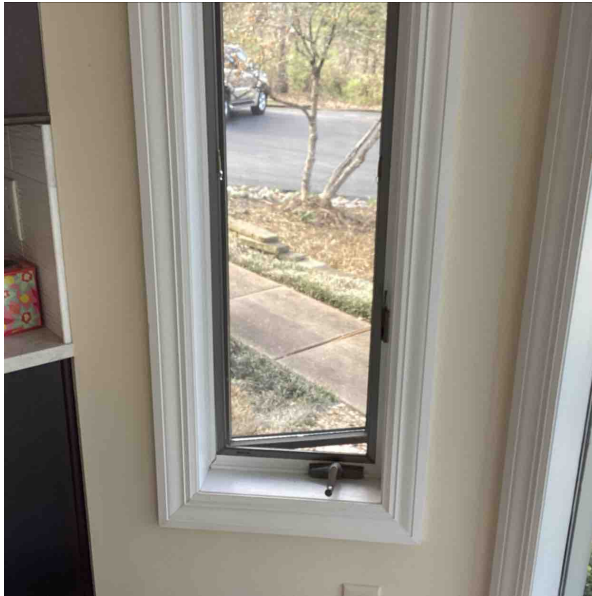
11.5.4 Casement crank(s) were damaged/didn't operate properly. Have a qualified contractor repair/replace components as needed for proper operation. (Kitchen)

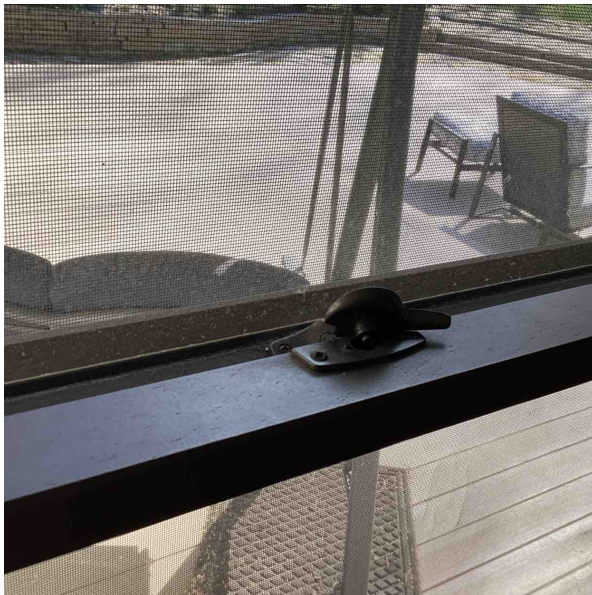
11.5.5 Missing/damaged lock hardware identified. Recommend repairs to ensure proper locking ability. (Primary Bedroom)

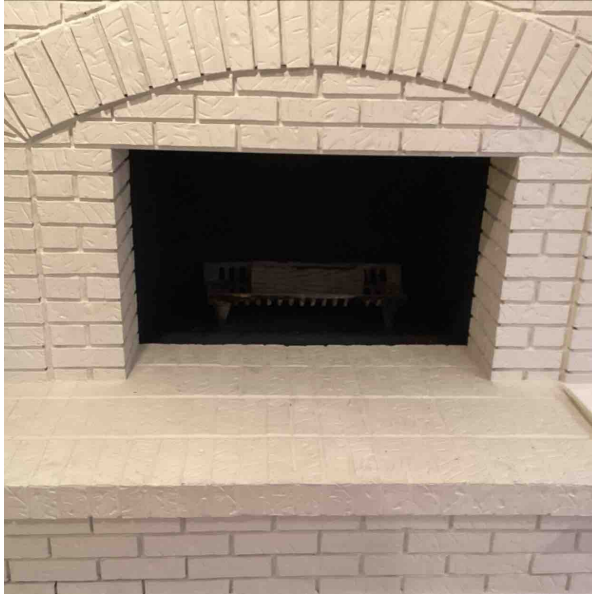
12.2.3 **The door and/or screen are missing or damaged. Repair this for improved safety. (Basement)**

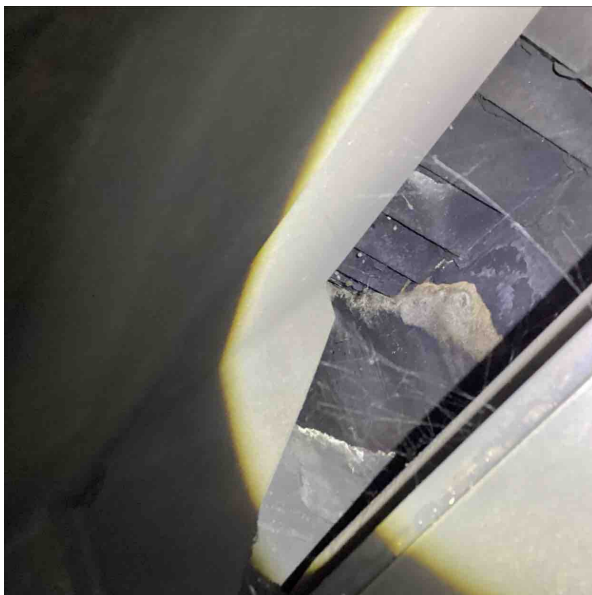
12.3.2 **Moisture staining noted in the fireplace flue, recommend further investigation by a qualified chimney contractor. (Basement)**
