RESIDENTIAL REPORT

2126 Krenning Rd
Beaufort, MO 63013

Job # Welling, LLC
05/11/2026

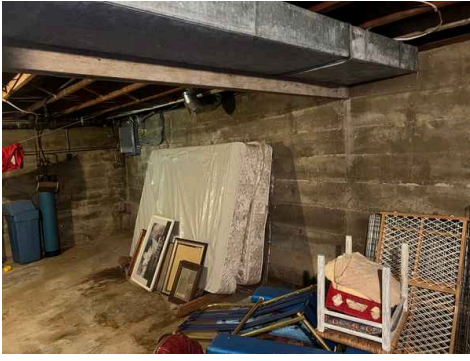
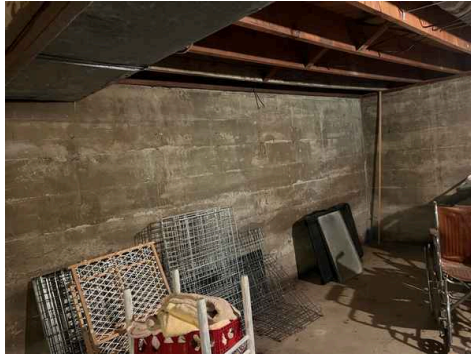
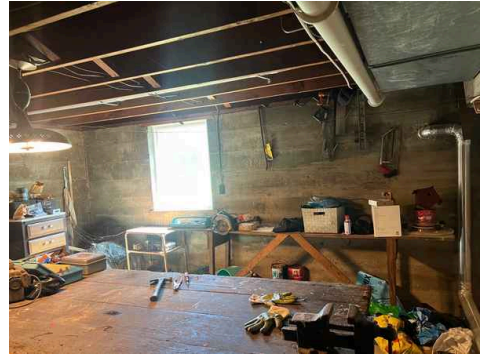
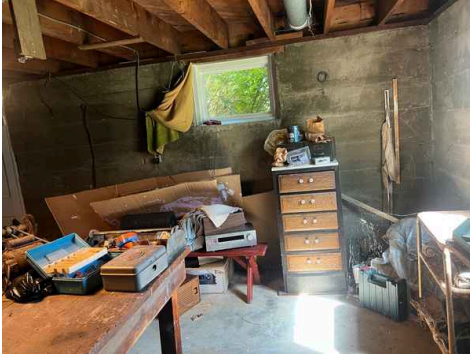
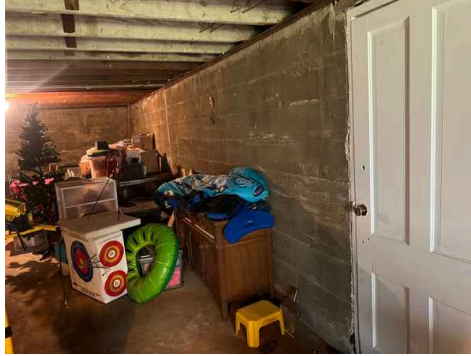
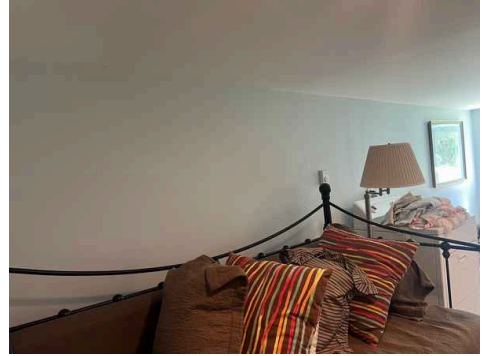
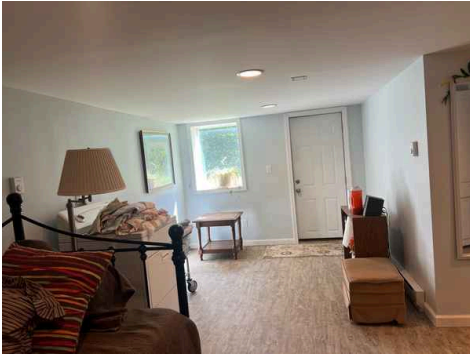
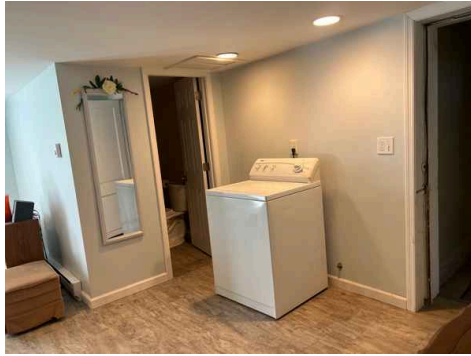
2.1.1 Foundation, Basement & Crawlspace

LIMITED VISIBILITY

BASEMENT

View of the foundation was limited due to finish materials and stored items.

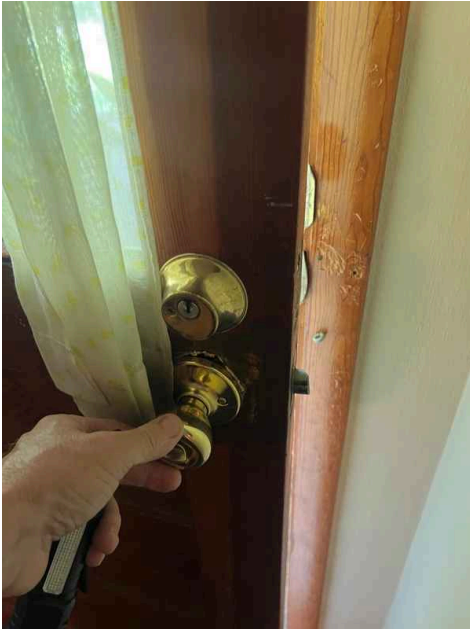
3.4.2 Exterior Doors

KEYED DEADBOLT(S)

REAR ENTRY

Recommend replacing all interior keyed deadbolts for safety purposes.

Contact a handyman or DIY project

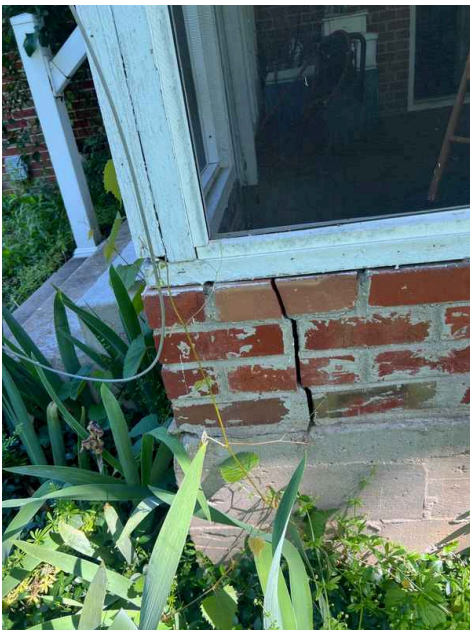
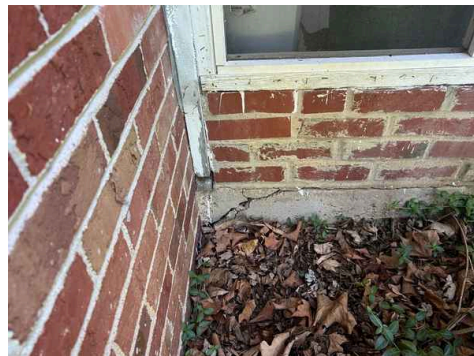
3.5.1 Decks, Balconies, Porches & Steps

CRACKING AND SETTLING

REAR PORCH

Cracking and settling are present in the concrete.

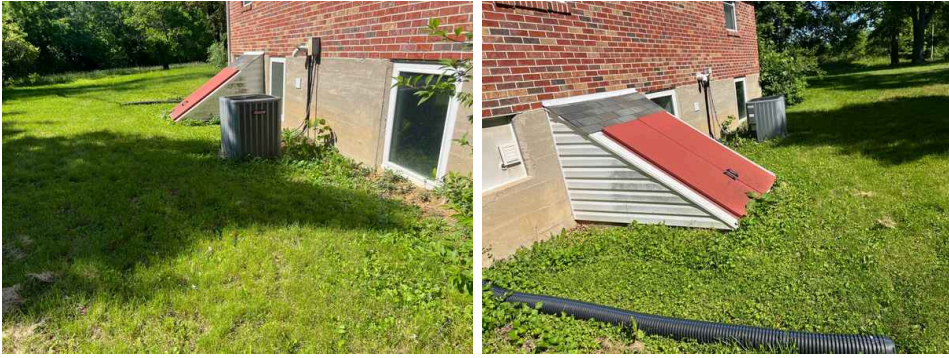
3.6.1 Vegetation, Grading, Drainage & Retaining Walls

NEGATIVE GRADING

EAST SIDE

Negative grade is present. Conditions may result in poor drainage and water intrusion.

Contact a qualified landscaping contractor

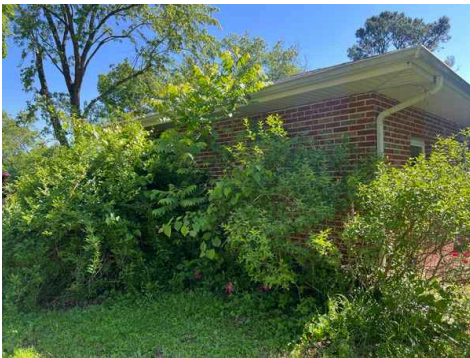
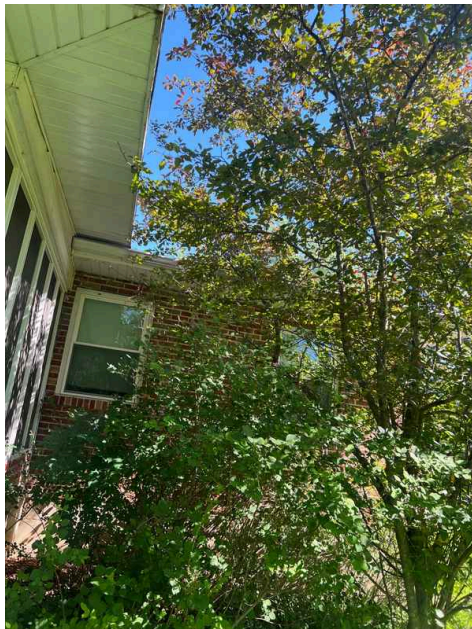
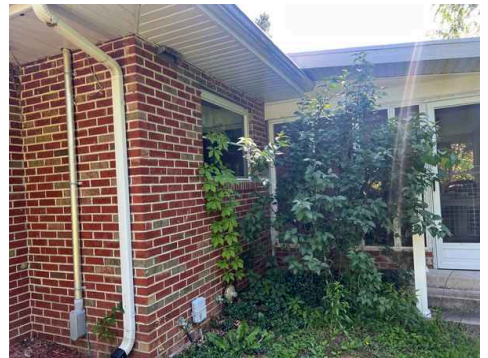
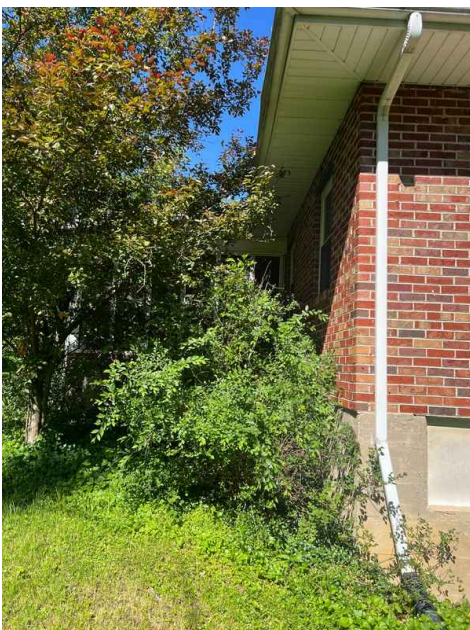
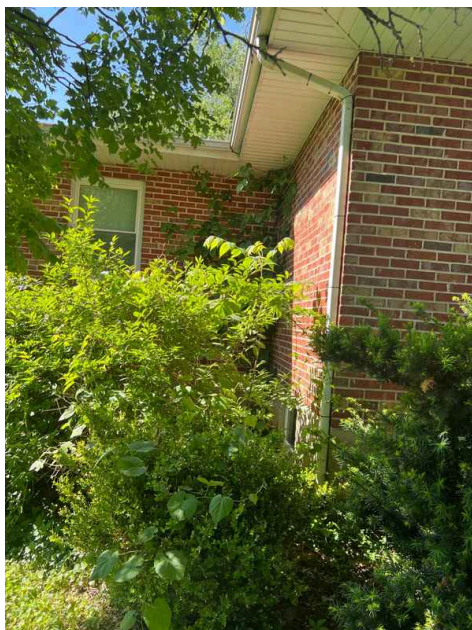
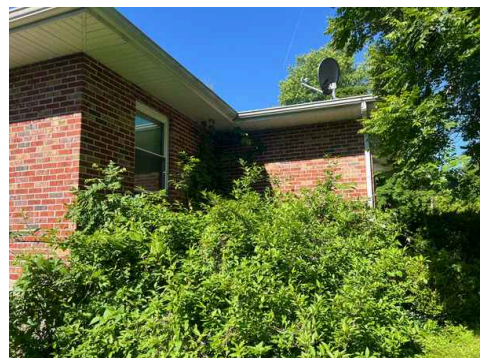
3.6.2 Vegetation, Grading, Drainage & Retaining Walls

TRIM VEGETATION

Trim vegetation off and away from the exterior walls.

Contact a handyman or DIY project

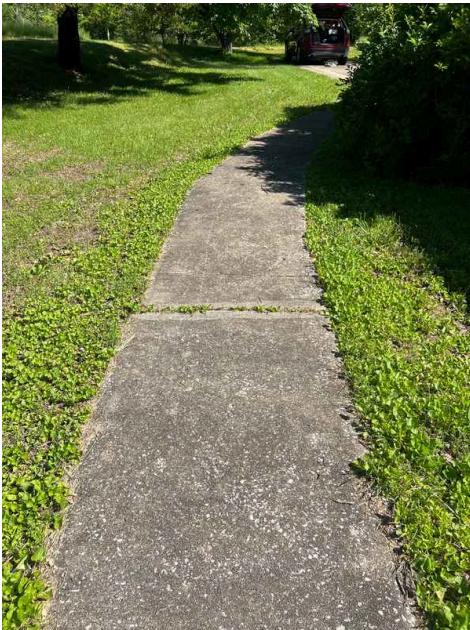
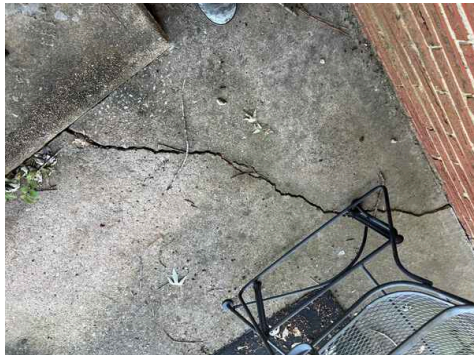
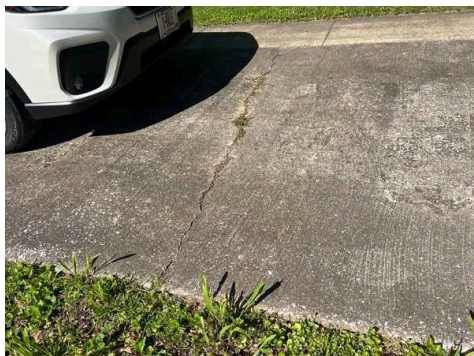
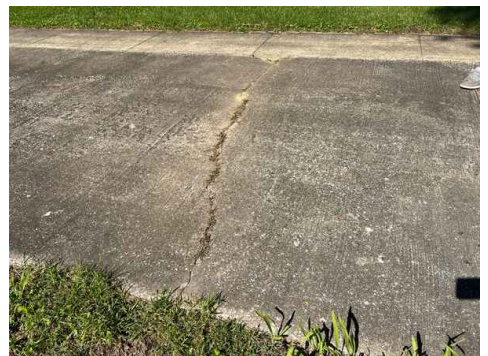
3.7.1 Walkways, Patios & Driveways

CRACKING/SETTLING/TRIP HAZARDS

DRIVEWAY, SIDEWALK, PORCH

General deterioration, cracking, settling, and trip hazards are present in the concrete flatwork.

Contact a qualified concrete contractor.

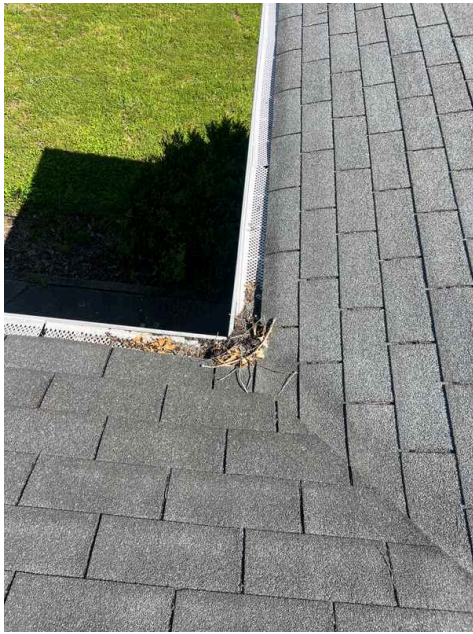
4.2.1 Roof Drainage Systems

DAMAGED GUTTER GUARDS

Gutter guards are damaged, have fallen into the gutters in several areas and do not perform as intended. Recommend replacement.

Contact a qualified professional.

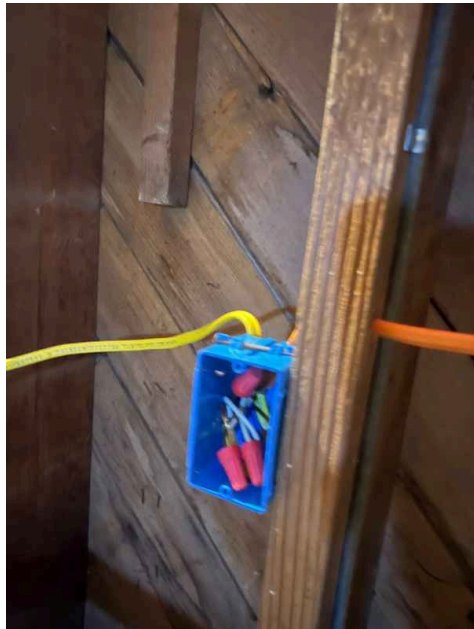
5.3.1 Branch Circuit Conductors, Overcurrent Devices and Compatibility of Their Amperage & Voltage

EXPOSED ENDS & SPLICES

BASEMENT

Enclosure required to the all open wire splices and junction boxes.

Contact a qualified electrical contractor.

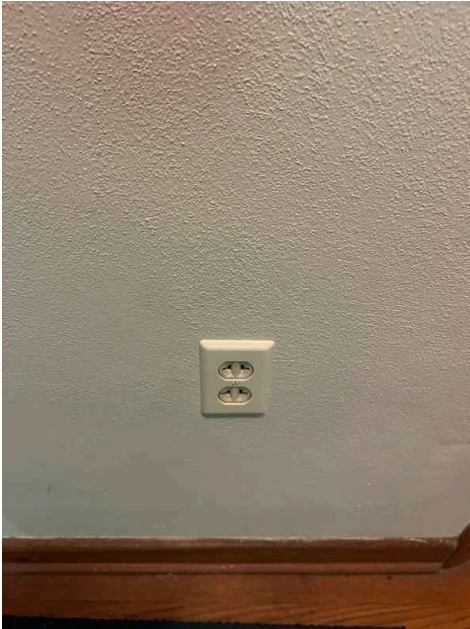
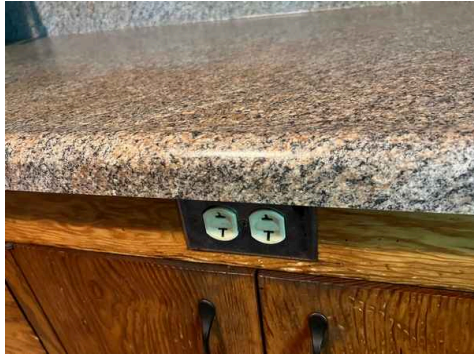
5.5.1 Polarity and Grounding of Receptacles

OUTLET(S) NOT GROUNDED

Ungrounded outlets are present throughout the house. Ungrounded outlets will not provide equipment protection.

Contact a qualified electrical contractor.

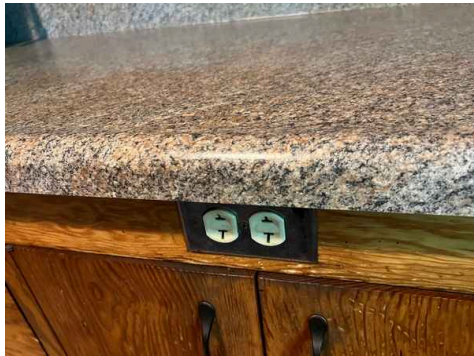
5.6.1 GFCI & AFCI

NO GFCI PROTECTION INSTALLED

KITCHEN, BATHROOM

GFI protection is not present at all required locations. Recommend qualified electrical contractor install GFI protection for safety purposes

Contact a qualified electrical contractor.

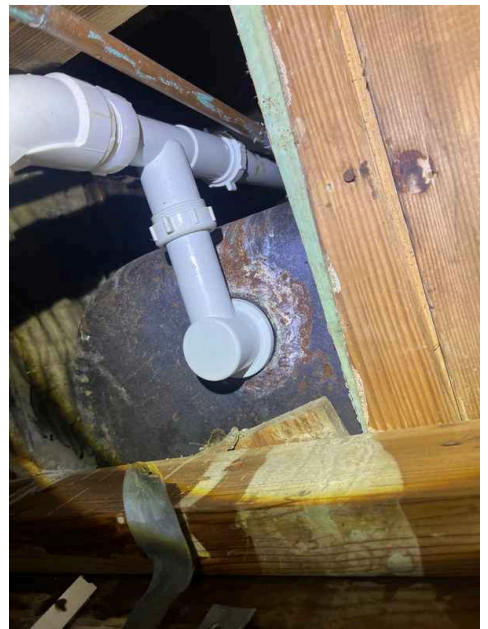
6.1.1 Fixtures / Faucets

DAMAGED TUB

BATHROOM

Rust is present at the drain. Monitor for leaking or replace.

Contact a qualified general contractor.

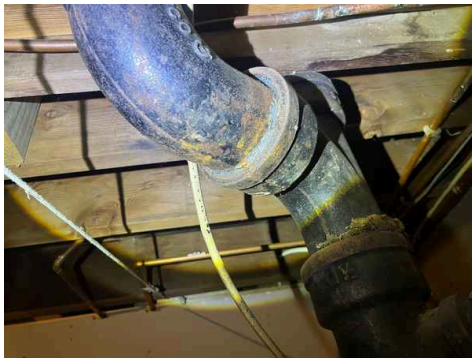
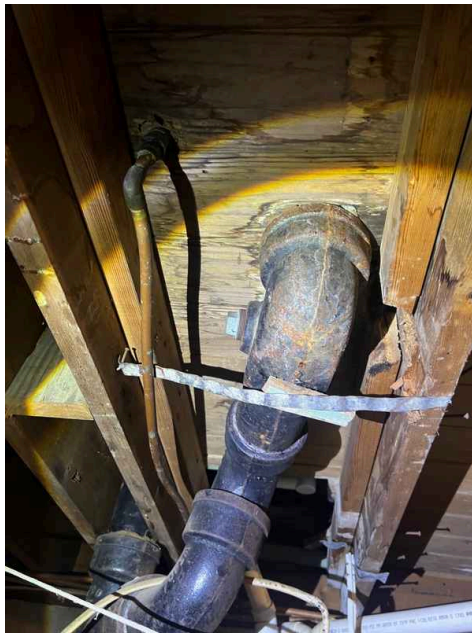
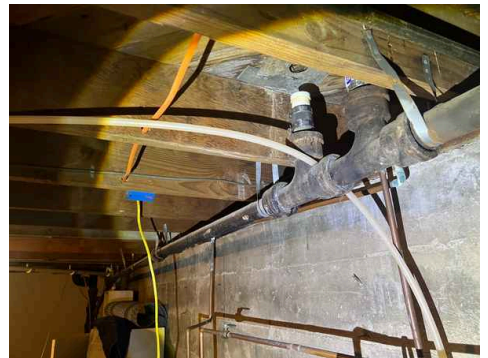
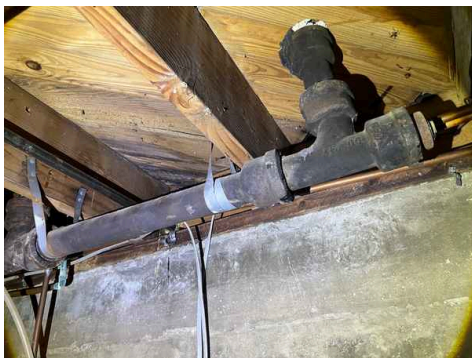
6.2.1 Drain, Waste, & Vent Systems

CAST IRON DRAINS

DRAIN LINES

Recommend replacing all cast iron drains due to age, rust, and evidence of previous leaking.

Contact a qualified plumbing contractor.

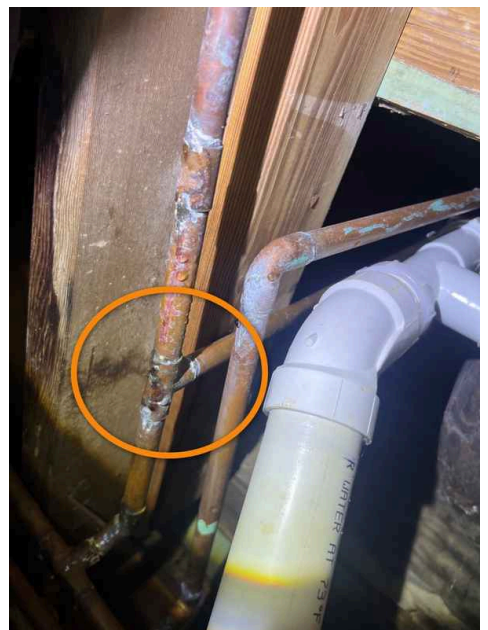
6.3.1 Water distribution

ACTIVE LEAKS

SHOWER SUPPLY LINE

Active leaking is present in the supply line(s).

Contact a qualified plumbing contractor.

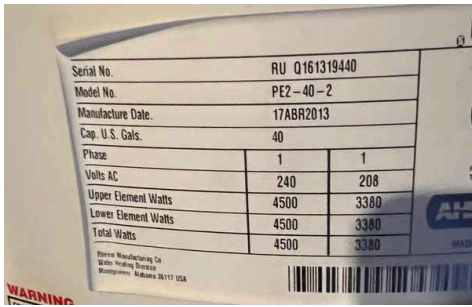
6.4.1 Water Heater

AT OR NEAR DESIGN LIFE

Unit is in working order but at or near design life.

Serial No.	RU Q161319440	
Model No.	PE2-40-2	
Manufacture Date:	17ABR2013	
Cap. U.S. Gals.	40	
Phase	1	1
Volts AC	240	208
Upper Element Watts	4500	3360
Lower Element Watts	4500	3360
Total Watts	4500	3360

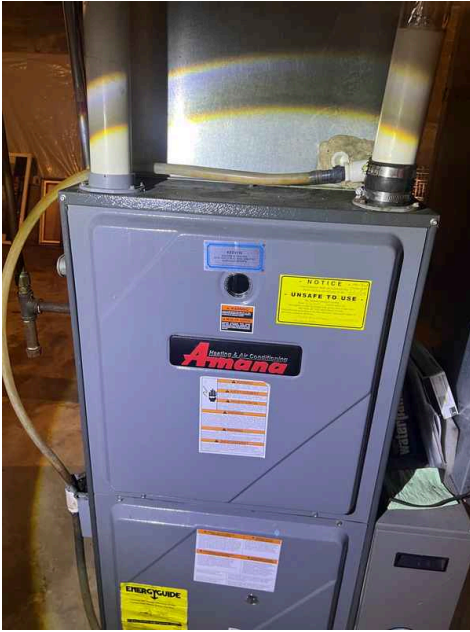
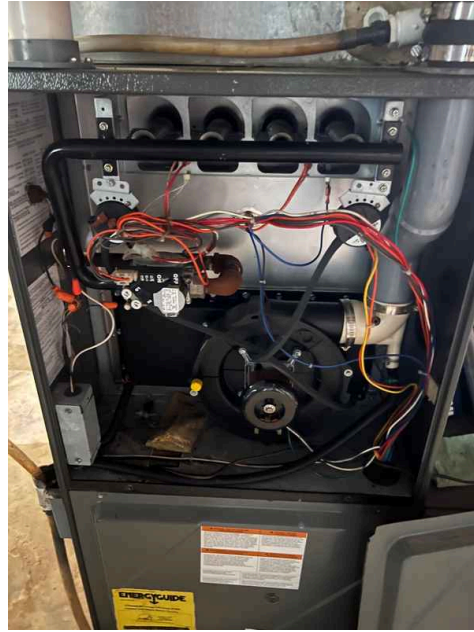
7.1.1 Heating Equipment

NEAR DESIGN LIFE

Unit(s) is in working order but at or near design life. Recommend upgrading for efficiency purposes.

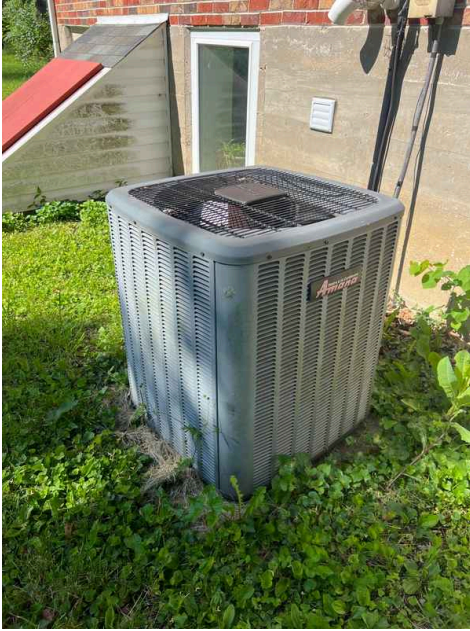
8.1.2 Cooling Equipment

BEYOND DESIGN LIFE

System is in working order but beyond design life. Recommend upgrading for efficiency purposes.

Contact a qualified HVAC professional.

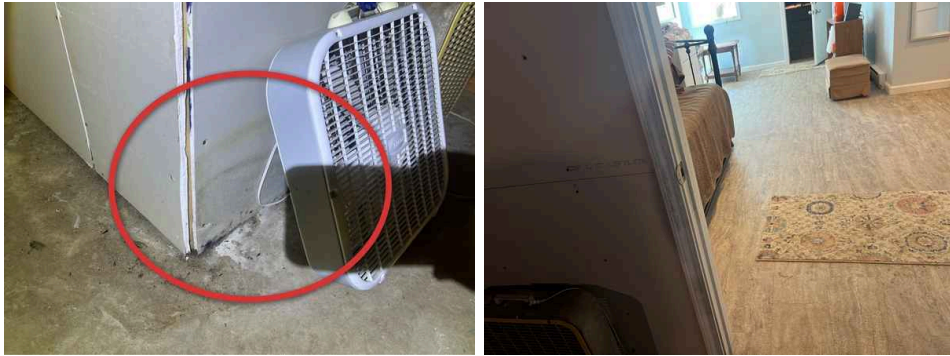
9.1.1 Walls

VISIBLE MOLD

BASEMENT

Visible mold is present on the drywall. Suspect high moisture conditions are being created by water intrusion at the floor to wall seam. Recommend removal and treatment of all molded materials for health and safety purposes. All sources of moisture should be eliminated to prevent further mold issues.

Contact a qualified professional.

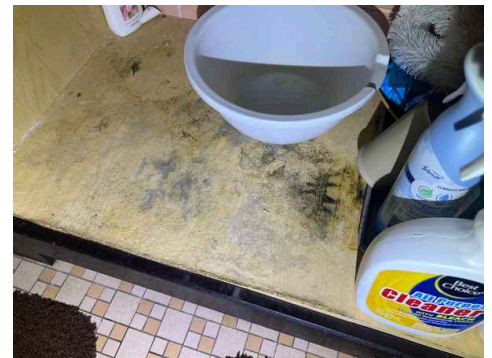
9.5.1 Countertops & Cabinets

VISIBLE MOLD

BATHROOM

Mold is present in the cabinet. Recommend removal or treatment by qualified professional for health and safety purposes.

Contact a qualified professional.

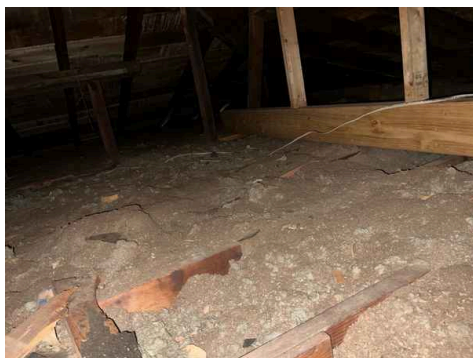
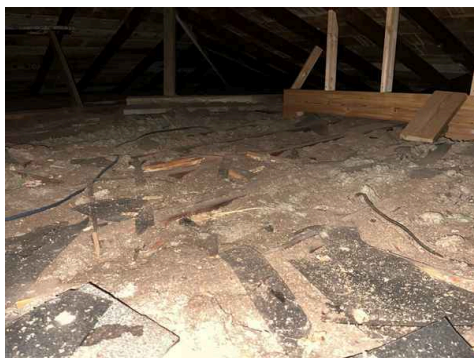
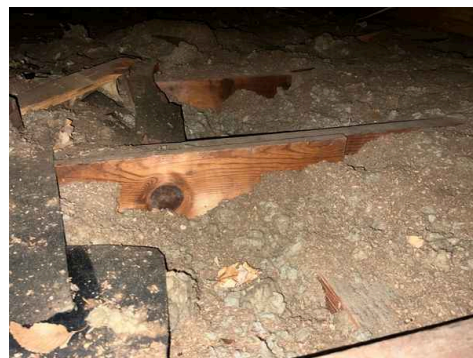
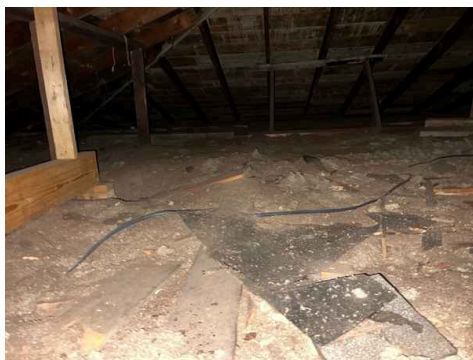
10.1.1 Attic Insulation

INSUFFICIENT

ATTIC

Insulation is matted and sparse due to typical settling and deterioration. Recommend additional insulation for efficiency purposes.

Contact a qualified insulation contractor.

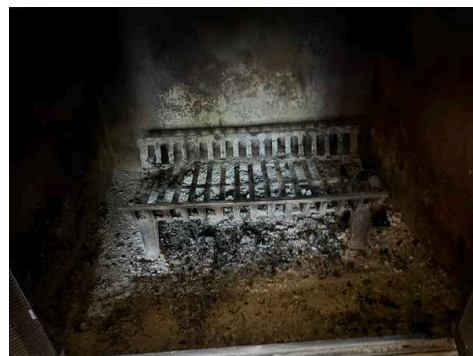
11.2.1 Chimney & Vent Systems

LEVEL II INSPECTION

Highly recommend a Level II inspection be performed before using. View of the components is extremely limited.

Contact a qualified professional.
