ENVIRONMENTAL SITE ASSESSMENT
60.914 ACRES ON MAHARD PARKWAY (FUTURE)
PROSPER, TEXAS

Standridge Companies
15640 Quorum Drive
Addison, Texas 75001

June 24, 2019

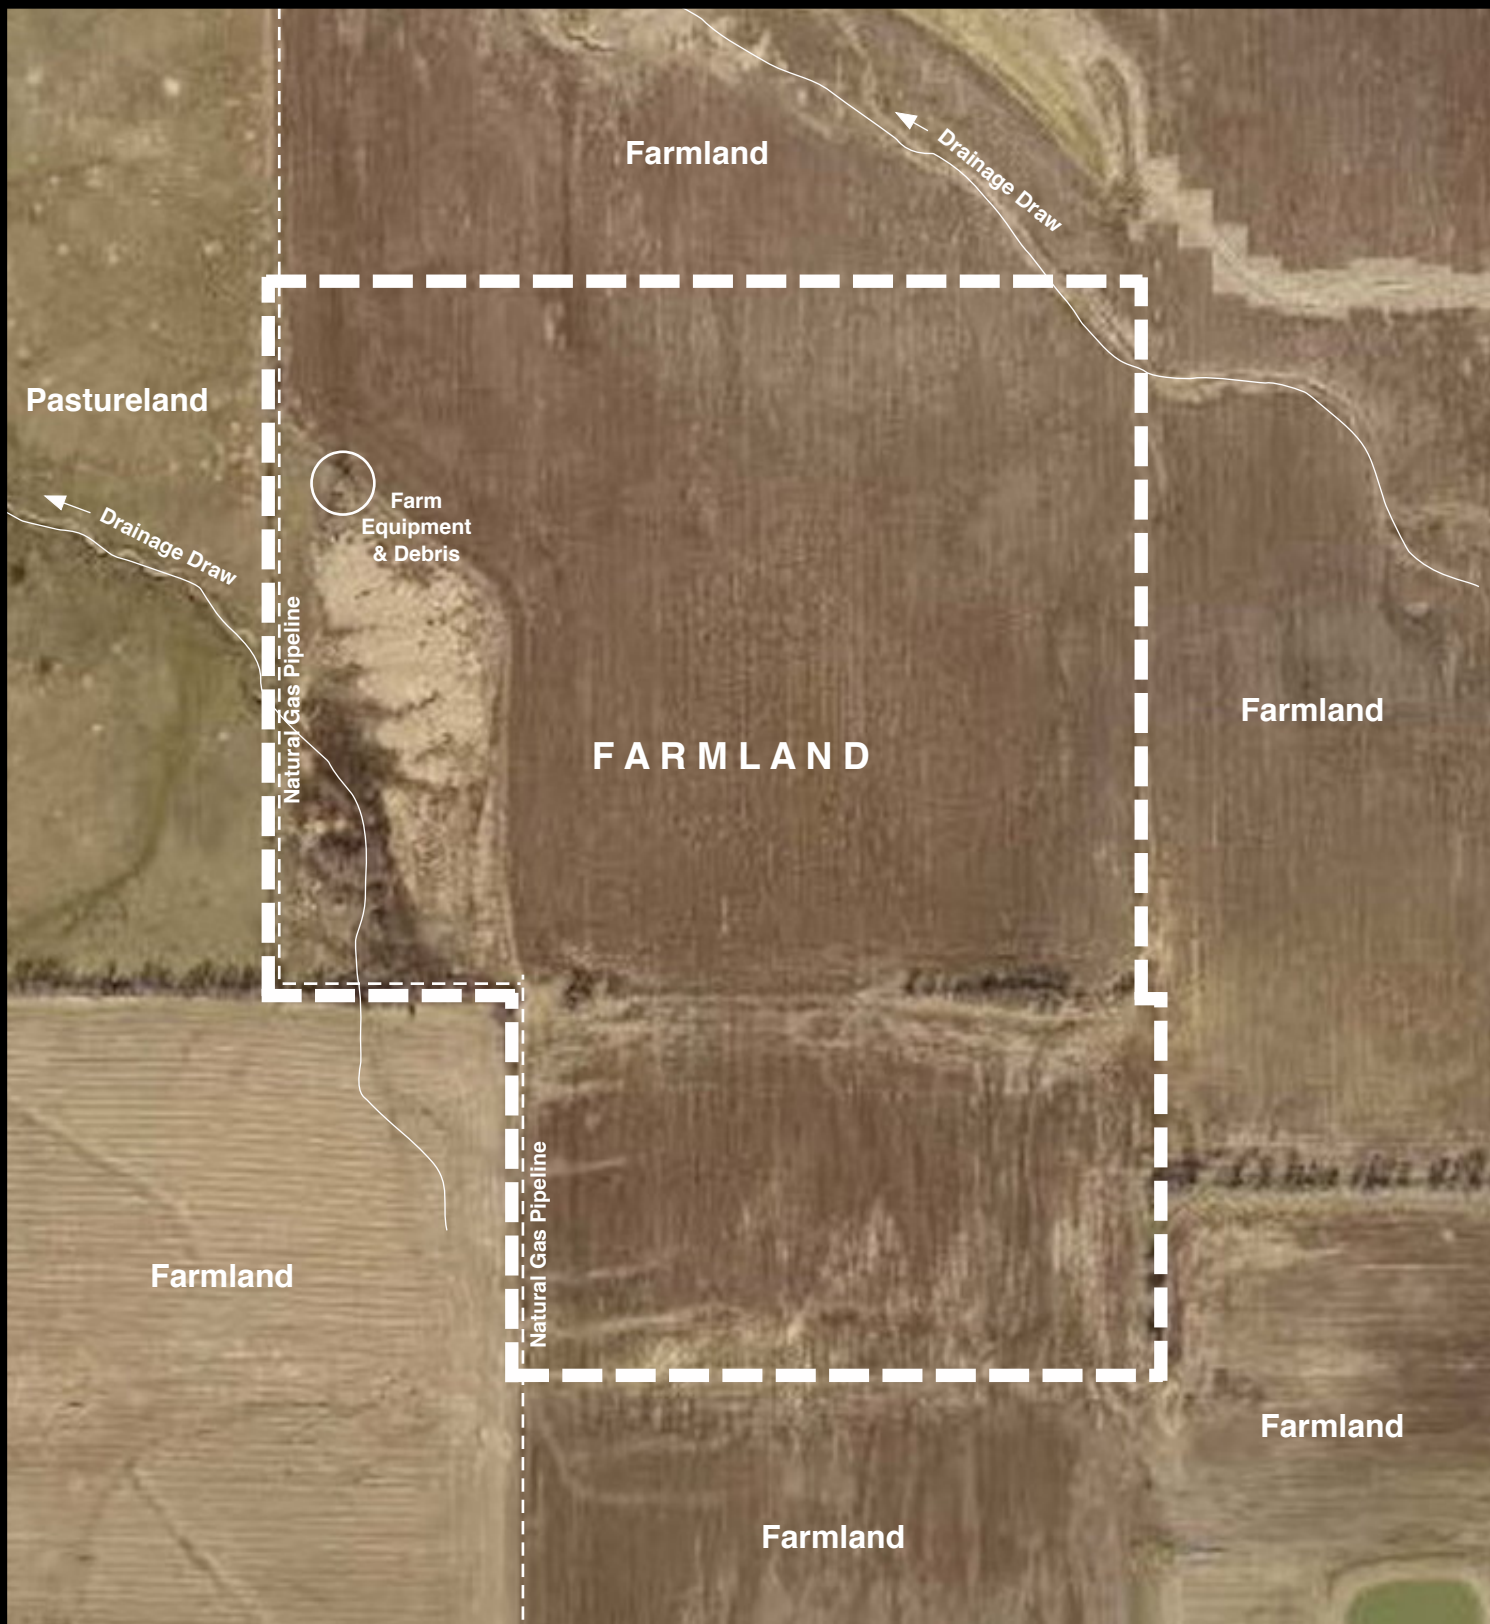
Figure 2 - Site Drawing
60.914 Acres on Mahard Parkway (Future)
Prosper, Texas

of land (see Figure 2 – Site Drawing). The site is undeveloped farmland (cotton). Two drainage draws, flowing from southeast to northwest, bisect the property. An underground natural gas pipeline is located on the subject property along the west boundary line.

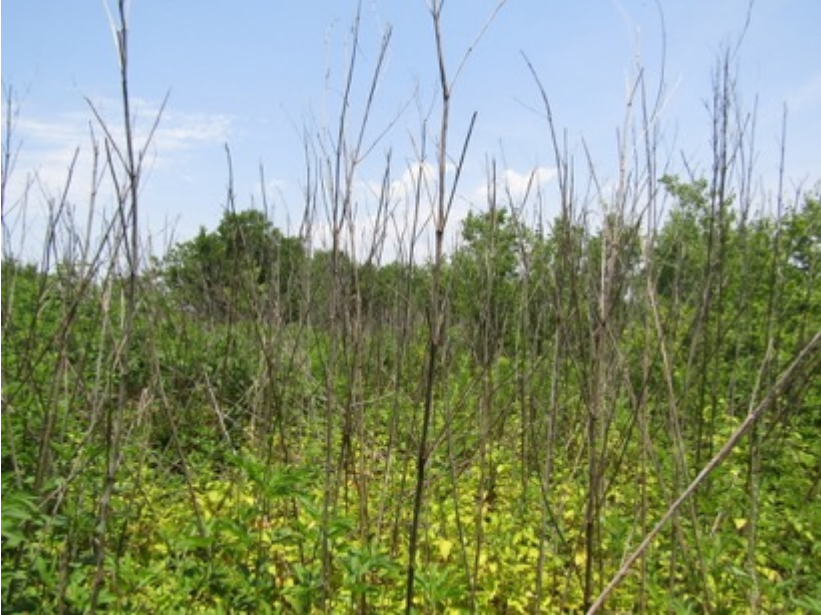
Photo 13 – View down (onto site) drainage draw as it enters onto subject property along northernmost south property line in western area of site.

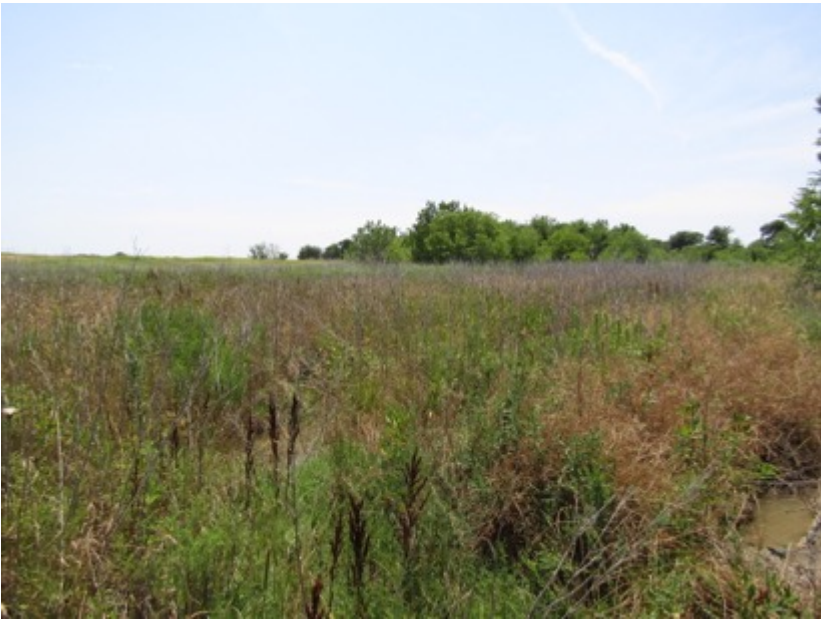
Photo 14 – View up (onto site) drainage draw as it exits subject property along northern portion of west boundary line.

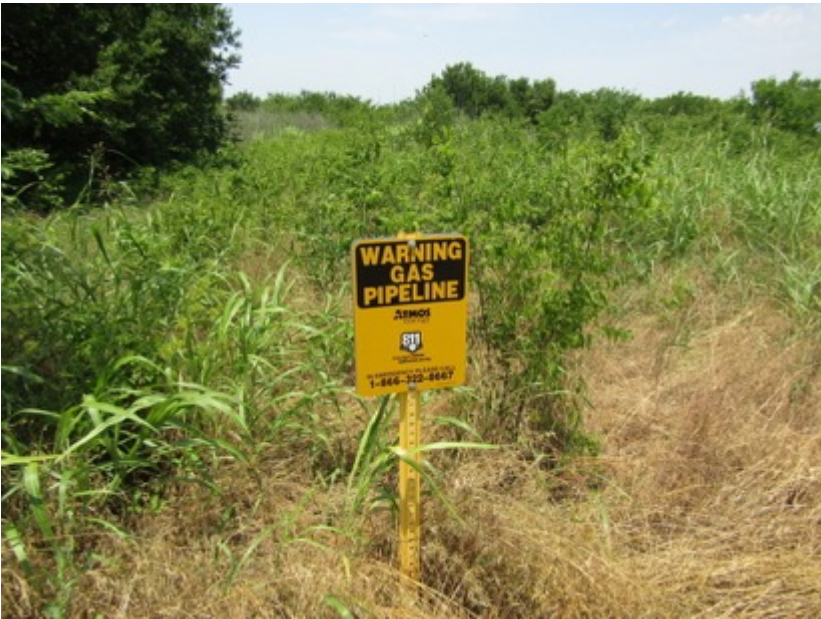
At the time of the site visit, no evidence of potentially hazardous chemicals or petroleum products was observed on the subject property; however, signage indicating an underground natural gas pipeline on the site along the west boundary line was present. No visual or olfactory evidence of leakage to the pipeline was observed. The landuse history review indicated that the

underground natural gas pipeline was installed on the property in 2006. No leaks or spills have been reported to be associated with this pipeline. This underground natural gas pipeline does not impact the environmental integrity of the subject property, and, therefore, does not constitute a recognized environmental condition at the site; however, development of the subject property needs to take into consideration the existence of this underground natural gas pipeline.

Photo 17 – View of natural gas pipeline sign on subject property along west boundary line.

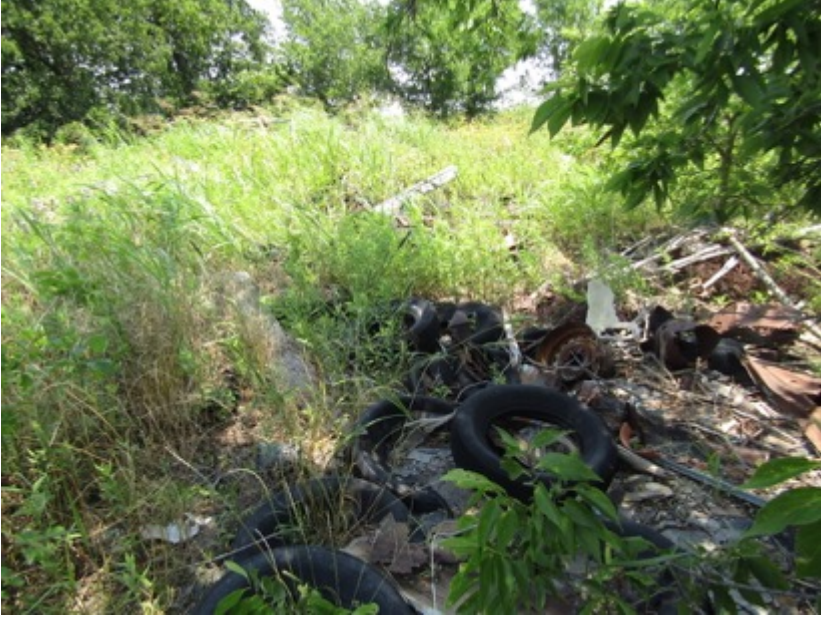
- At the time of the site visit, farm debris was observed in the northwest quadrant of the subject property. No evidence of hazardous materials was observed to be associated with said debris; however, numerous discarded auto/truck/tractor tires were present. This debris does not impact the environmental integrity of the subject property, and, therefore, does not constitute a recognized environmental condition at the site. The discarded tires should be disposed of in accordance with state and federal regulations.

Photo 19 – View of farm debris located in northwest quadrant of site. No hazardous materials was observed to be associated with this debris; however, numerous discarded auto/truck/tractor tires were present.

At the time of the site visit, no evidence of the generation of hazardous wastes or other wastes was observed on the subject property. Additionally, no evidence of stained soil or unexplained dead-or-dying vegetation was observed on the site. Farm debris was observed in the northwest quadrant of the property. No evidence of hazardous materials was observed to be associated with said debris; however, numerous discarded auto/truck/tractor tires were present. This debris does not impact the environmental integrity of the subject property, and, therefore, does not constitute a recognized environmental condition at the site. The discarded tires should be disposed of in accordance with state and federal regulations.

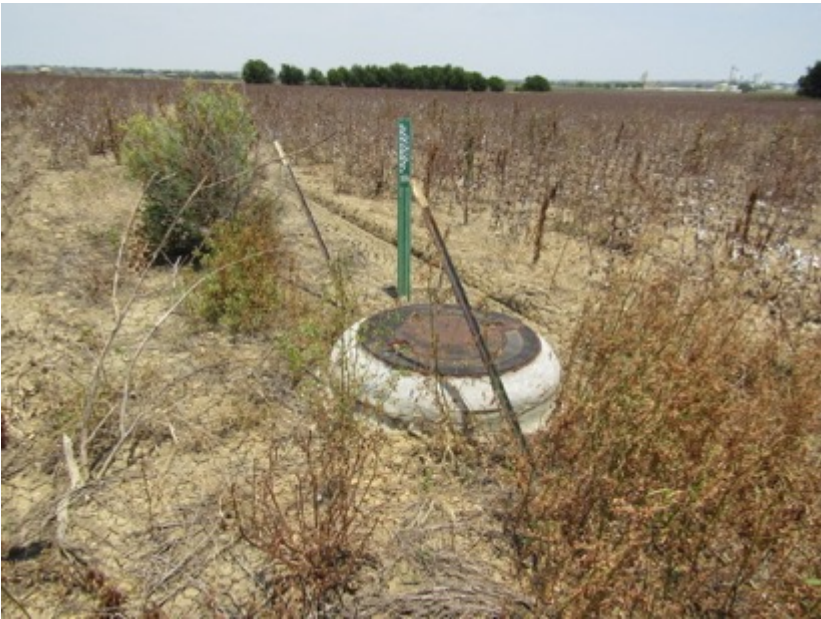
Photo 20 – View of sewer manhole located just off south boundary line of site.
