NPI MISSOURI INC

## RESIDENTIAL REPORT

1845 Flottmann Rd  
Gerald, MO 63037

Jason Wallingford  
09/15/2026

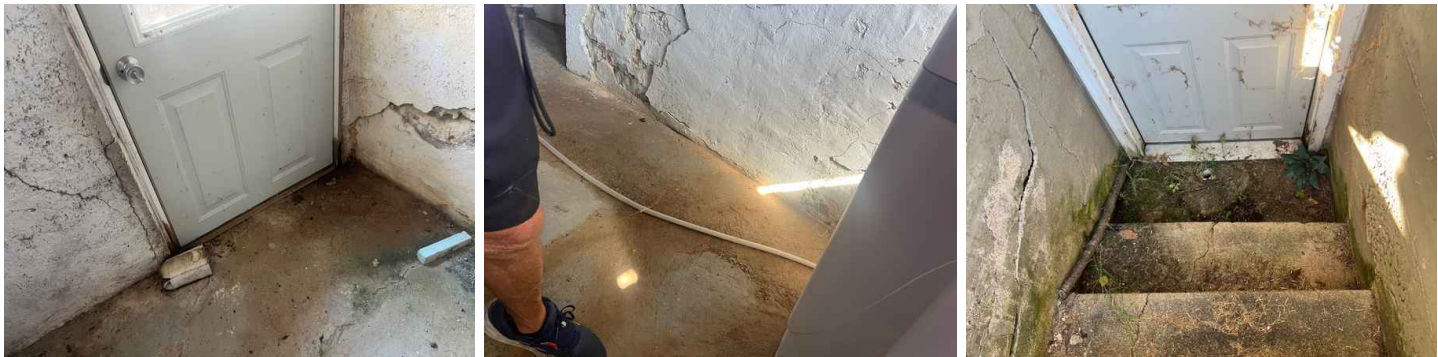
2.1.2 Foundation, Basement & Crawlspaces

WATER INTRUSION

BASEMENT

Evidence of water intrusion is present at the floor to wall seam and basement door.

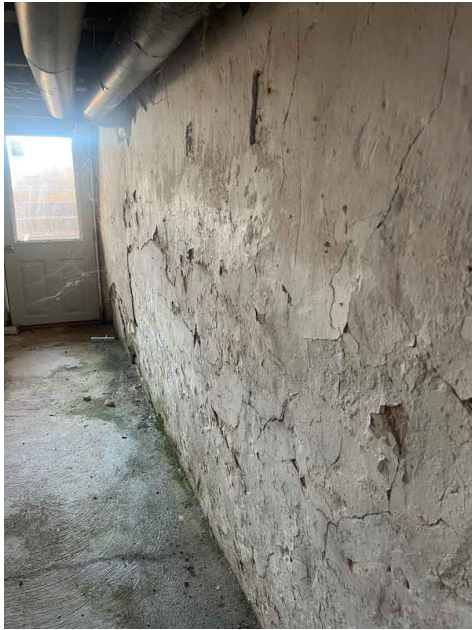
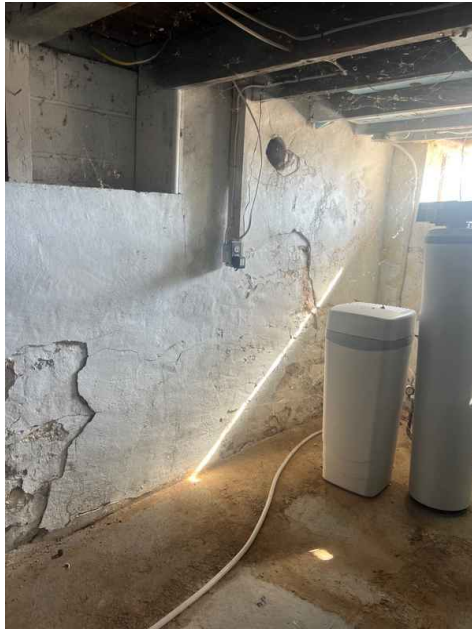
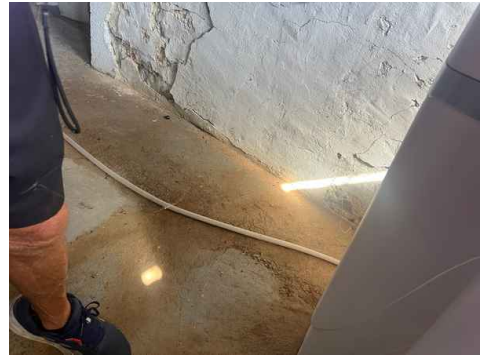
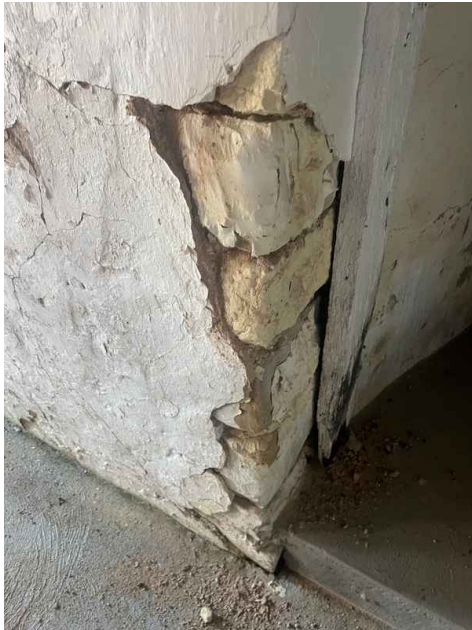
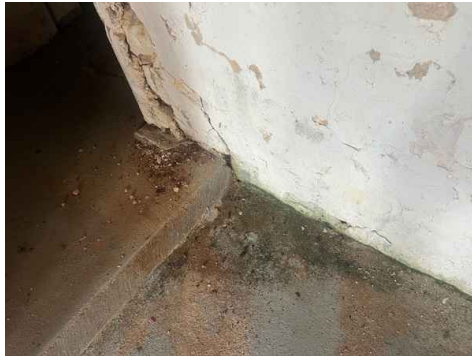
2.1.3 Foundation, Basement & Crawlspaces

SETTLING/MOVEMENT

ORIGINAL FOUNDATION

Original section of foundation is stone and 110 years old stone. Bowing in the foundation walls and interior floors that are not level indicate settling and movement. Conditions are typical for the age and construction style.

Contact a qualified professional engineer

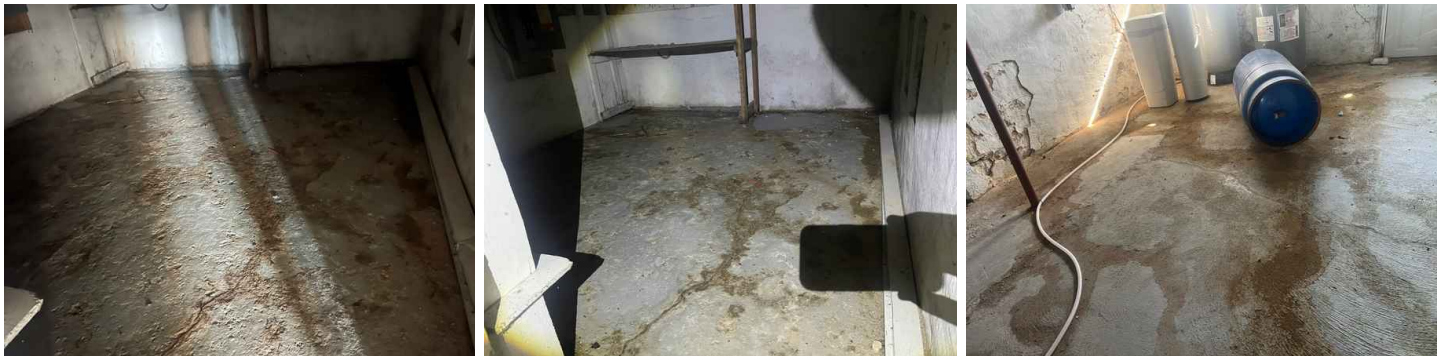
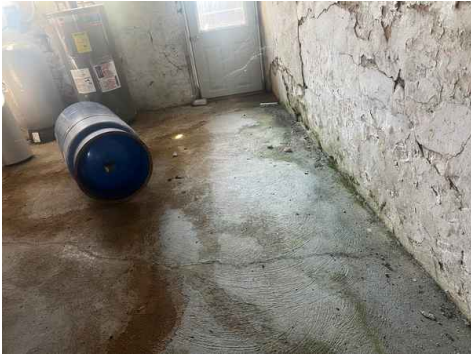
2.2.1 Floor Structure

**EVIDENCE OF WATER INTRUSION**

BASEMENT

Water stains and high moisture at the floor cracks and floor to wall seams indicate hydrostatic water pressure under the home. Recommend further evaluation by a water proofing contractor.

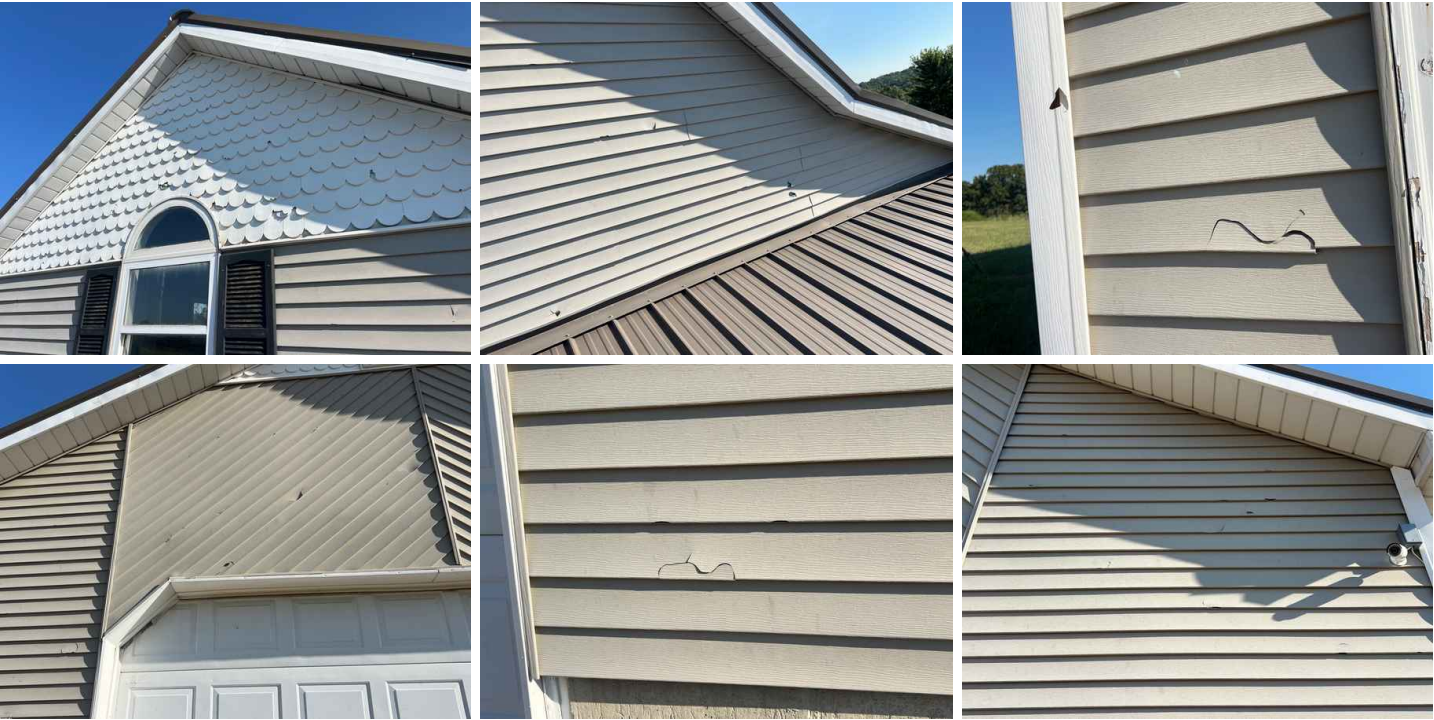
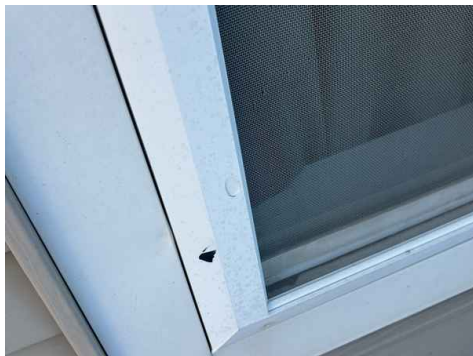
3.1.1 Siding, Flashing & Trim

DAMAGED VINYL SIDING/TRIM

FRONT SURFACE

Extensive hail damage is present in the vinyl siding and trim. Recommend replacing.

Contact a qualified professional.

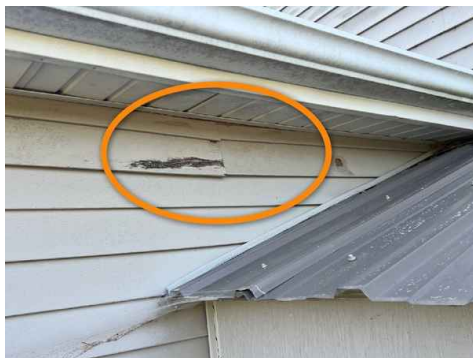
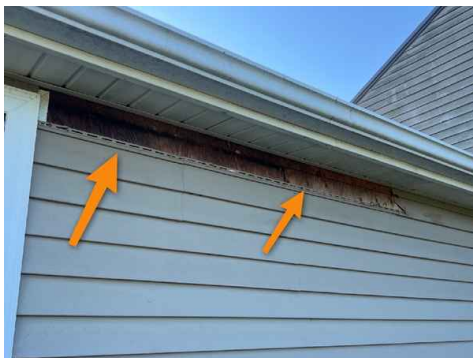
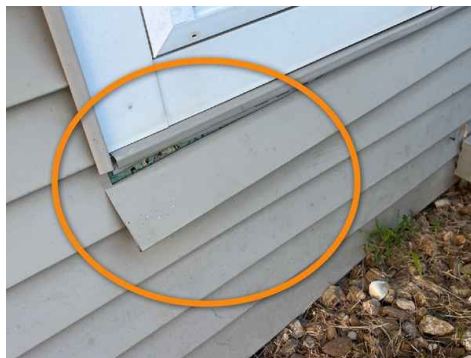
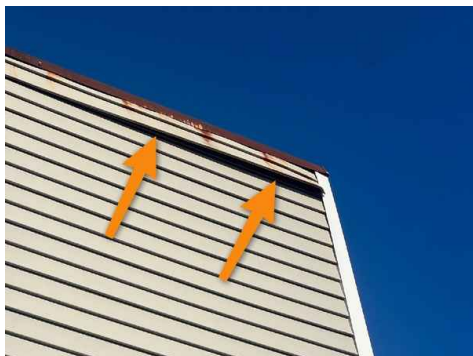
### 3.1.2 Siding, Flashing & Trim

#### **LOOSE/SEPARATED/MISSING SIDING**

SEVERAL AREAS

Maintenance required to the loose and missing vinyl siding.

Contact a handyman or DIY project

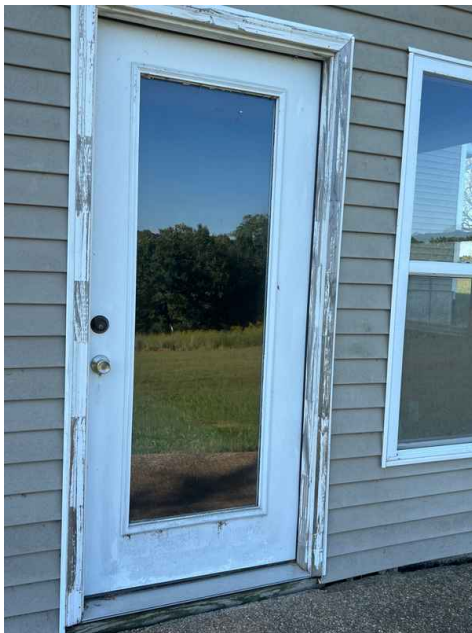
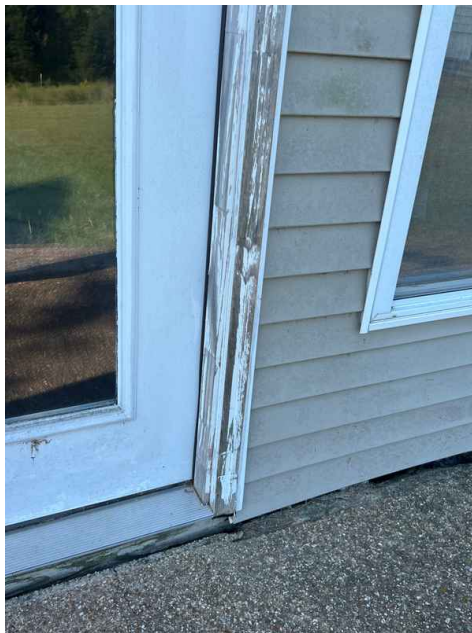
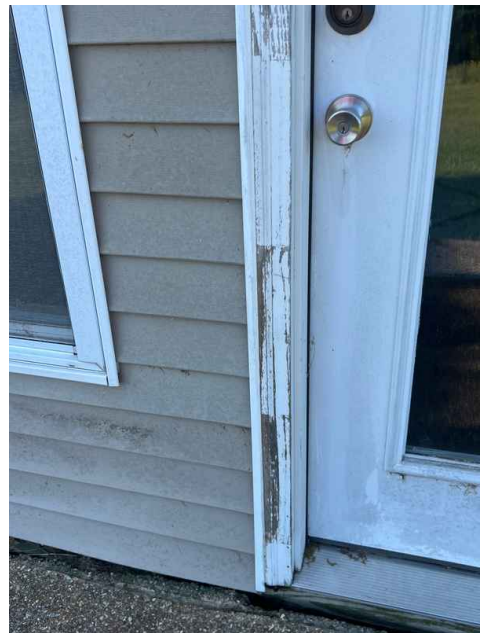
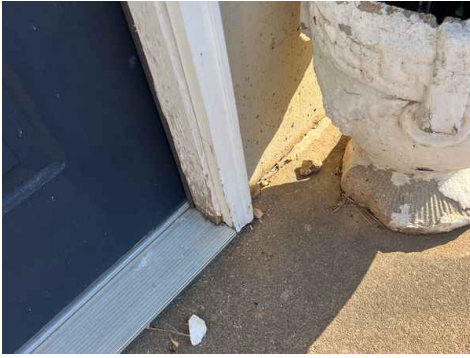
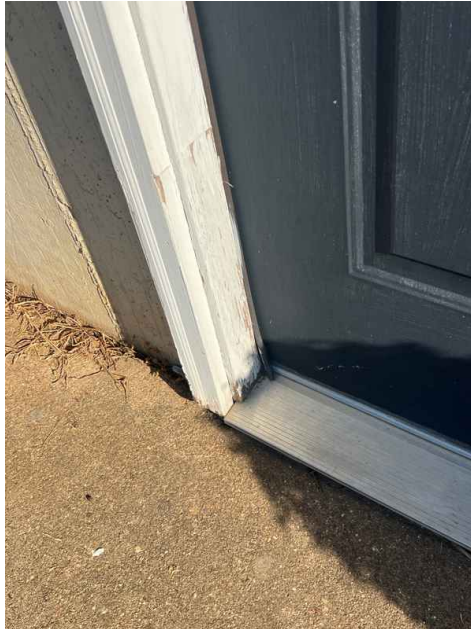
### 3.4.1 Exterior Doors

## DOOR MAINTENANCE

### SEVERAL DOORS

Maintenance or replacement required to weather damaged and deteriorated trim.

Contact a handyman or DIY project

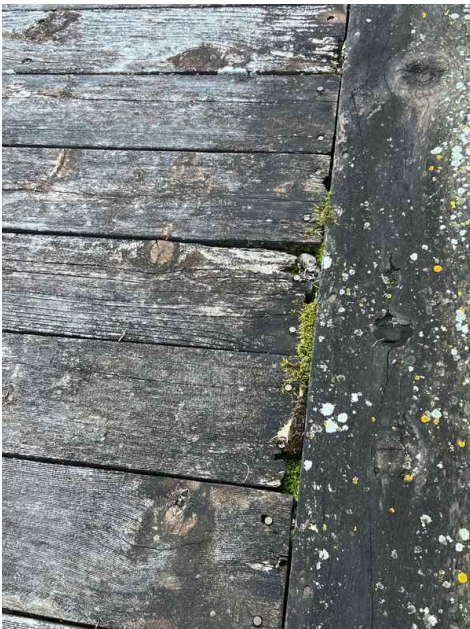
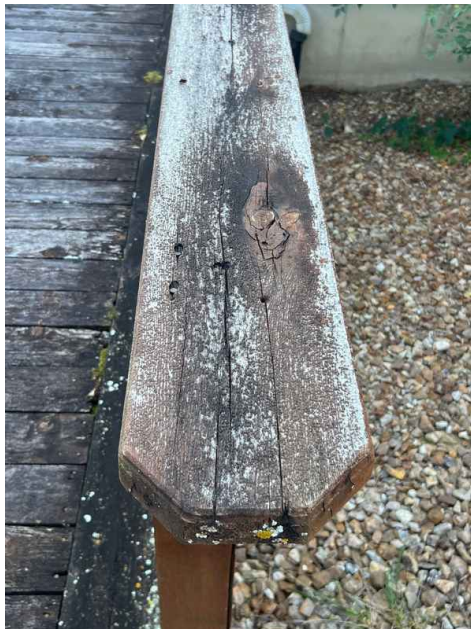
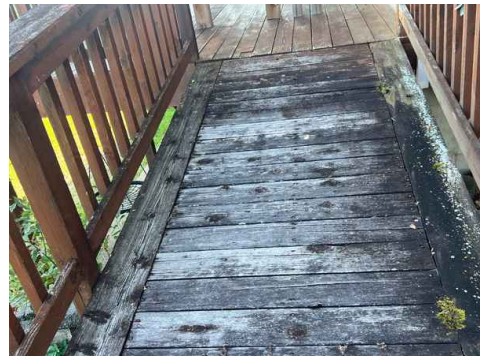
### 3.5.1 Decks, Balconies, Porches & Steps

#### **DECK - DETERIORATED COMPONENTS**

##### DECK

Excessive deterioration is present in the wooden ramp, floor boards, stair and rail assemblies. Recommend maintenance or replacement where required for safety purposes.

Contact a qualified general contractor.

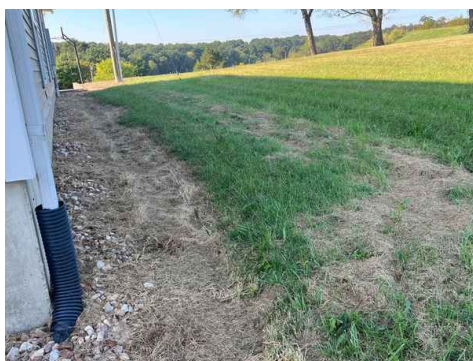
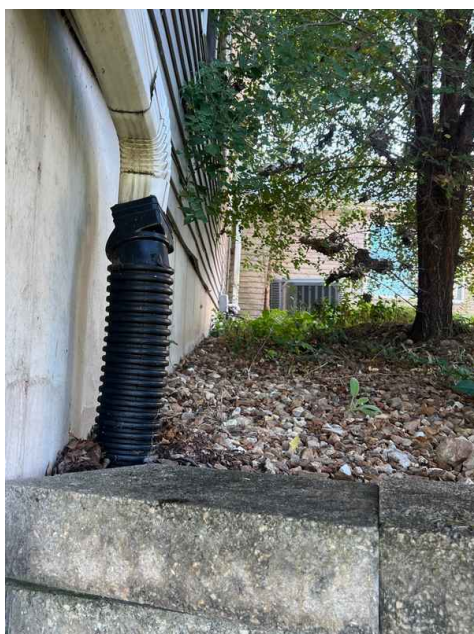
### 3.6.1 Vegetation, Grading, Drainage & Retaining Walls

#### **POOR DRAINAGE**

##### FRONT

Low areas next the home do not allow water to freely drain away from the foundation in several areas. Conditions may result in water and moisture intrusion.

Contact a qualified landscaping contractor

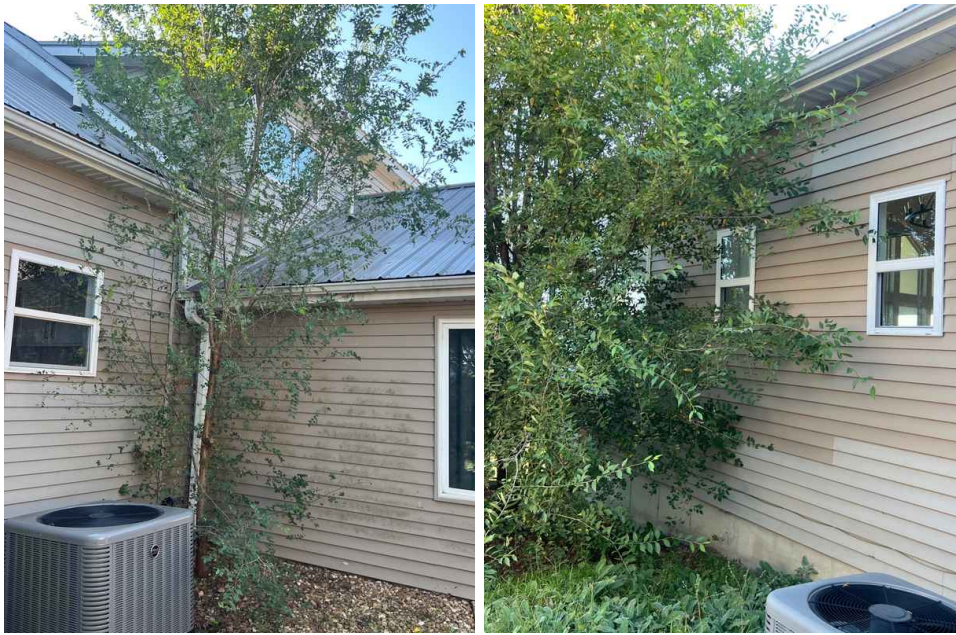
### 3.6.2 Vegetation, Grading, Drainage & Retaining Walls

#### **TRIM VEGETATION**

Trim vegetation off and away from the exterior walls.

Recommendation  
Contact a handyman or DIY project

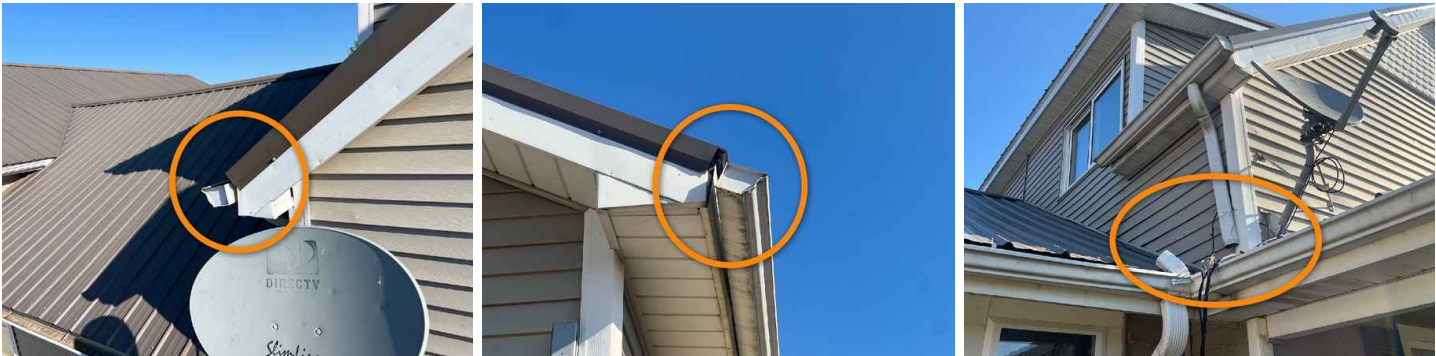
4.2.1 Roof Drainage Systems

**LOOSE GUTTERS**

SEVERAL AREAS

Gutters are loose and pulling away from the house.

Contact a qualified professional.

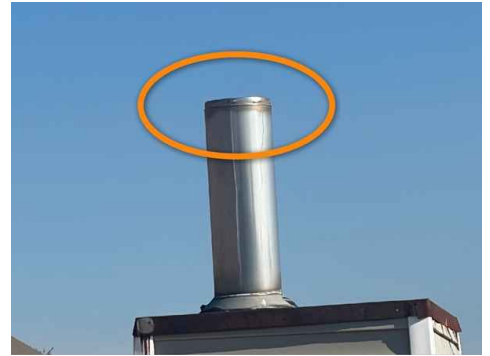
## 4.4.1 Skylights, Chimneys &amp; Roof Penetrations

**CHIMNEY CAP MISSING**

No chimney cap was observed. This is important to protect from moisture intrusion and protect the chimney. Recommend a qualified roofer or chimney expert install.

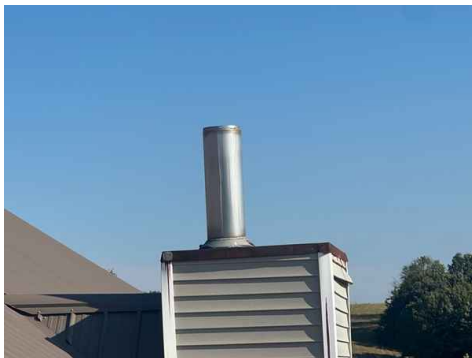
## 4.4.2 Skylights, Chimneys &amp; Roof Penetrations

**RUSTED CHASE COVER**

Recommend repairs or replacement to the rusted chase cover to prevent further deterioration and water intrusion.

Contact a qualified roofing professional.

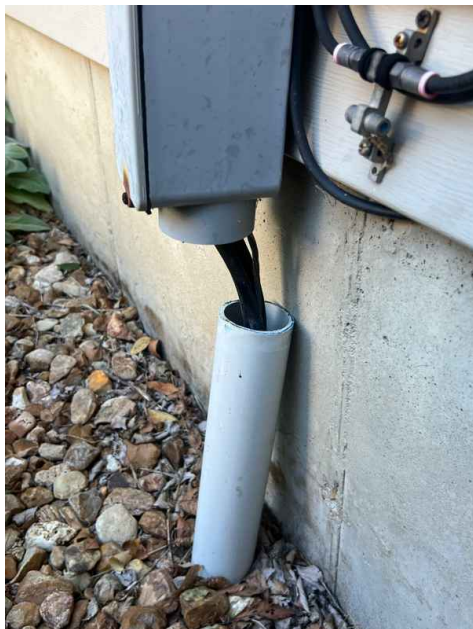
### 5.1.1 Service Entrance Conductors

#### **ENTRANCE CABLE EXPOSED**

Maintenance required to the separated conduit that is exposing the entrance cable at the meter.

Contact a qualified professional.

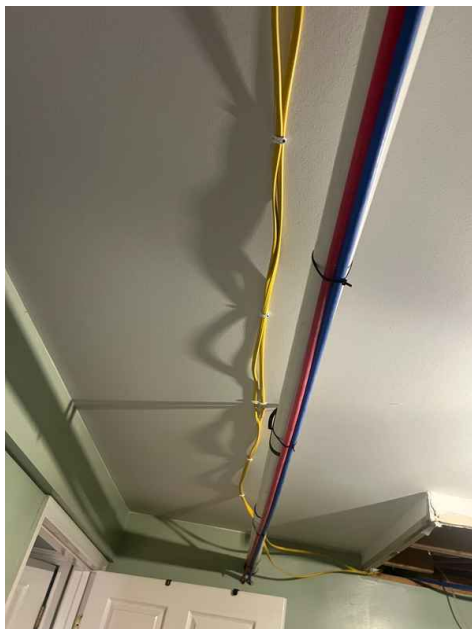
### 5.3.1 Branch Circuit Conductors, Overcurrent Devices and Compatibility of Their Amperage & Voltage

#### **IMPROPER WIRING**

##### BASEMENT

Improperly run and unsecured wiring is present in the basement. Recommend repairs by a qualified electrical contractor for safety purposes.

Contact a qualified electrical contractor.

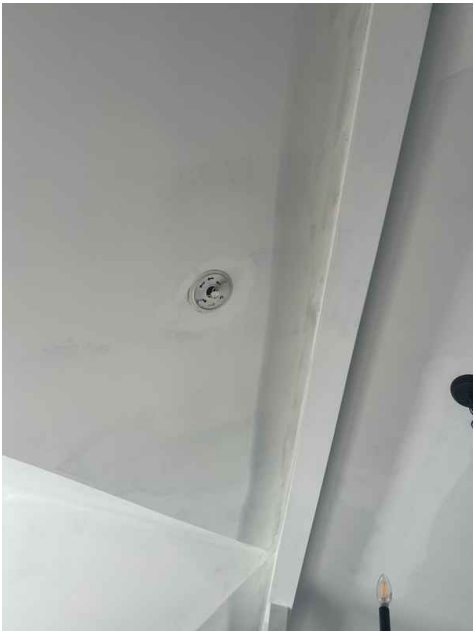
### 5.7.1 Smoke Detectors

#### **MISSING**

Several smoke detectors are missing. Check and replace all missing, inoperable and expired detectors upon occupancy.

Recommendation  
Contact a handyman or DIY project

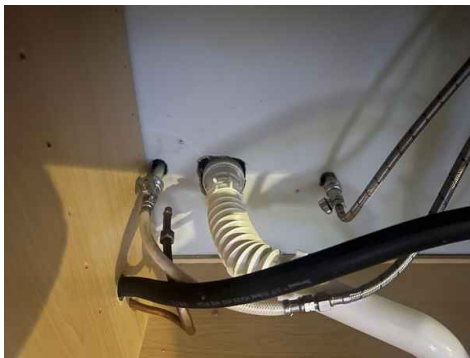
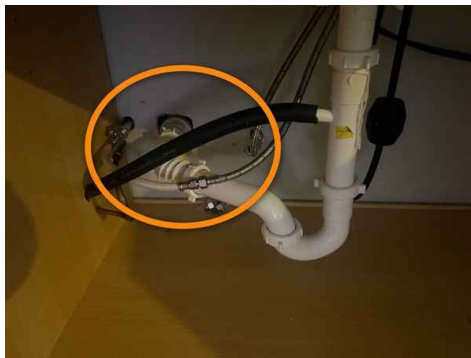
### 6.2.1 Drain, Waste, & Vent Systems

#### FLEXIBLE DRAIN LINE

Recommend replacing all flexible drain lines. Flexible drain lines (typically corrugated or accordion-style plastic tubing) are sometimes used in plumbing systems but are generally not recommended for permanent drain installations. Standard rigid piping (PVC, cast iron, or copper) is preferred because flexible lines can trap debris, sag, and create flow problems over time.

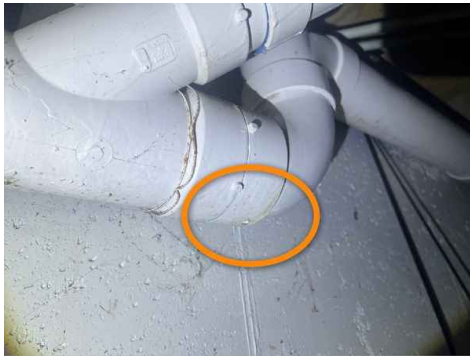
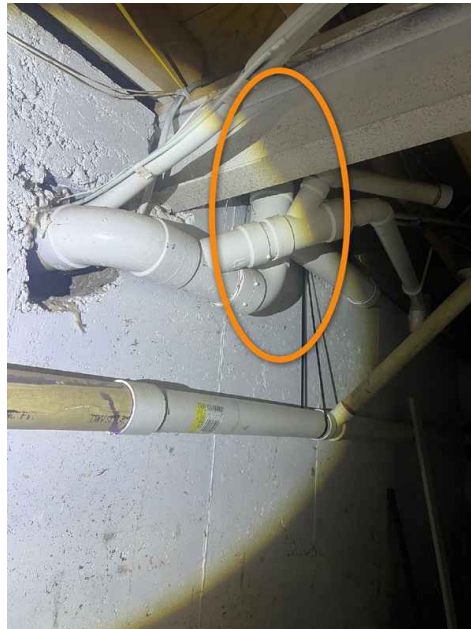
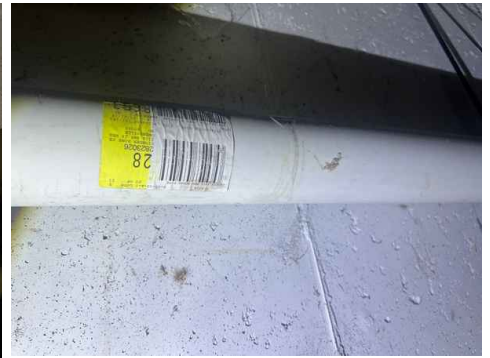
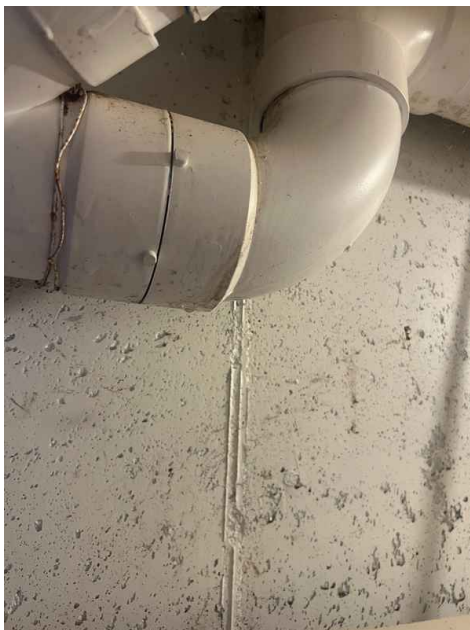
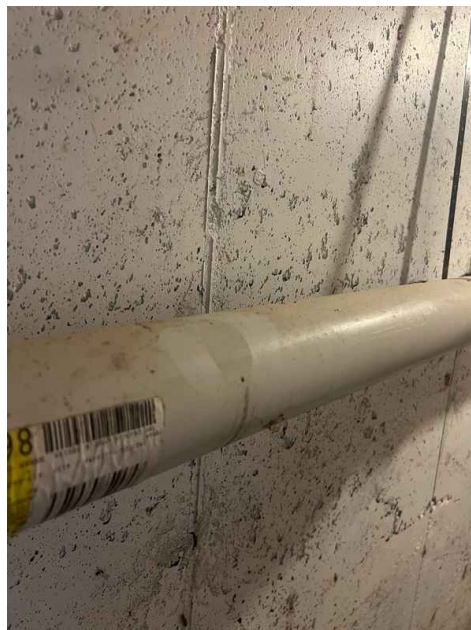
### 6.2.2 Drain, Waste, & Vent Systems

#### LEAKS

Active leaking is present at the waste lines. Source of leak could not be determined.

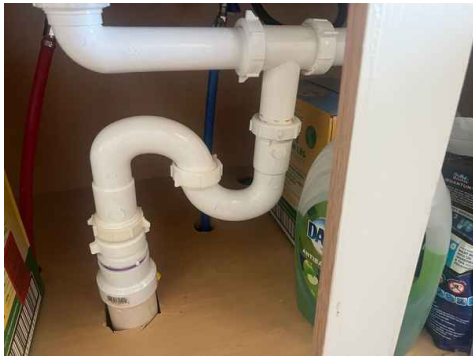
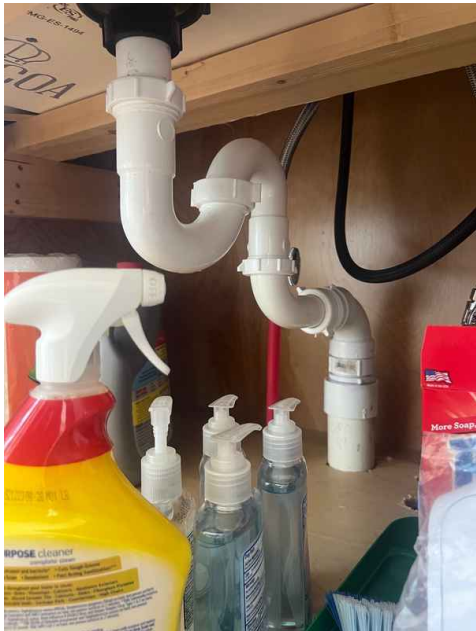
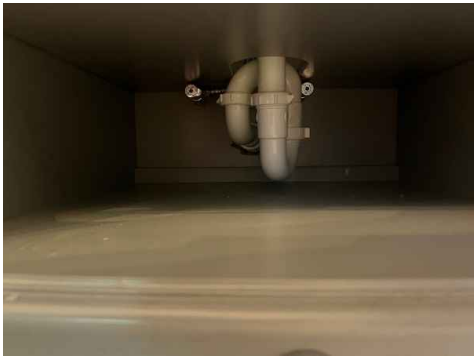
### 6.2.3 Drain, Waste, & Vent Systems

#### **IMPROPER INSTALLATION - S-TRAP**

S-trap configurations observed. Recommend evaluation and repair by a qualified professional.

Contact a qualified plumbing contractor.

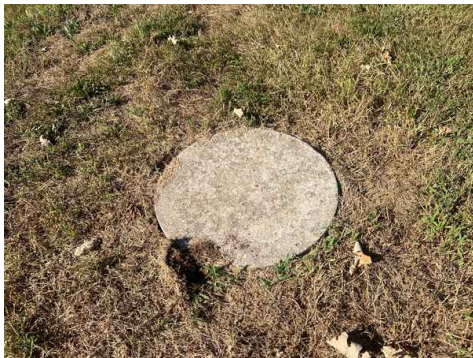
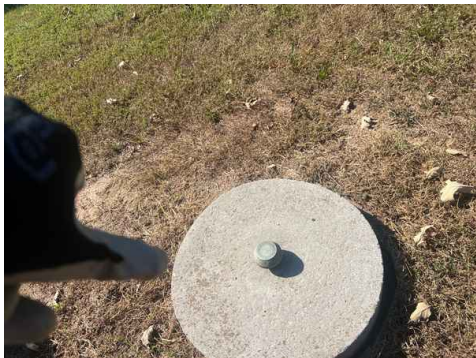
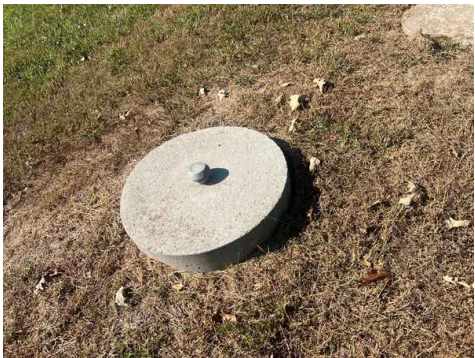
6.8.1 Septic System

**SEPTIC SYSTEM DEFICIENCIES**

Contact a qualified professional.

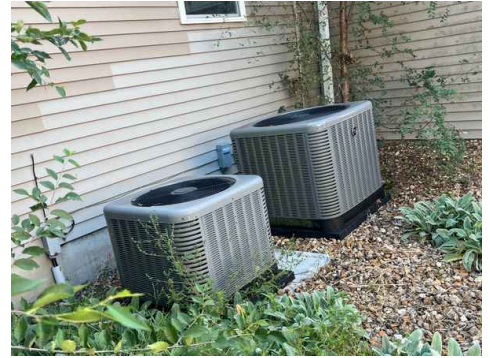
Pad has settled allowing the units to become unlevelled. This can cause accelerated deterioration of components. Recommend licensed HVAC contractor level the unit.

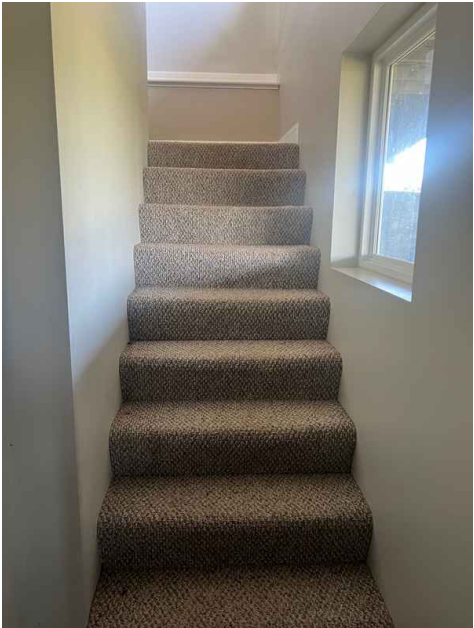
Handrails are missing at the stairs. This is a safety hazard. Recommend a qualified handyman install a handrail.

Contact a handyman or DIY project

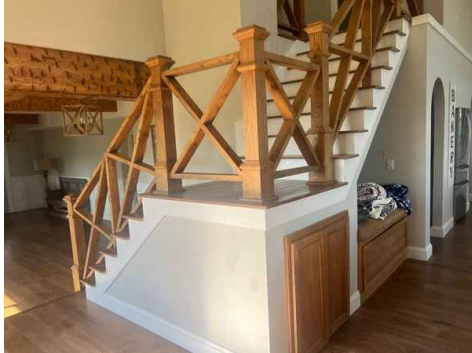
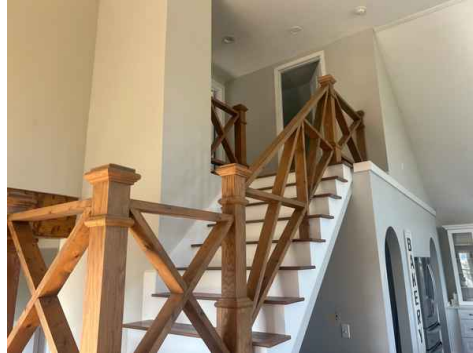
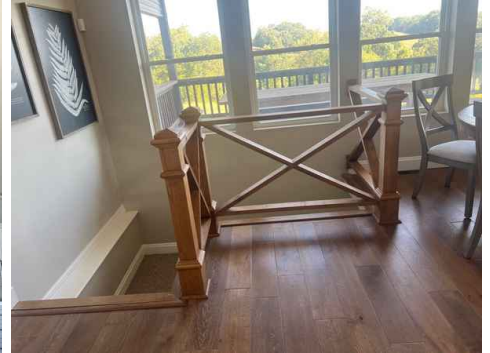
## 9.4.2 Steps, Stairways &amp; Railings

**UNSAFE OPENINGS**

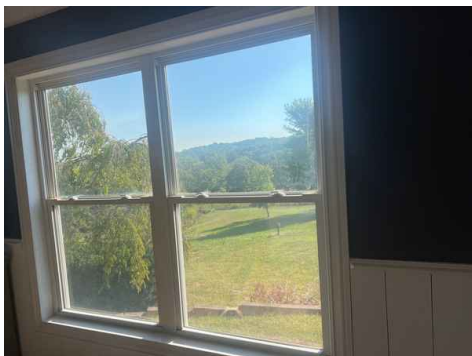
## 9.7.1 Windows

**FAILED SEAL(S)**

Window pane(s) appear fogged due to failed seals. Recommend further evaluation and an estimate of replacement by a qualified contractor. Due to interior and exterior conditions failed seals may not be detectible at the time of the inspection.

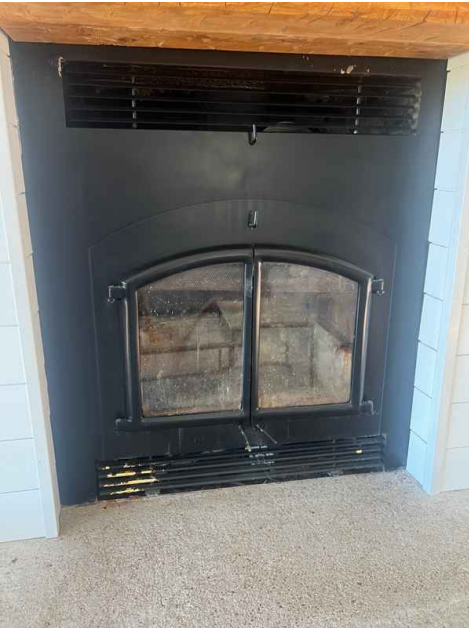
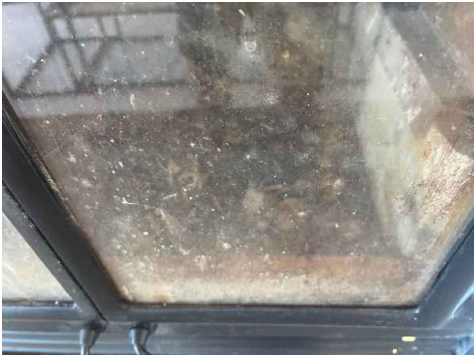
Recommend fireplace, flue, and chimney be inspected before use.

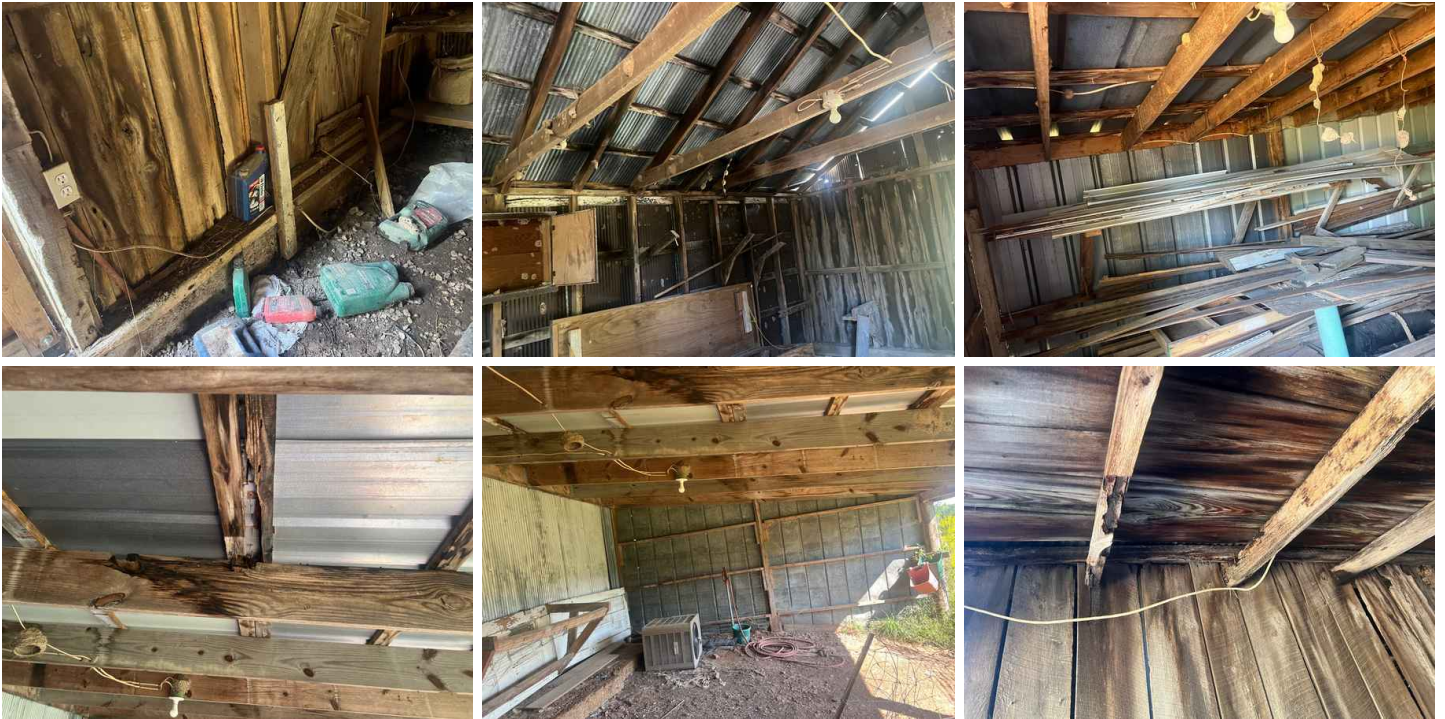
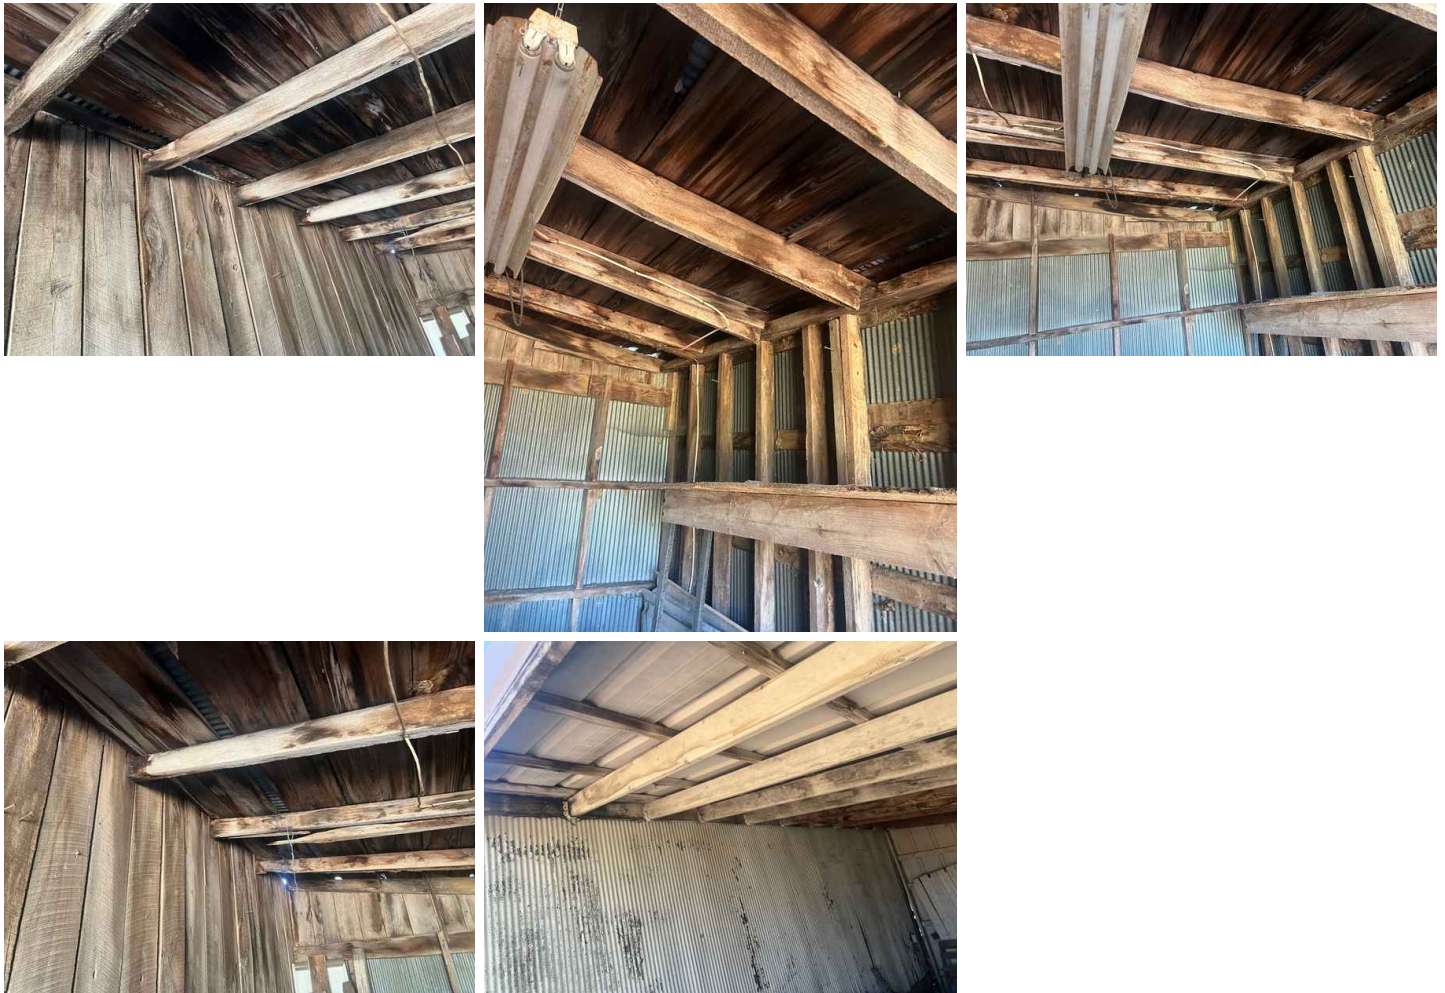
STRUCTURAL DAMAGE

Extensive structural damage and deterioration are present throughout the wall/roof framing. Conditions impact the structural integrity of the building and pose a safety risk. Recommend repairs/replacement by a qualified professional.

Recommendation  
Contact a qualified professional.

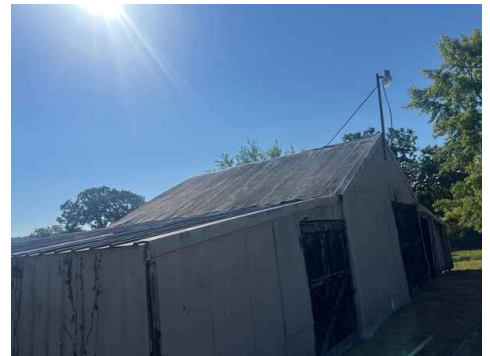
### 13.2.1 Roof

#### **BEYOND DESIGN LIFE**

Roof is beyond design life and leaking in several areas.

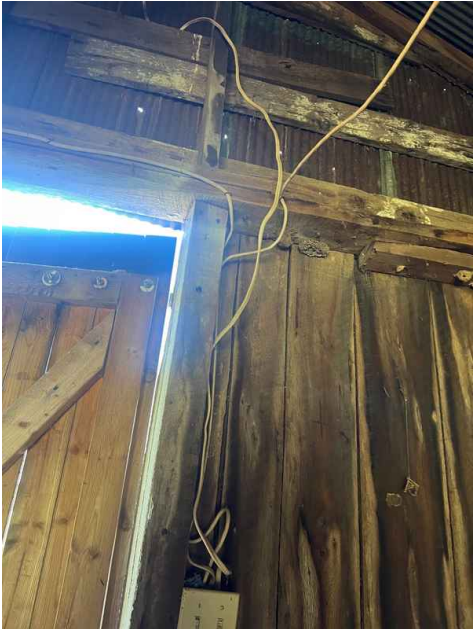
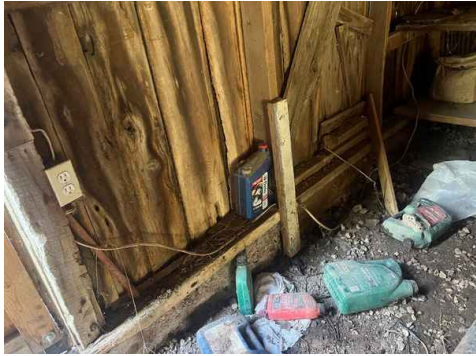
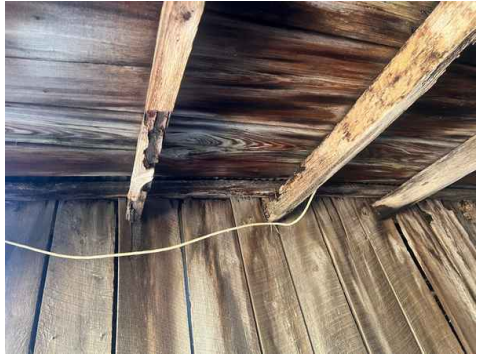
### 13.3.1 Utilities

#### **OPEN AND IMPROPER WIRING**

Maintenance required to the loose and unprotected wiring for safety purposes.
