## RESIDENTIAL REPORT

26442 Highway 49  
Lesterville, MO 63654

12/04/2025

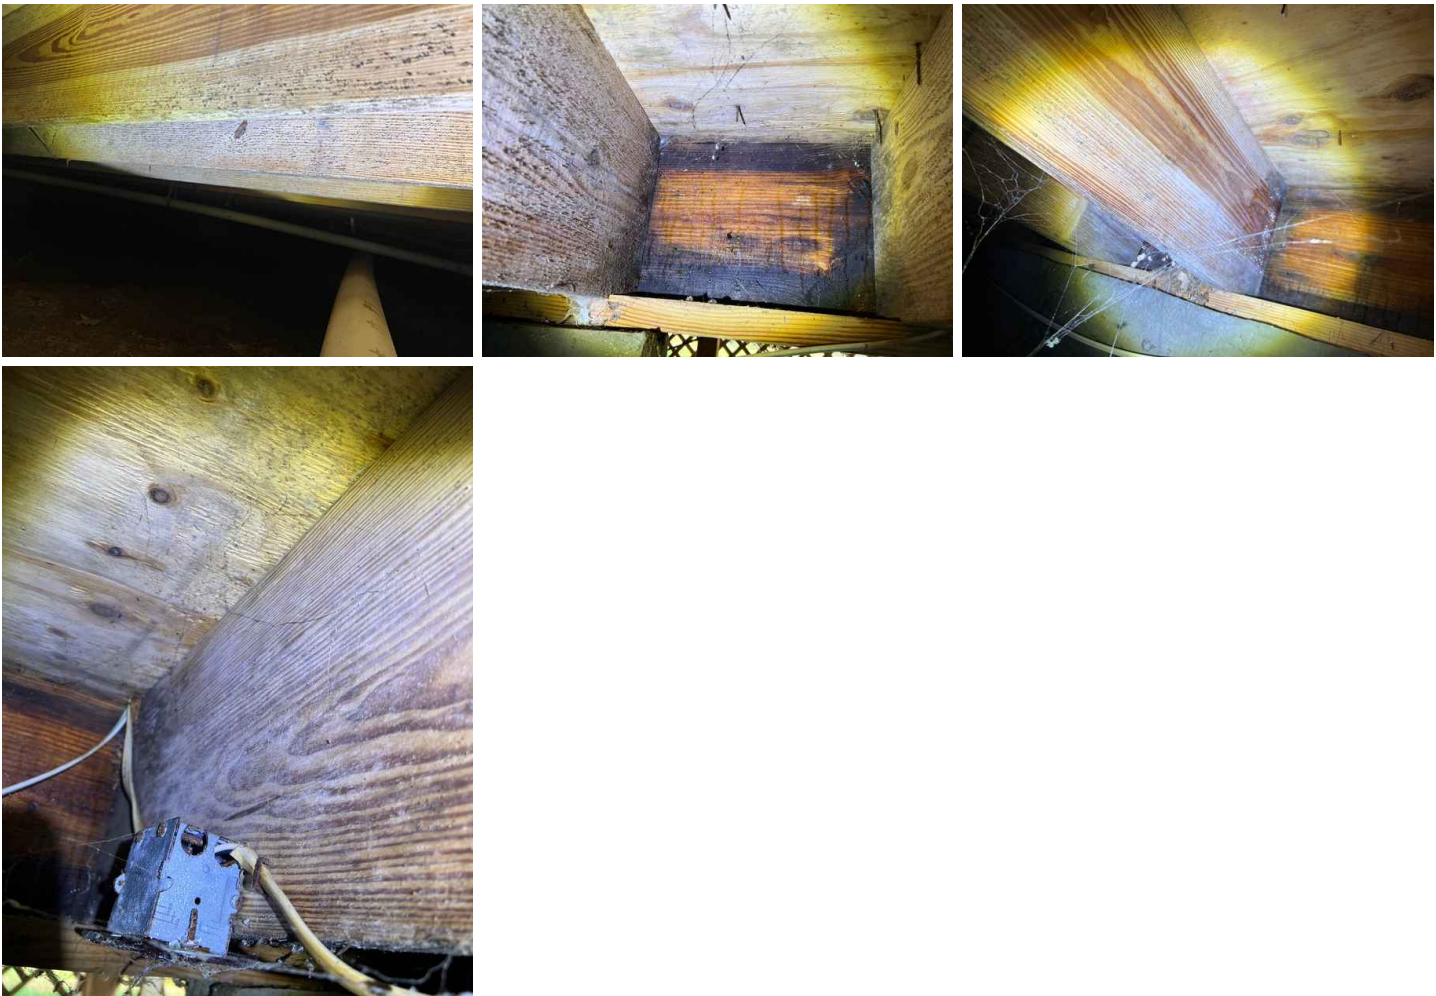
2.1.2 Foundation, Basement & Crawlspaces

MOLD

CRAWL SPACE

Heavy presence of mold is present throughout the crawl space. Conditions are due to the excessively high moisture content. Recommend removal or treatment of all molded materials and eliminating all sources of moisture.

Contact a qualified mold remediation contractor

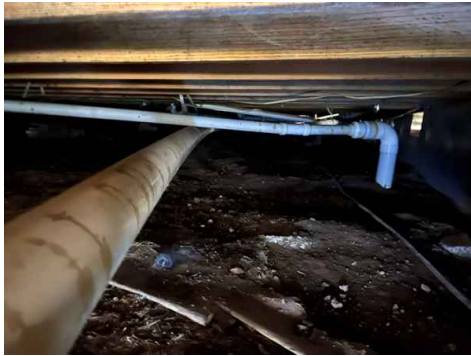
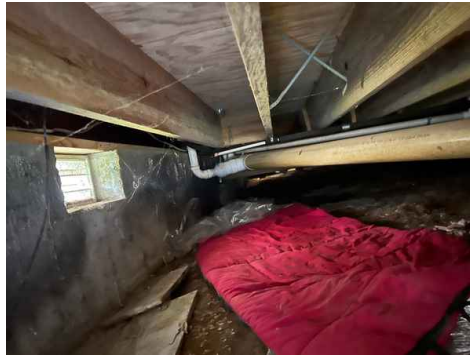
## 2.1.3 Foundation, Basement &amp; Crawlspace

**MISSING/DAMAGED VAPOR BARRIER**

## CRAWLSPACE

Vapor barrier is not present. Recommend installing vapor barrier.

Contact a handyman or DIY project

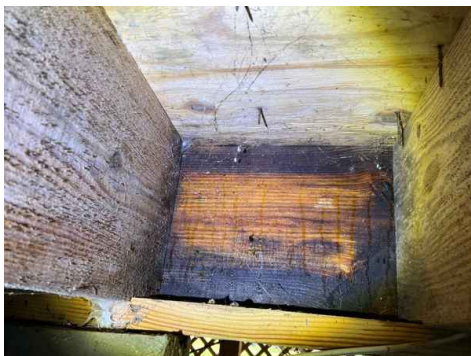
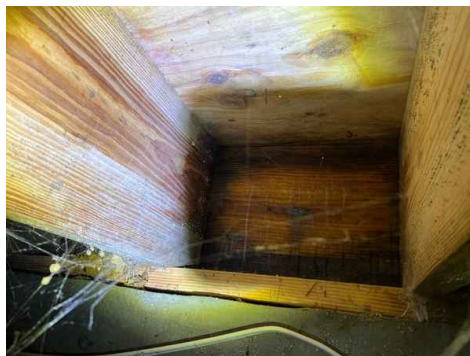
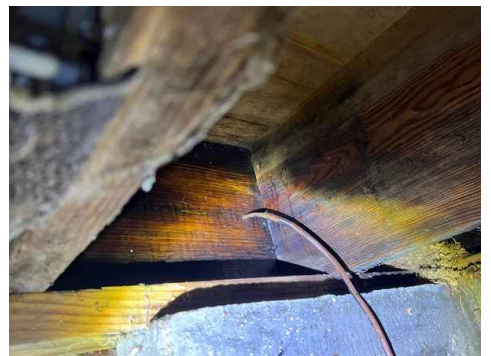
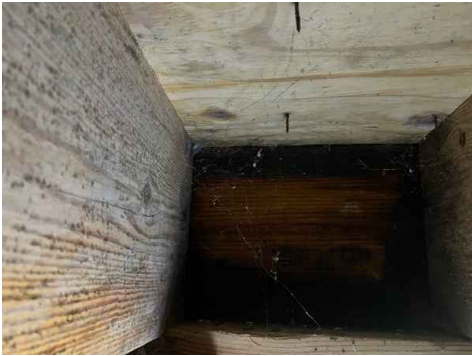
## 2.2.1 Floor Structure

**WATER DAMAGE**

## CRAWL SPACE

Extremely high moisture content in the crawl space is resulting in excessive saturation of the framing components, conditions will result in premature degradation of the wood components.

Contact a qualified professional.

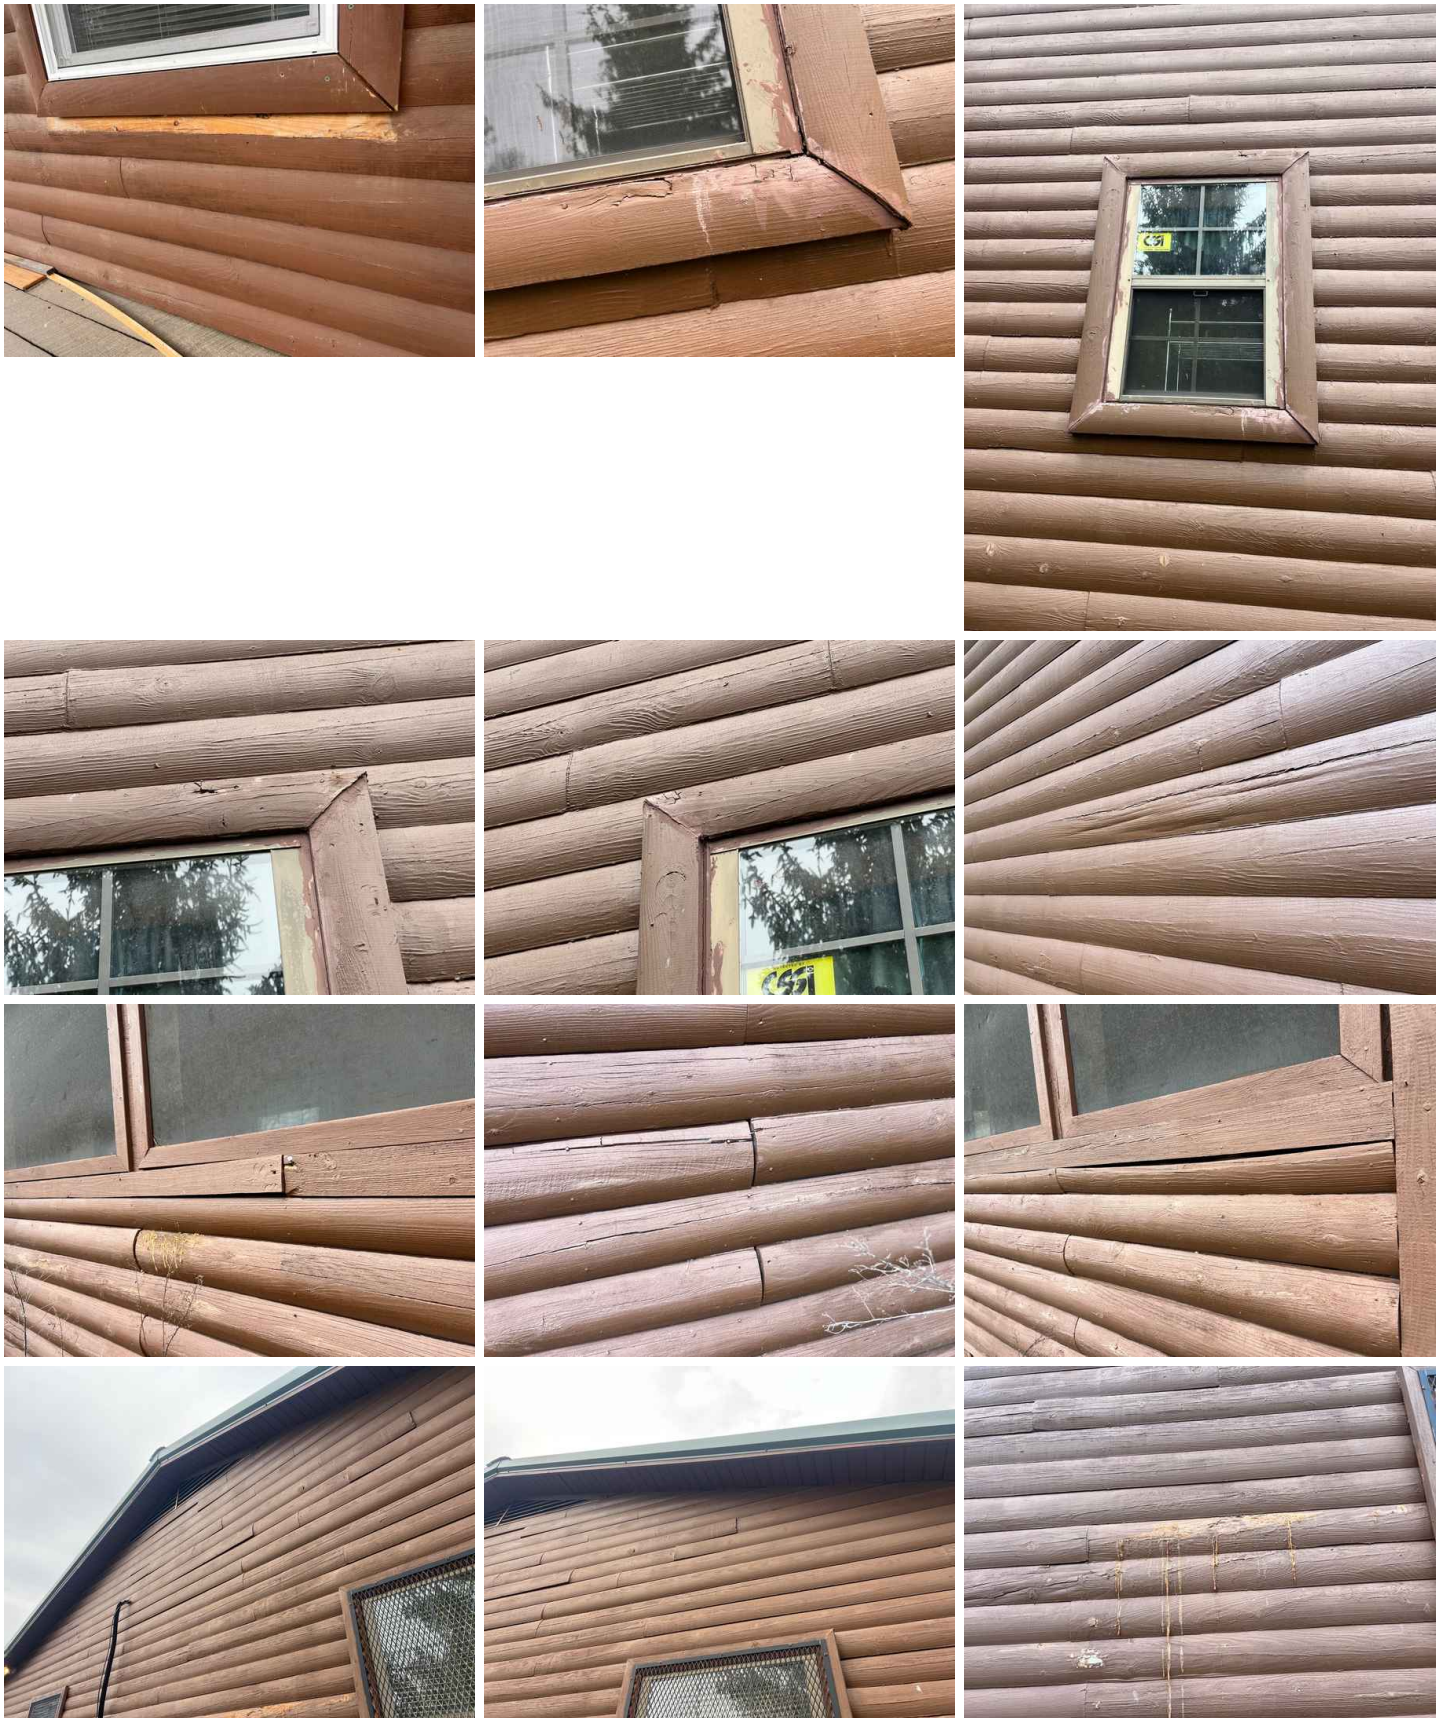
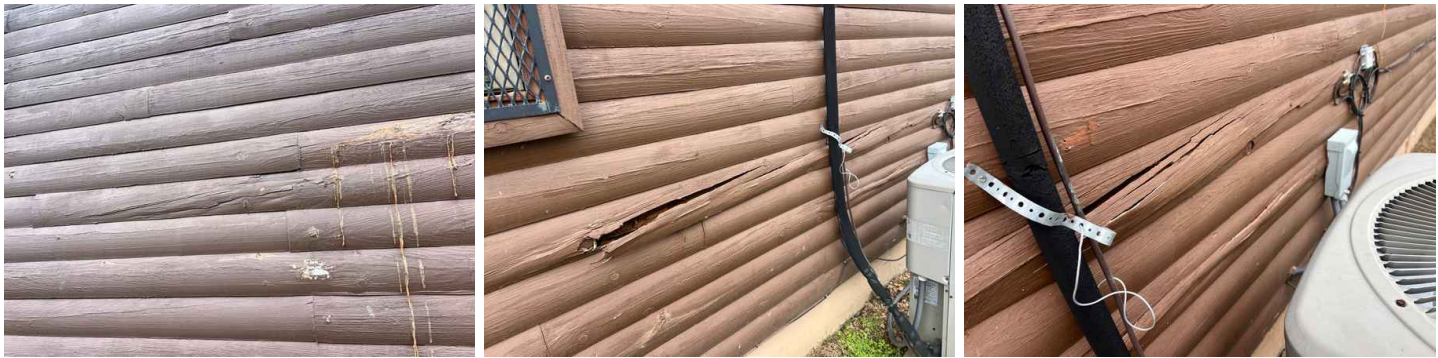
3.1.1 Siding, Flashing & Trim

GENERAL DETERIORATION (WOOD/COMPOSITE)

EXTERIOR FINISH

General deterioration, loose material, weather damaged, previous repairs and missing components are present throughout the exterior. Recommend maintenance and replacement were required to prevent further deterioration.

Contact a qualified professional.

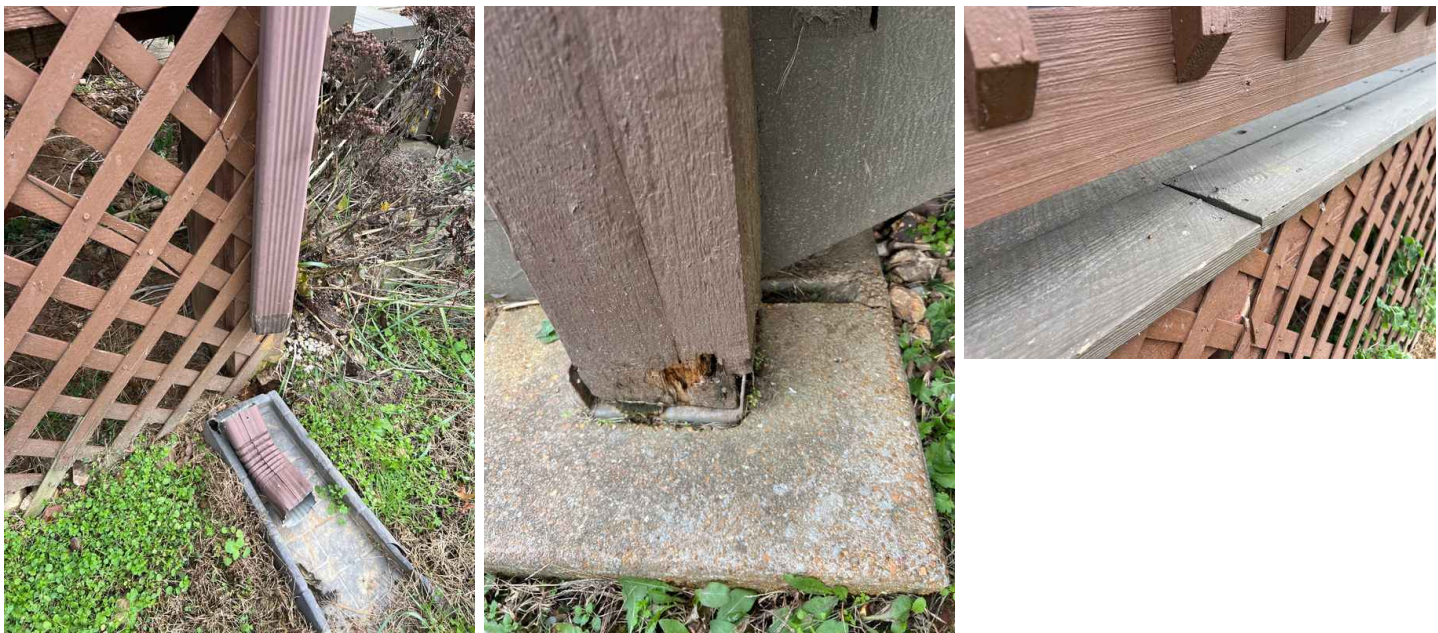
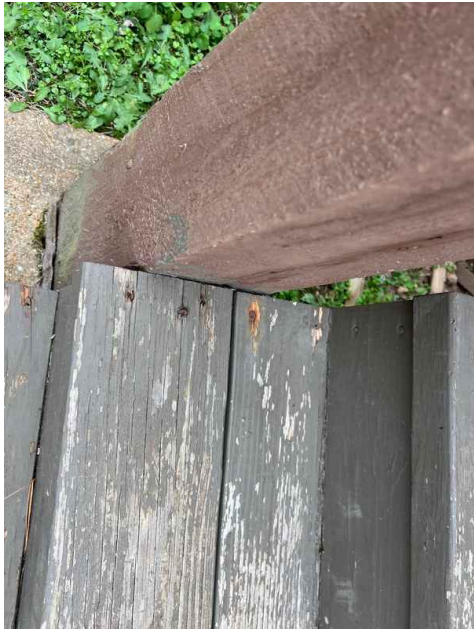
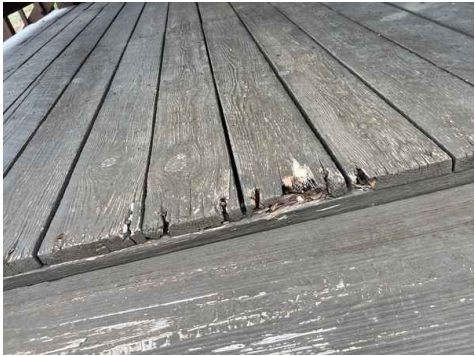
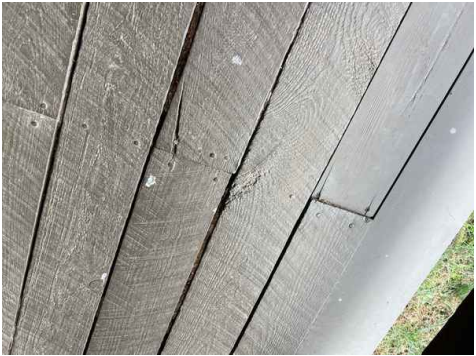
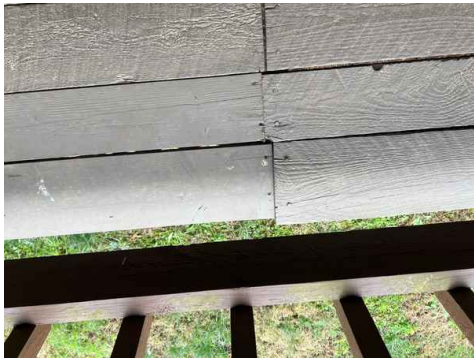
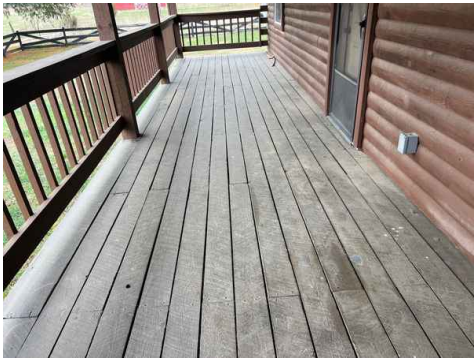
3.5.1 Decks, Balconies, Porches & Steps

**GENERAL DETERIORATION**

FRONT PORCH

Front porch flooring, stair assemblies and railings show signs of deterioration. Raised fasteners, poor wood to earth clearance and previous repairs. Recommend maintenance to prevent further deterioration.

Contact a qualified deck contractor.

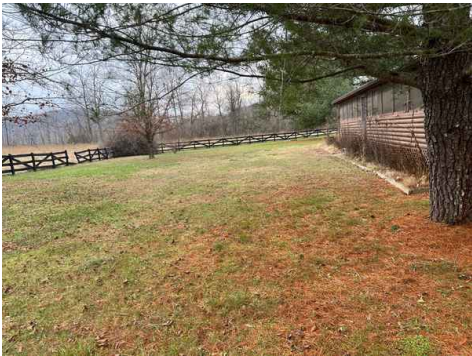
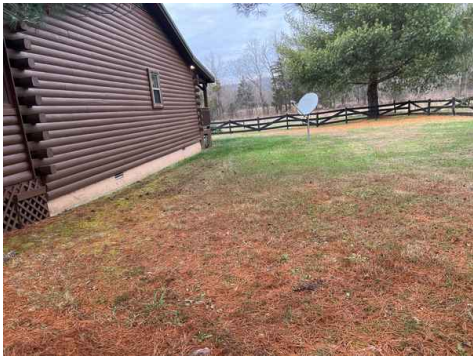
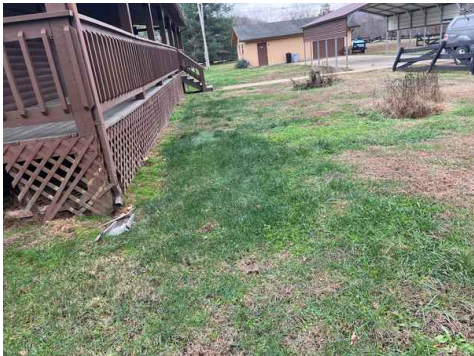
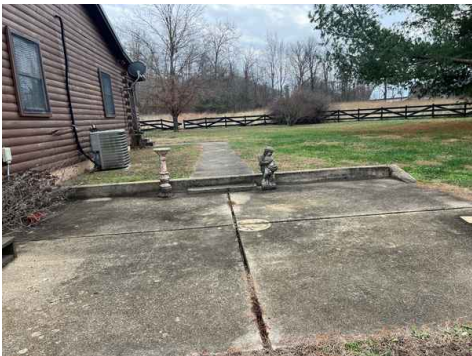
3.6.1 Vegetation, Grading, Drainage & Retaining Walls

**POOR DRAINAGE**

EXTERIOR

Home is constructed on a level lot that does not allow water to drain away from the foundation. Conditions are resulting in hydrostatic water and excessive condensation in the crawl space.

Contact a handyman or DIY project

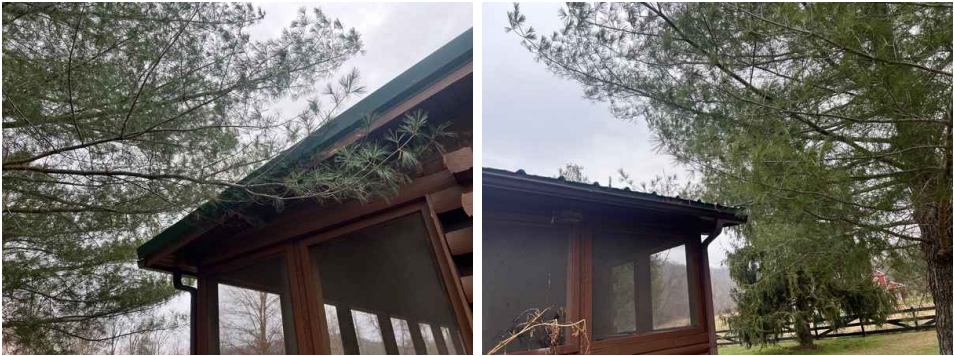
3.6.2 Vegetation, Grading, Drainage & Retaining Walls

**TRIM VEGETATION**

Trim vegetation off and away from the exterior walls.

Contact a handyman or DIY project

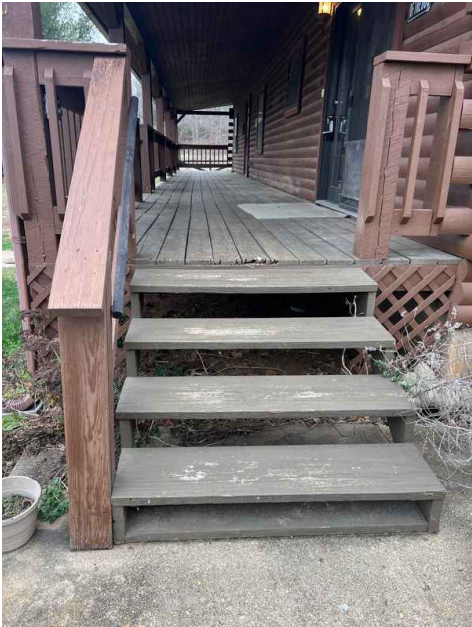
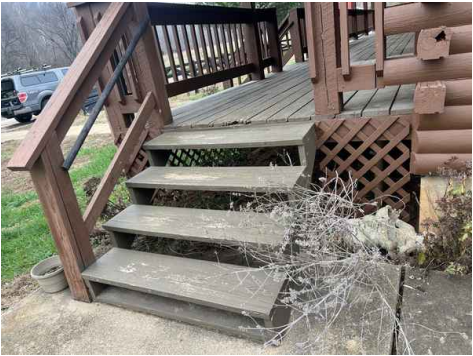
3.7.1 Walkways, Patios & Driveways

**UNSAFE RAIL OPENINGS**

FRONT PORCH

Unsafe rail openings are present at the exterior steps.

Contact a qualified professional.

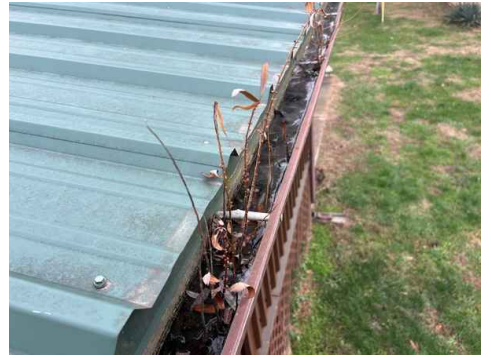
4.2.1 Roof Drainage Systems

CLOGGED/DEBRIS

ROOF

Downspouts are clogged and filled with debris.

Contact a handyman or DIY project

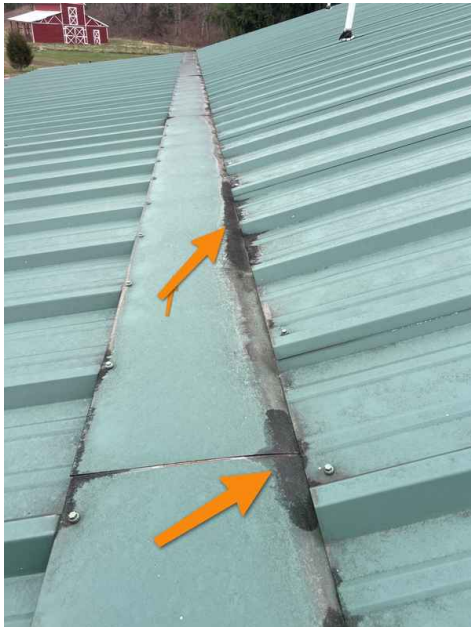
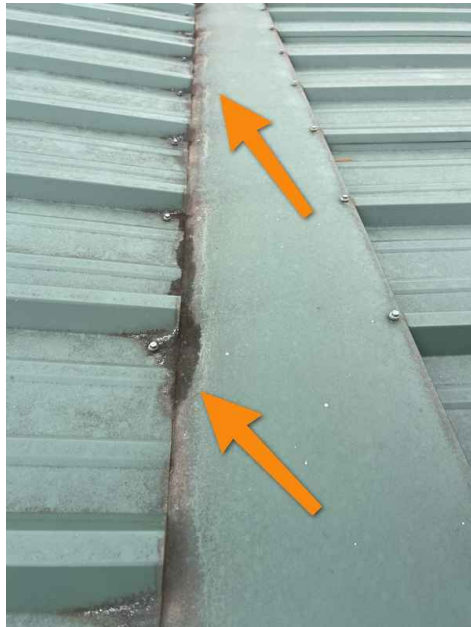
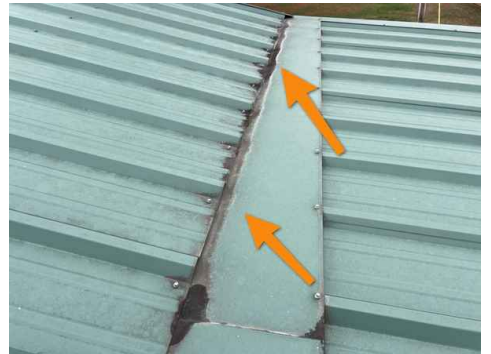
## 4.3.1 Flashings

**IMPROPER INSTALLATION**

## ROOF

Transition flashing between the roof and front porch has a negative slope allowing water to pond. Conditions may result in water intrusion.

Contact a qualified roofing professional.

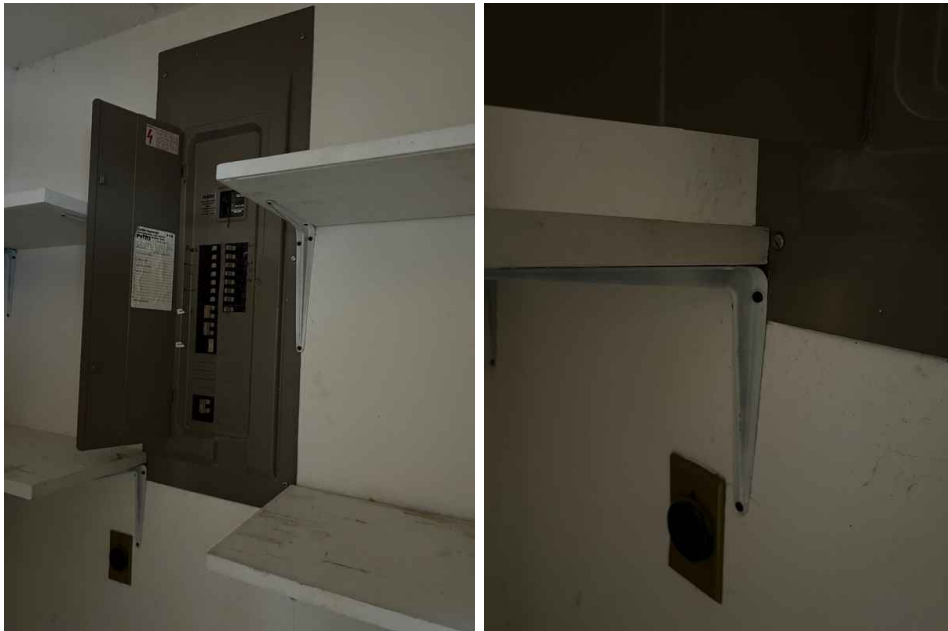
5.2.1 Service and Grounding Equipment, Main Overcurrent Device, Main and Distribution Panels

### PANEL CLEARANCE

Insufficient clearance is present at the panel. Panel requires 36" of clearance from top of panel to floor for safety purposes.

Contact a handyman or DIY project

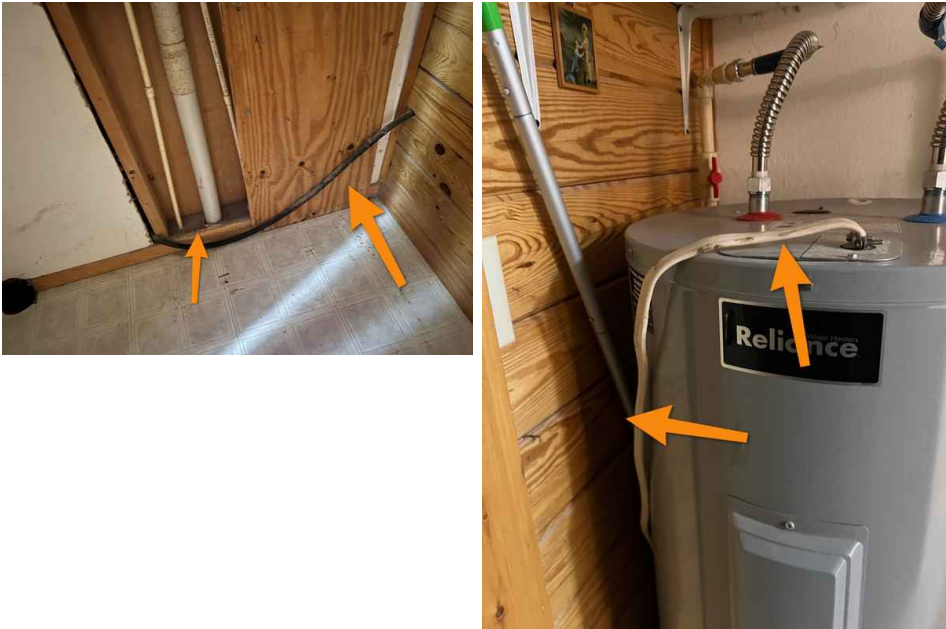
5.3.1 Branch Circuit Conductors, Overcurrent Devices and Compatibility of Their Amperage & Voltage

### IMPROPER WIRING

UTILITY ROOM

Improperly run and unsecured wiring is present in the utility room and water heater. Recommend repairs by a qualified electrical contractor for safety purposes.

Contact a qualified electrical contractor.

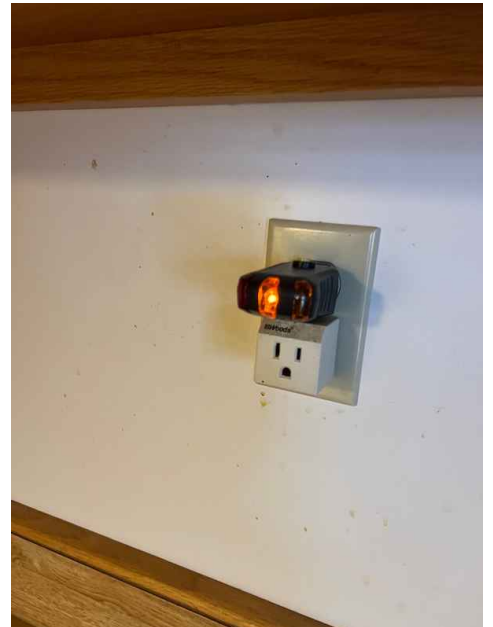
## 5.6.1 GFCI &amp; AFCI

**NO GFCI PROTECTION INSTALLED**

KITCHEN, BATHROOMS

GFI protection is not present at all required locations. Recommend qualified electrical contractor install GFI protection for safety purposes

Contact a qualified electrical contractor.

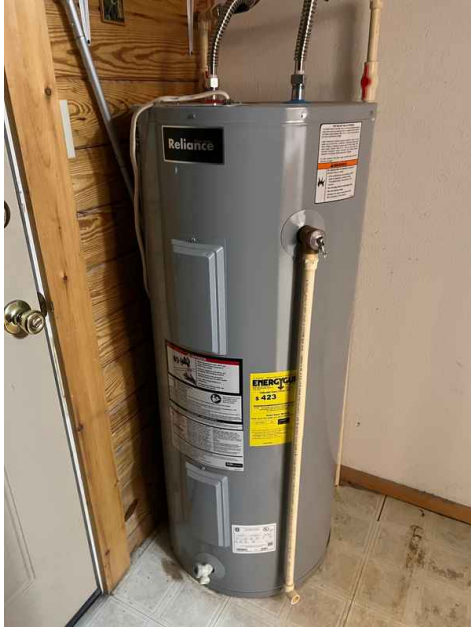
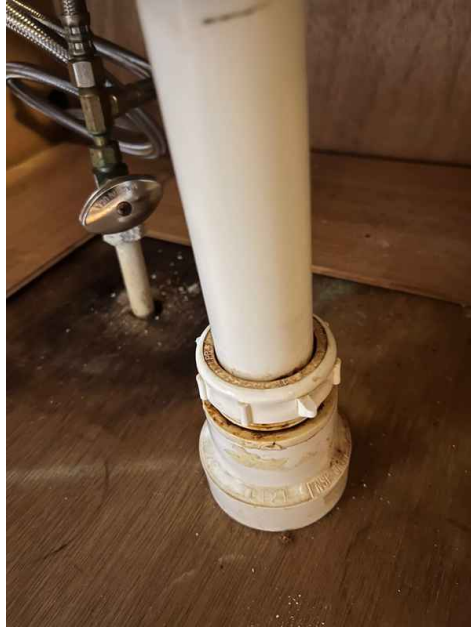
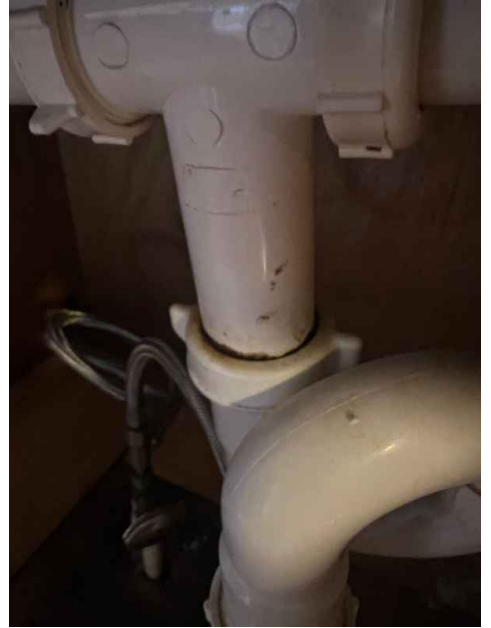
6.2.1 Drain, Waste, & Vent Systems  
**SEEPAGE**  
KITCHEN

Evidence of seepage is present at the drain connections. Recommend maintenance to prevent leaking.

Contact a qualified plumbing contractor.

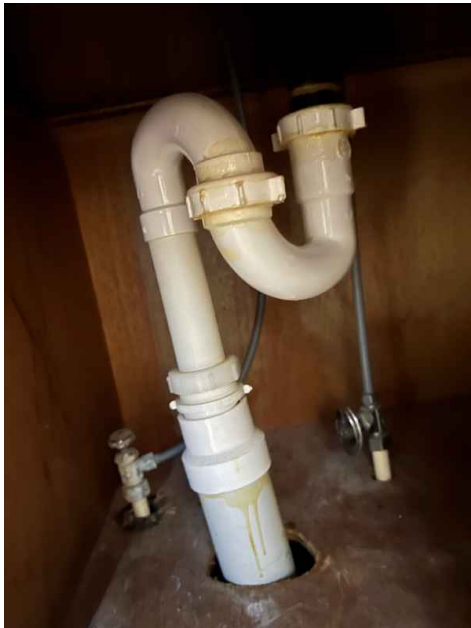
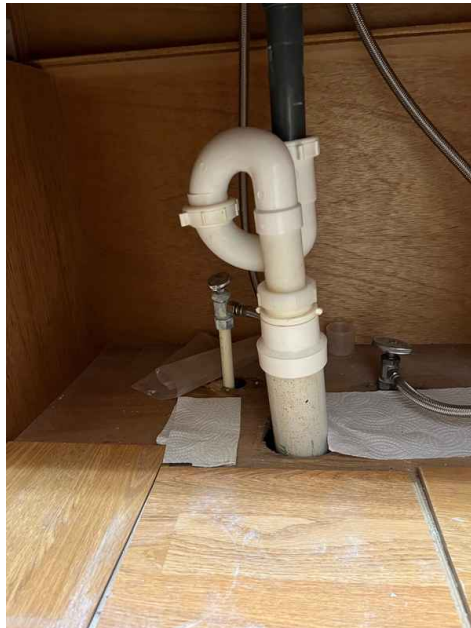
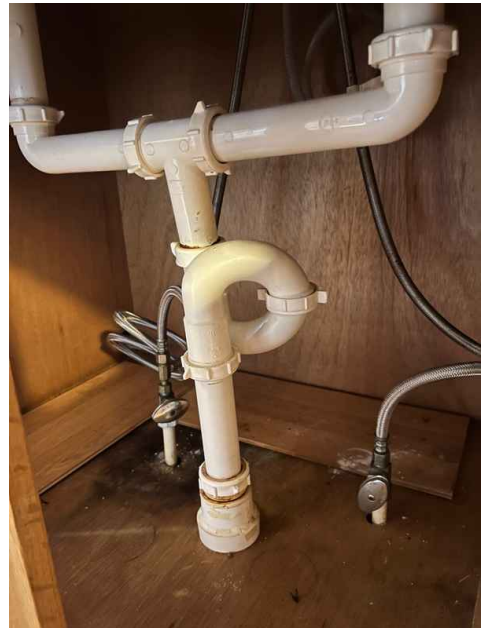
#### 6.2.2 Drain, Waste, & Vent Systems

### IMPROPER INSTALLATION - S-TRAP

BATHROOMS, KITCHEN

S-trap configurations observed. Recommend evaluation and repair by a qualified professional.

Contact a qualified plumbing contractor.

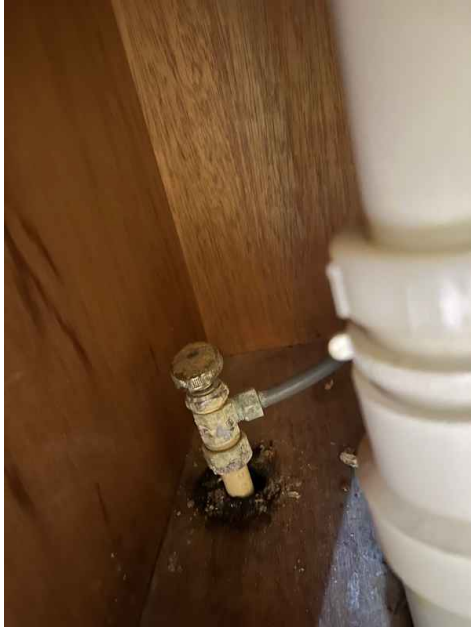
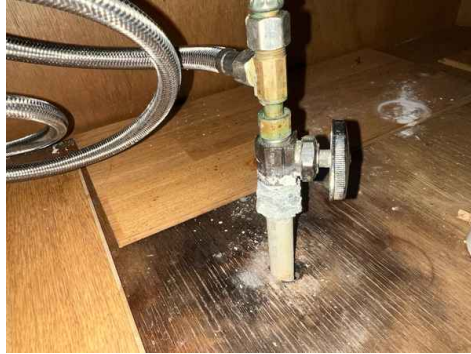
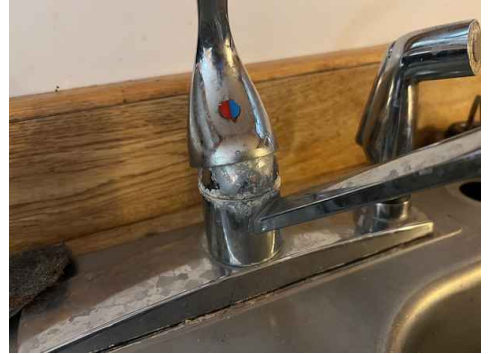
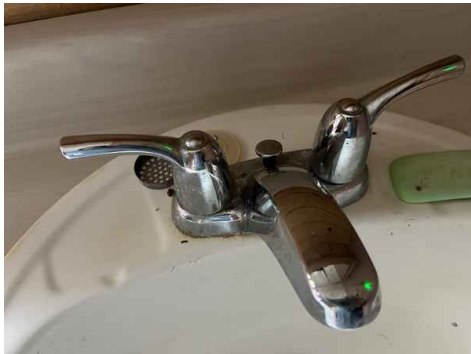
## 6.3.1 Water distribution

**CORROSION**

## KITCHEN, BATHROOMS

Corrosion is present on the valves and fixtures in several areas. Recommend further evaluation and replacement where necessary to prevent leaking.

Contact a qualified plumbing contractor.

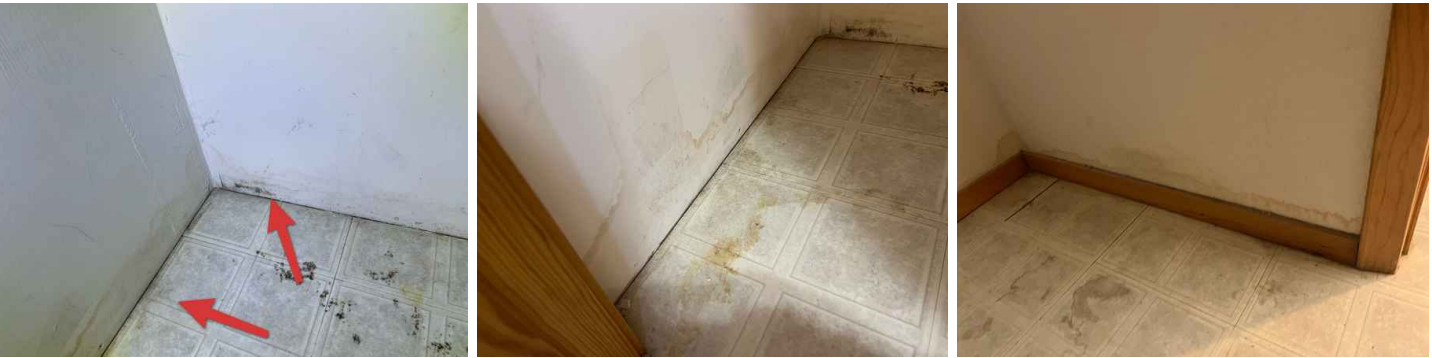
Visible mold is present on the drywall and finish materials. Conditions are due high moisture content. Recommend removal and treatment of all molded materials for health and safety purposes. All sources of moisture should be eliminated to prevent further mold issues.

Recommendation  
Contact a qualified professional.

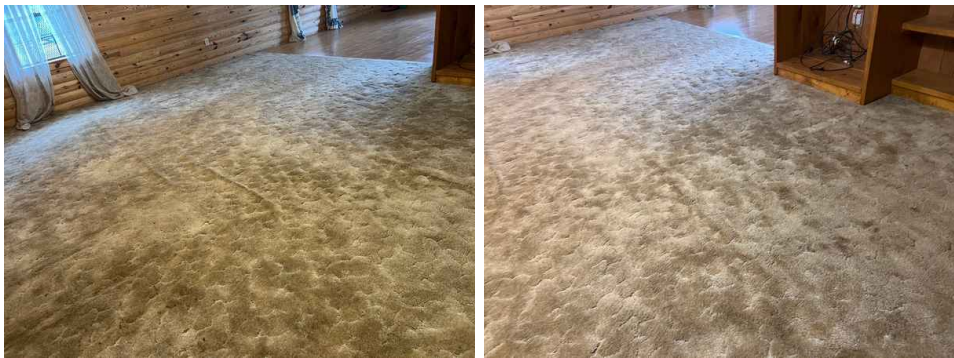
9.3.1 Floors  
**BUCKLED CARPET**

Maintenance or replacement recommended to all buckled carpet to eliminate trip hazards.

Contact a qualified professional.

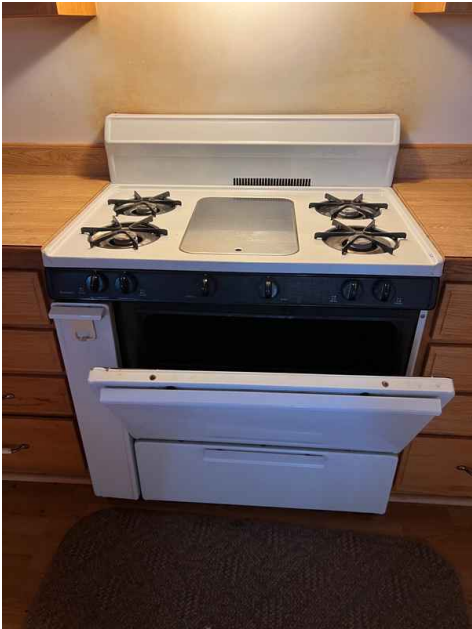
10.4.1 Design Life

STOVE

Appliances are beyond design life. Appliances were cycled and operational at inspection.

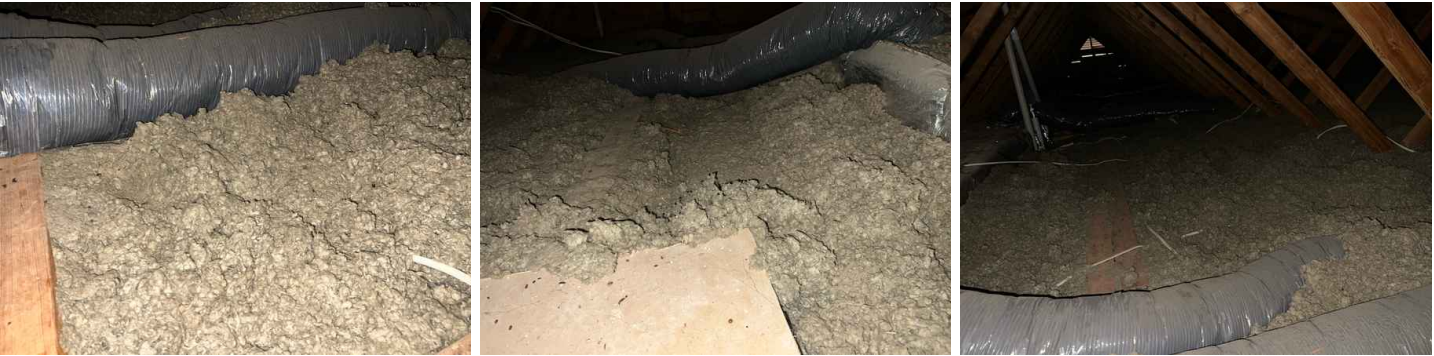
Insulation is matted due to typical settling and foot traffic. Recommend additional insulation for efficiency purposes.

Recommendation  
Contact a qualified insulation contractor.

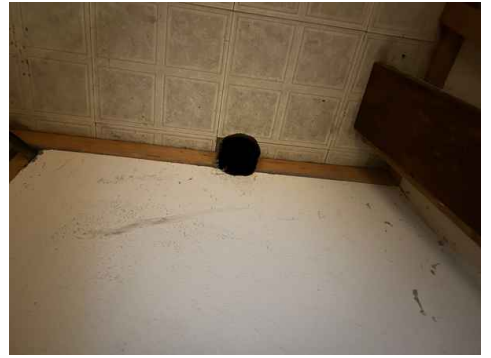
**NO DRYER VENT**

Dryer did not have visible venting to the exterior at time of inspection. This can cause a reduction in air flow and affect dryer performance. Recommend a qualified HVAC contractor or handyman install venting to the exterior.
