# SQUARED AWAY HOME INSPECTIONS

## RESIDENTIAL INSPECTION

2009 St Marys Blvd  
Jefferson City, MO 65109

09/21/2026

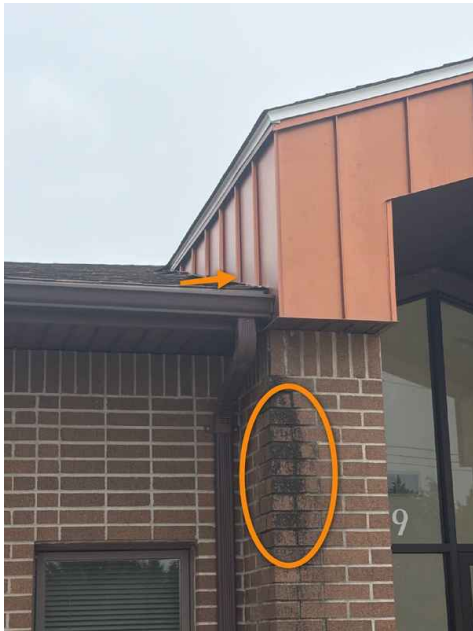
##### MISSING KICK OUT FLASHING

Kick out flashing is absent at the roof-to-wall transition. This flashing diverts water away from the wall and foundation, preventing moisture intrusion. Without it, water running down the roof can channel directly into the wall cavity, causing wood rot, structural damage, and interior water damage. A roofing professional should install appropriate kick out flashing at this transition point.

Contact a qualified roofing professional.

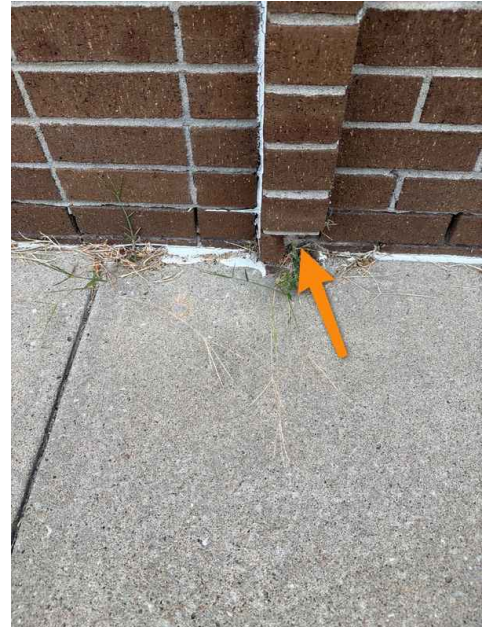
### 3.3.1 Wall Coverings, Trim, & Vents

#### **BRICK OR MORTAR - DAMAGED**

Tuckpointing to the brick is needed in one or more places as preventive maintenance. Some signs include mortar joints that are broken, cracked or partially missing. Bricks that are cracked or crumbling will also require immediate attention.

Contact a qualified masonry professional.

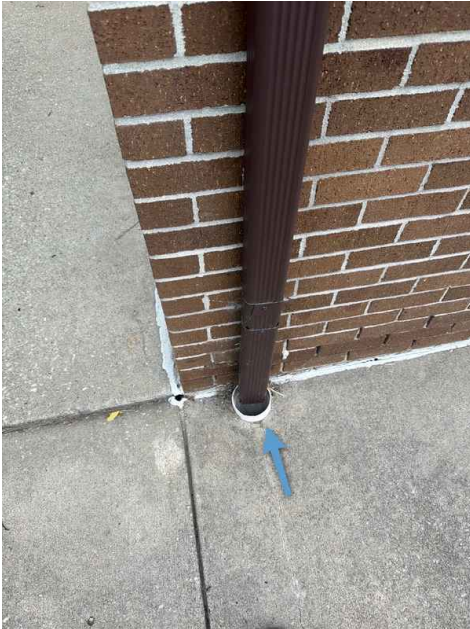
#### 3.4.1 Downspouts

##### **DOWNSPOUTS DISCHARGE POINT**

The down spouts of this home drain into pipes but where they discharge to could not be verified. Recommend checking with current home owners and further analysis to ensure drains are not clogged and are discharging away from the homes foundation. Also as part of your routine maintenance consider periodically filling with water to ensure drain path is not clogged and discharging properly or observe discharge point and gutter system during heavy rain.

Contact a handyman or DIY project

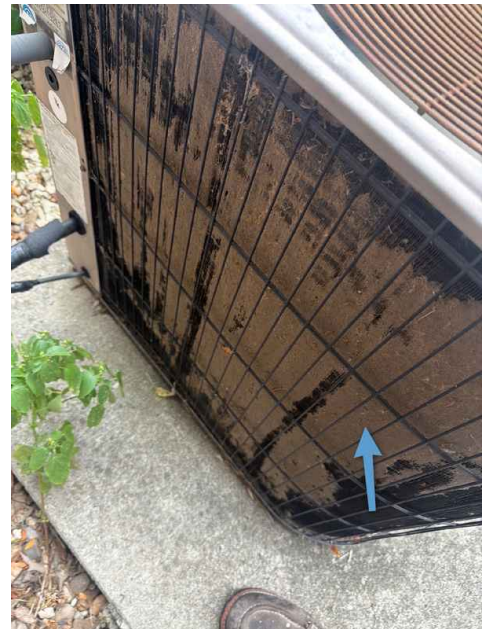
### 3.6.1 Cooling Outside Unit

#### **AIR FLOW RESTRICTED**

Air flow to the air conditioner condenser was restricted by debris. This may result in inefficient operation. Recommend annual inspection and cleaning by HVAC professional.

Routine Maintenance

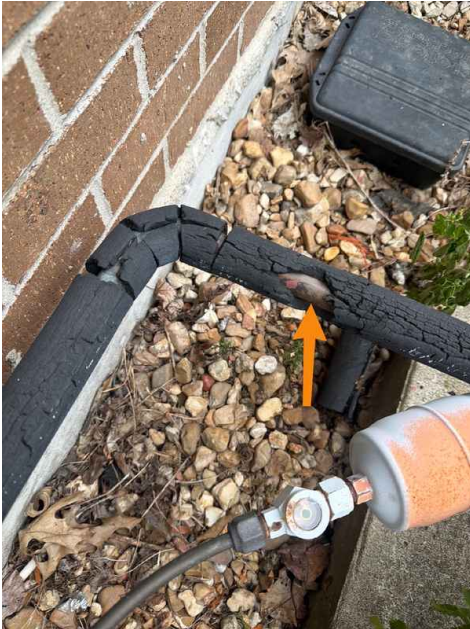
### 3.6.2 Cooling Outside Unit

#### **INSULATION MISSING OR DAMAGED**

Outside AC unit missing or damaged insulation on refrigerant line can cause energy loss and condensation. Recommend replacing insulation.

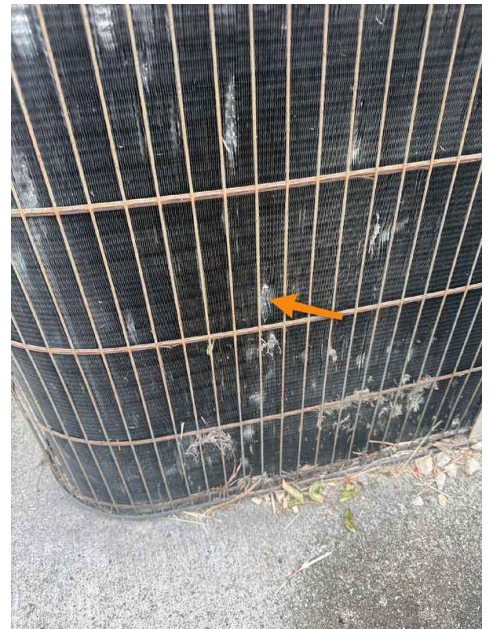
### 3.6.3 Cooling Outside Unit

#### **FINS DAMAGED**

I observed indications of damaged fins on the exterior compressor unit of the cooling system. Recommend annual cleaning, inspection and evaluation by HVAC professional.

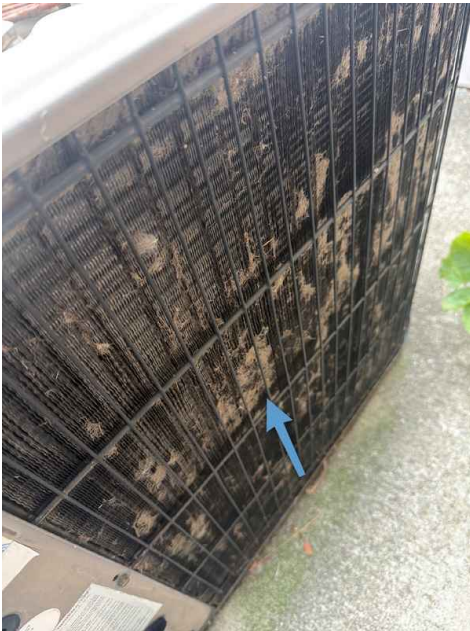
### 3.7.1 Cooling Outside Unit 2

#### **AIR FLOW RESTRICTED**

Air flow to the air conditioner condenser was restricted by debris. This may result in inefficient operation. Recommend annual inspection and cleaning by HVAC professional.

Routine Maintenance

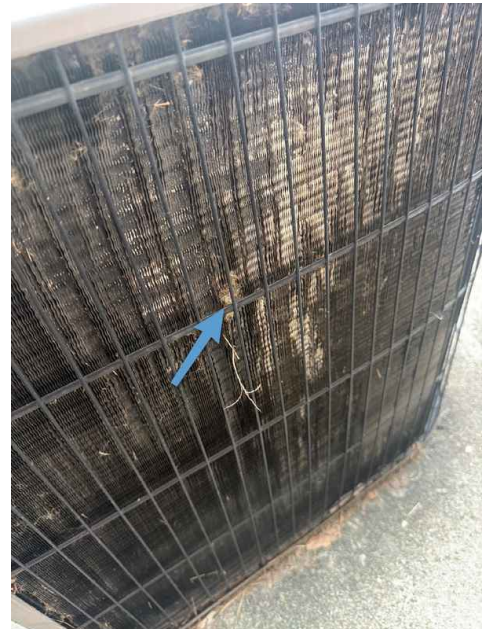
### 3.8.1 Cooling Outside Unit 3

#### **AIR FLOW RESTRICTED**

Air flow to the air conditioner condenser was restricted by debris. This may result in inefficient operation. Recommend annual inspection and cleaning by HVAC professional.

Contact a qualified HVAC professional.

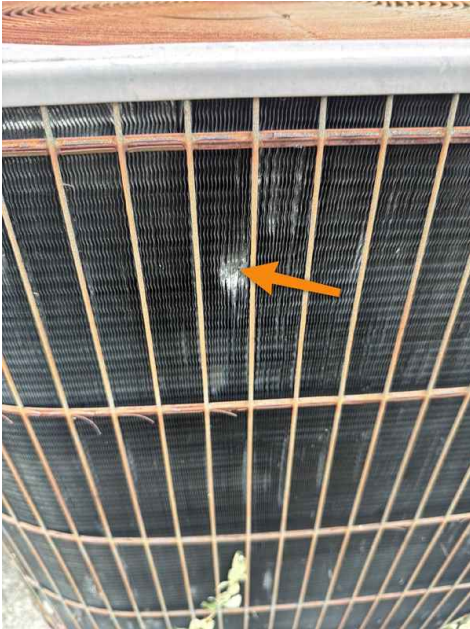
### 3.8.3 Cooling Outside Unit 3

#### **FINS DAMAGED**

I observed indications of damaged fins on the exterior compressor unit of the cooling system. Recommend annual cleaning, inspection and evaluation by HVAC professional.

Contact a qualified HVAC professional.

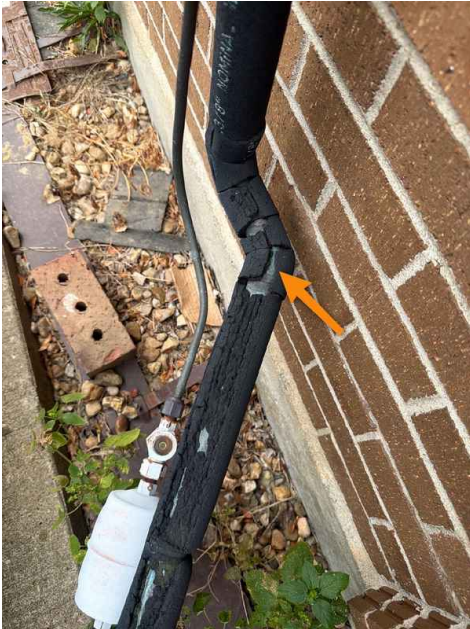
### 3.9.2 Cooling Outside Unit 4

#### **INSULATION MISSING OR DAMAGED**

Outside AC unit missing or damaged insulation on refrigerant line can cause energy loss and condensation. Recommend replacing insulation.

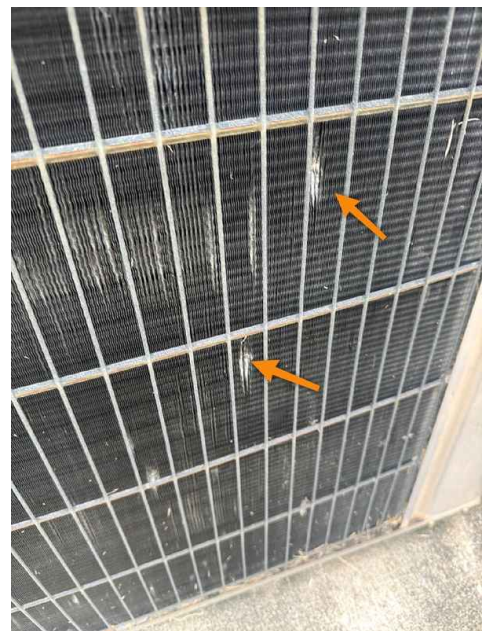
#### **FINS DAMAGED**

I observed indications of damaged fins on the exterior compressor unit of the cooling system. Recommend annual cleaning, inspection and evaluation by HVAC professional.

Contact a qualified HVAC professional.

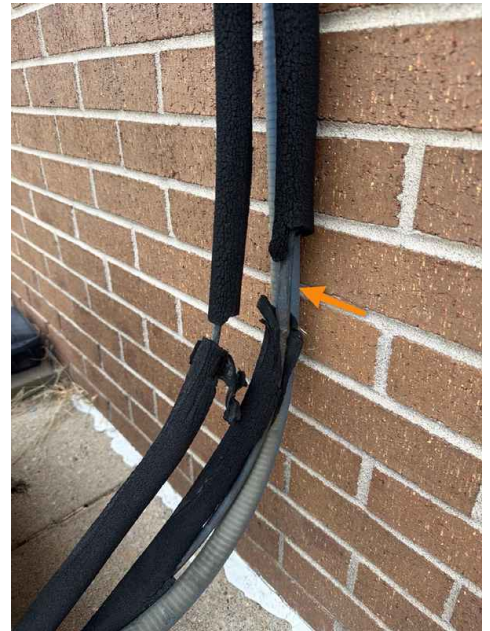
### 3.10.1 Cooling Outside Unit 5

#### **INSULATION MISSING OR DAMAGED**

Outside AC unit missing or damaged insulation on refrigerant line can cause energy loss and condensation. Recommend replacing insulation.

Contact a qualified HVAC professional.

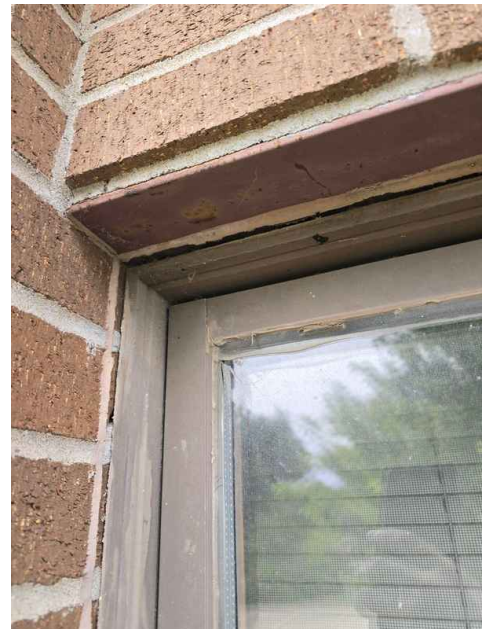
### 3.14.1 Exterior Windows & Screens

#### **WINDOW CASE CAULKING**

The caulking is worn, deteriorated, or missing in one or more places. Recommend replacing with new caulk to prevent moisture and insect intrusion as well as improve homes energy efficiency.

Contact a handyman or DIY project

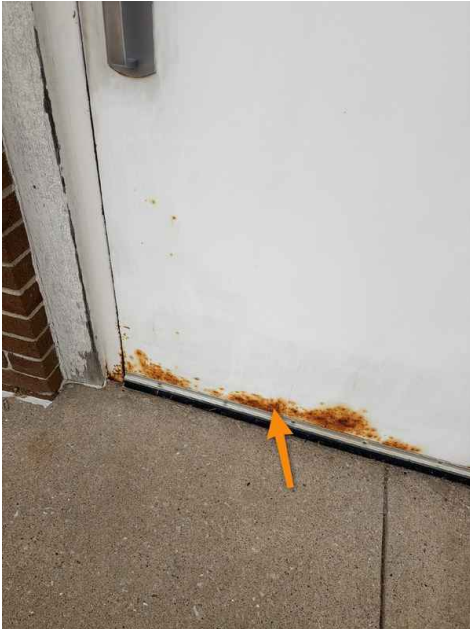
### 3.15.1 Exterior Doors

#### **DOOR PAINT/REFINISH NEEDED**

Door finish is worn. Recommend refinish and/or paint to maximize service life.

Contact a handyman or DIY project

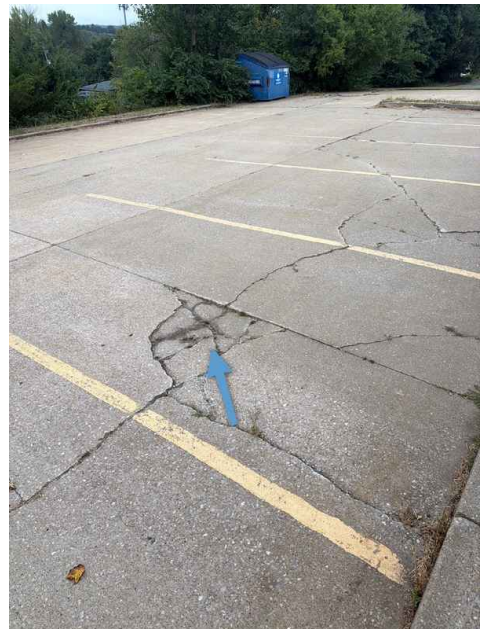
### 3.16.1 Walkways, Patios & Driveways

#### **DRIVEWAY CRACKING - MINOR**

Minor cosmetic cracks observed, which may indicate movement in the soil. Recommend monitor and/or have concrete contractor patch/seal to prevent further deterioration from moisture and freezing.

Contact a qualified concrete contractor.

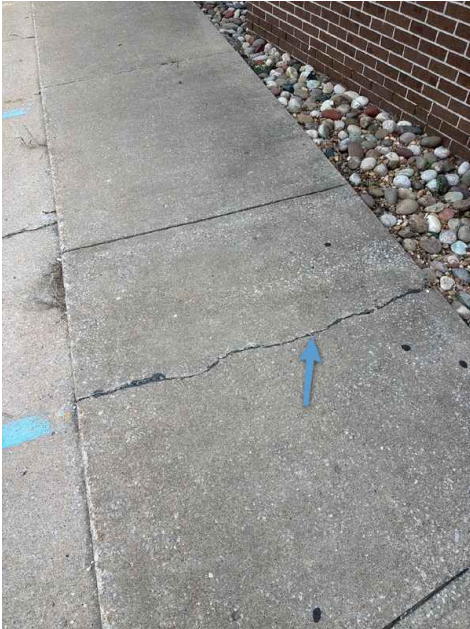
### 3.16.2 Walkways, Patios & Driveways

#### **WALKWAY CRACKING - MINOR**

Minor cosmetic cracks observed. Recommend monitor and/or have concrete contractor patch/seal to prevent further deterioration from moisture and freezing.

Contact a handyman or DIY project

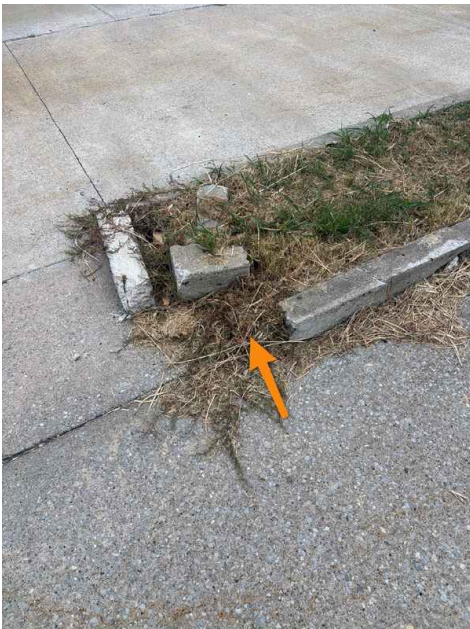
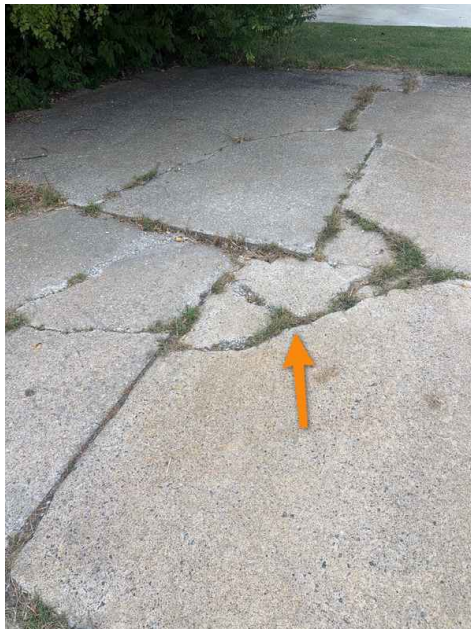
### 3.16.3 Walkways, Patios & Driveways

#### **DRIVEWAY CRACKING - MAJOR**

Major cracks observed to the driveway and the curbs. Recommend have concrete contractor patch/seal to prevent further deterioration from moisture and freezing.

Contact a qualified concrete contractor.

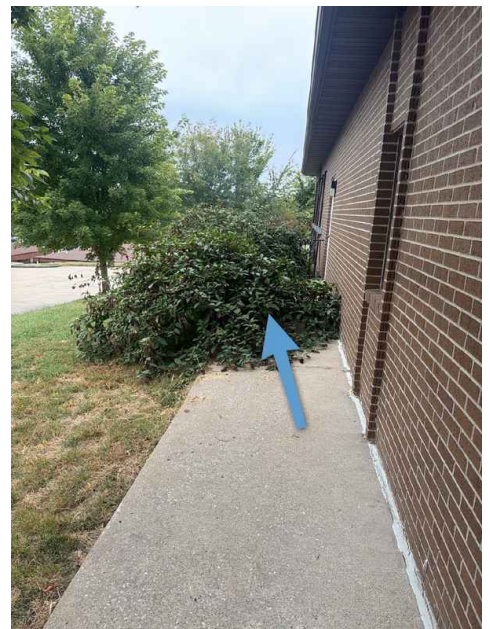
## 3.20.1 Vegetation, Grading, &amp; Drainage

**DENSE VEGETATION NEAR HOME**

I observed dense vegetation around the house in areas. This condition limited and restricted my visual inspection. Dense vegetation and landscaping up against or near the house foundation and exterior walls may be prone to water penetration and insect infestation.

Trimming, pruning and some landscaping is recommended.

Contact a handyman or DIY project

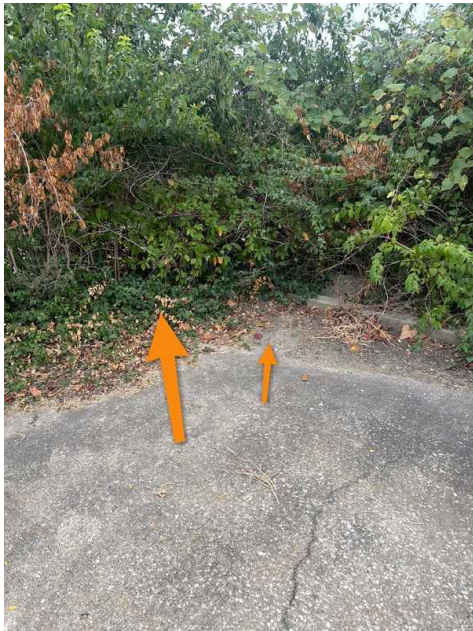
## 3.20.2 Vegetation, Grading, &amp; Drainage

**DRAIN - CLOGGED OR DAMAGED**

Where the water flows to the edge of the parking lot it is clogged with debris and is overgrown. Recommend further evaluation and repair

Contact a qualified landscaping contractor

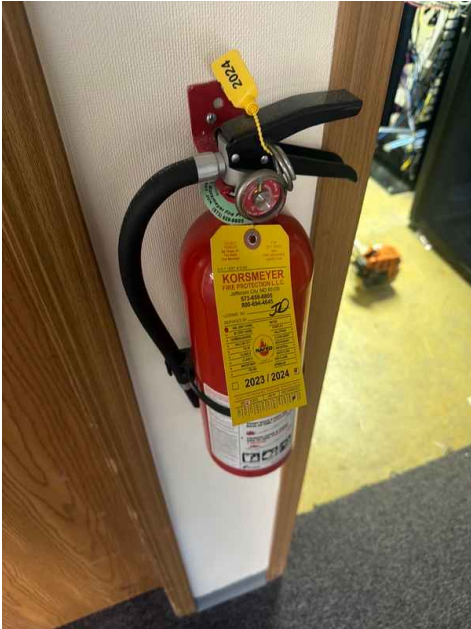
4.1.1 General

One or more fire extinguishers are out of date and no longer certified for use. An expired extinguisher may not function properly in an emergency, reducing its effectiveness in suppressing fires. The extinguisher should be replaced or recharged by a qualified professional to ensure it meets current safety standards.

Recommendation  
Contact a qualified professional.

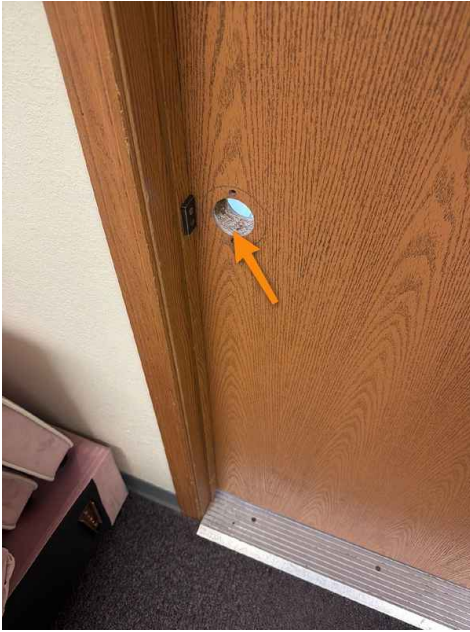
#### 5.2.2 Doors

##### **LOOSE OR MISSING HARDWARE**

This door has loose or missing hardware. Recommend to repair or replace for proper operation of the door.

Contact a handyman or DIY project

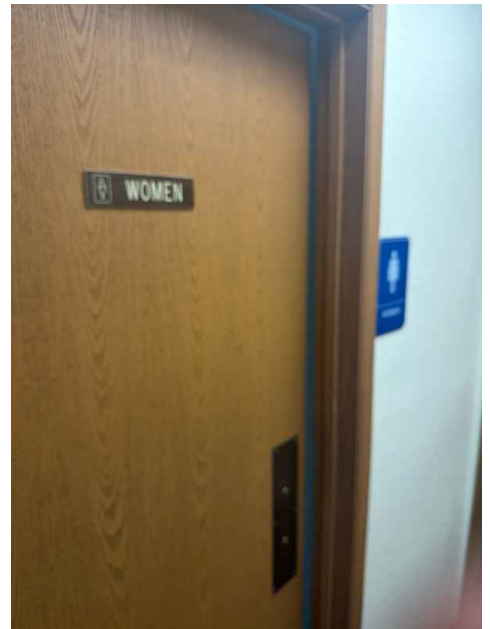
### 5.2.3 Doors

#### **DOOR DOESN'T LATCH**

Door doesn't latch properly. Recommend handyman repair latch and/or strike plate.

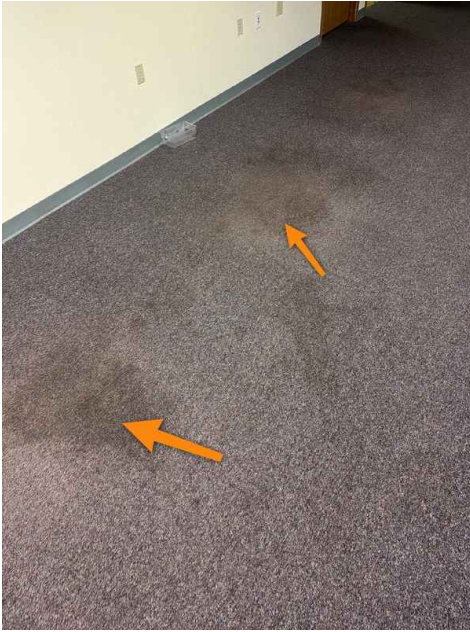
### 5.4.1 Floors

Carpet had areas of staining or soiling and loose. Recommend to clean repair and replace as needed.

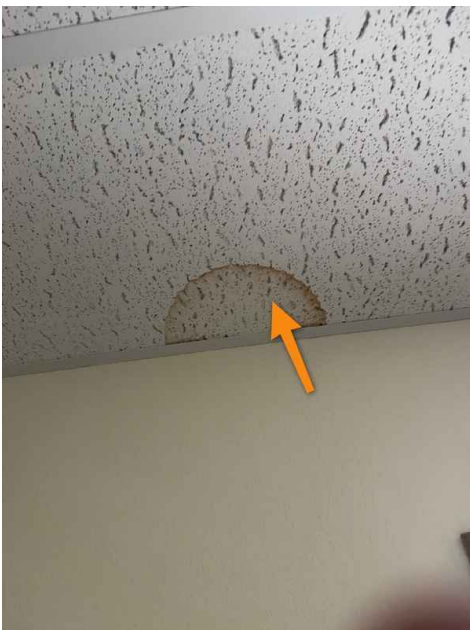
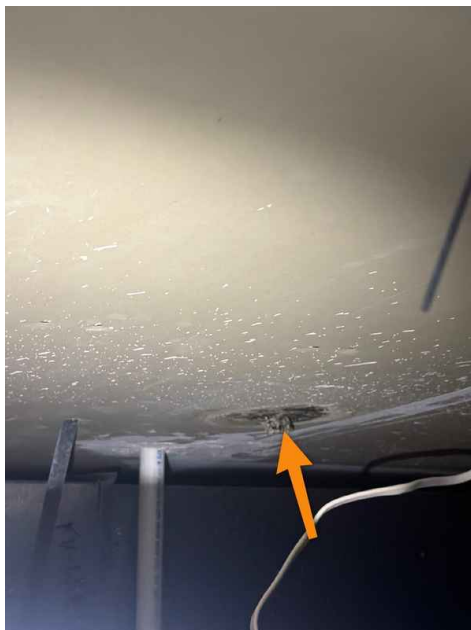
### MOISTURE DAMAGE

Contact a qualified general contractor.

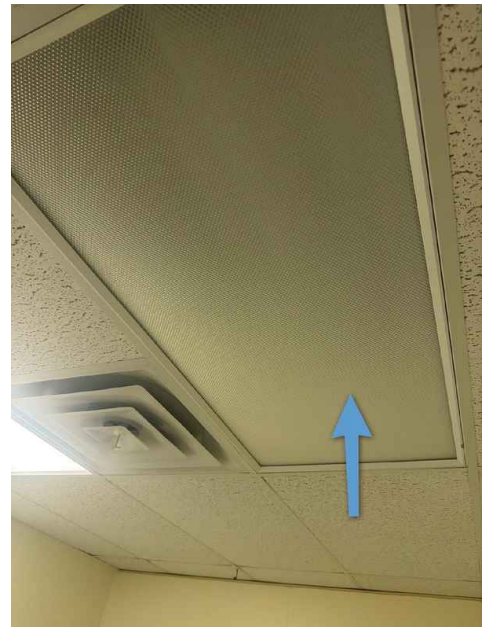
## 6.3.1 Lighting &amp; Fan Fixtures

**LIGHT INOPERABLE**

Contact a handyman or DIY project

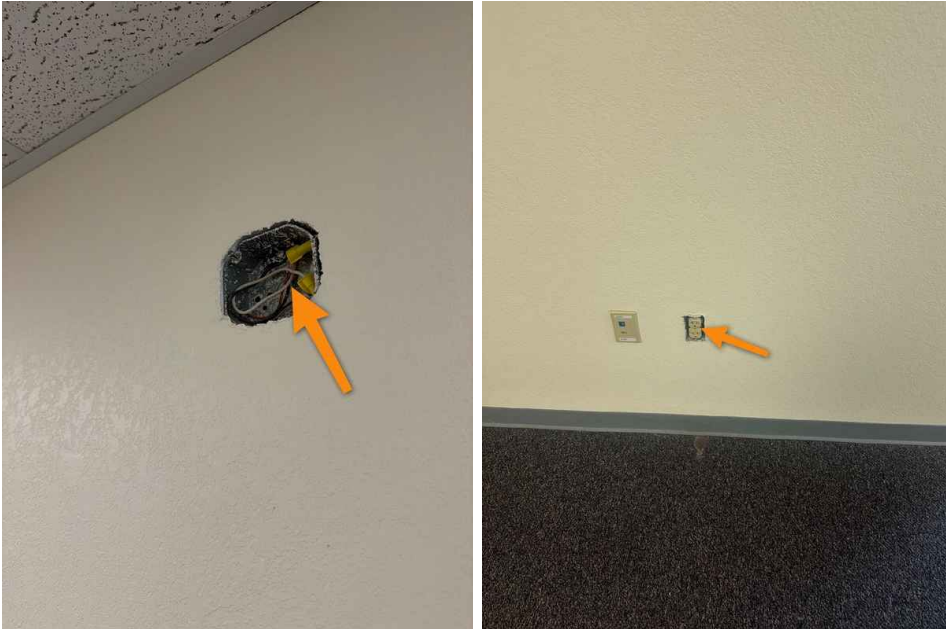
## 6.5.1 Receptacles &amp; GFCI

**COVER OR PLATES MISSING**

Contact a handyman or DIY project

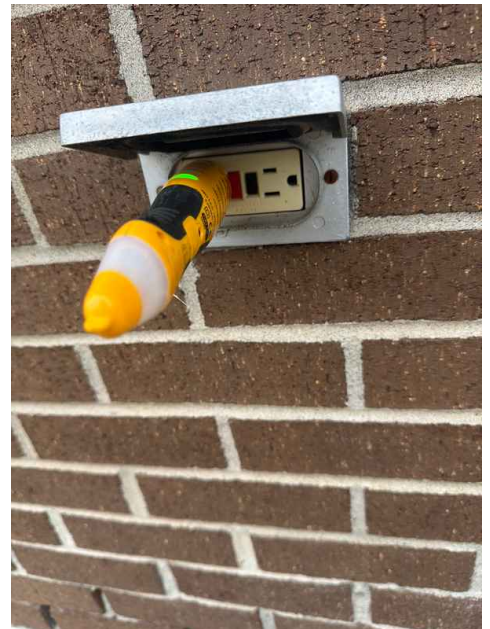
#### 6.5.2 Receptacles & GFCI

##### **GFCI FAILED TO TRIP**

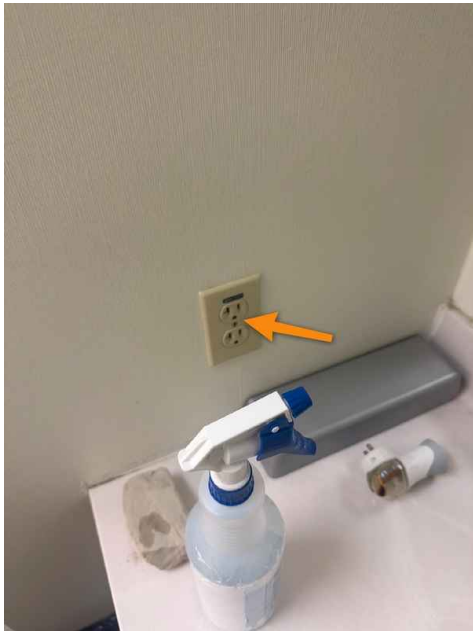
#### 6.5.3 Receptacles & GFCI

##### **GFCI RESET ACCESSIBLE**

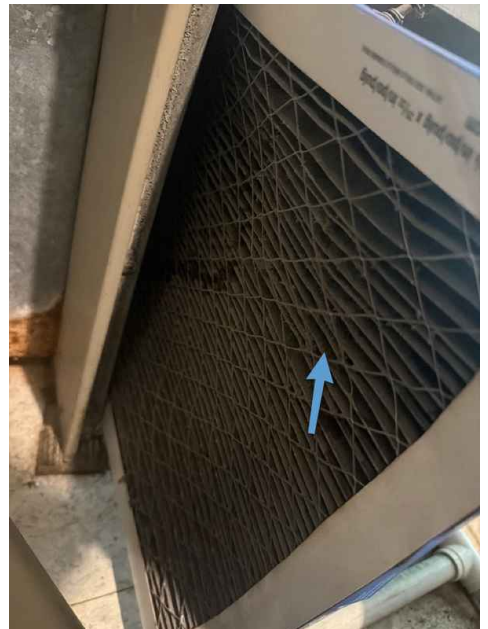
#### 8.4.2 Heating & Cooling Equipment Inside 2

##### **NEEDS SERVICING/CLEANING**

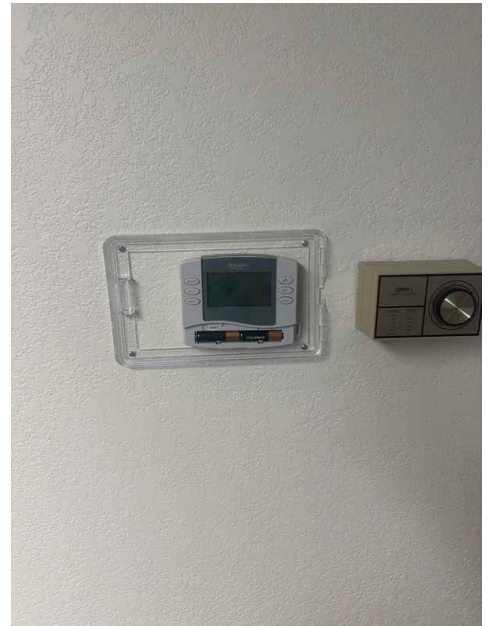
8.6.4 Heating & Cooling Equipment Inside 4

**HEATING AND COOLING INOP**

Contact a qualified heating and cooling contractor
