# Inspection Report

## Wilper Estate

**Property Address:**  
507 Hope St  
Monroe City MO 63456

## Integrity Home Inspection

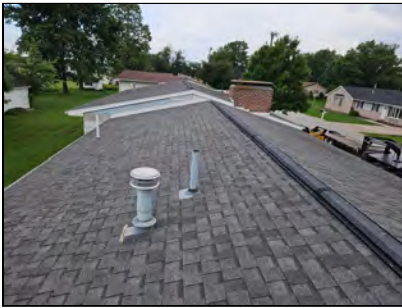
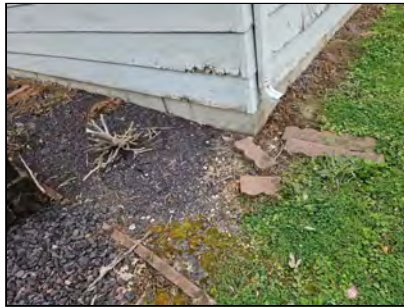
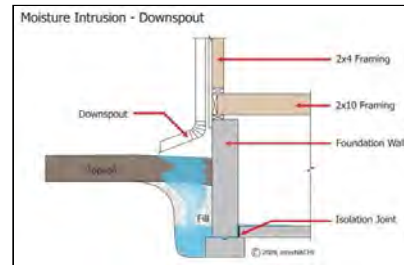
downspouts

(1) Downspouts are dumping too close to foundation. Suggest getting water away from foundation by 5'. Water settling by the foundation could cause settling of the foundation or could find its way into the basement/crawlspace or lower level of the home.

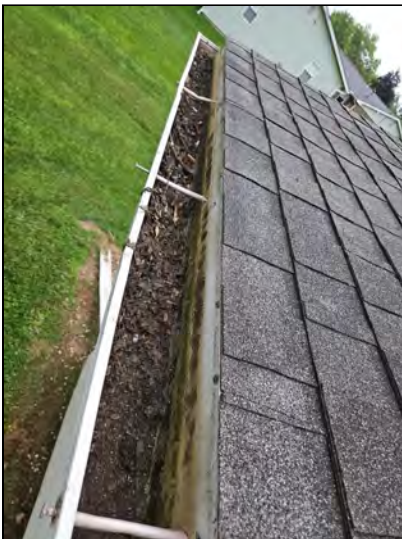
Nw corner

(2) Gutter is pulling away on the front of the home and rainwater has the ability to run behind the gutter. Additionally debris was observed in the guttering.

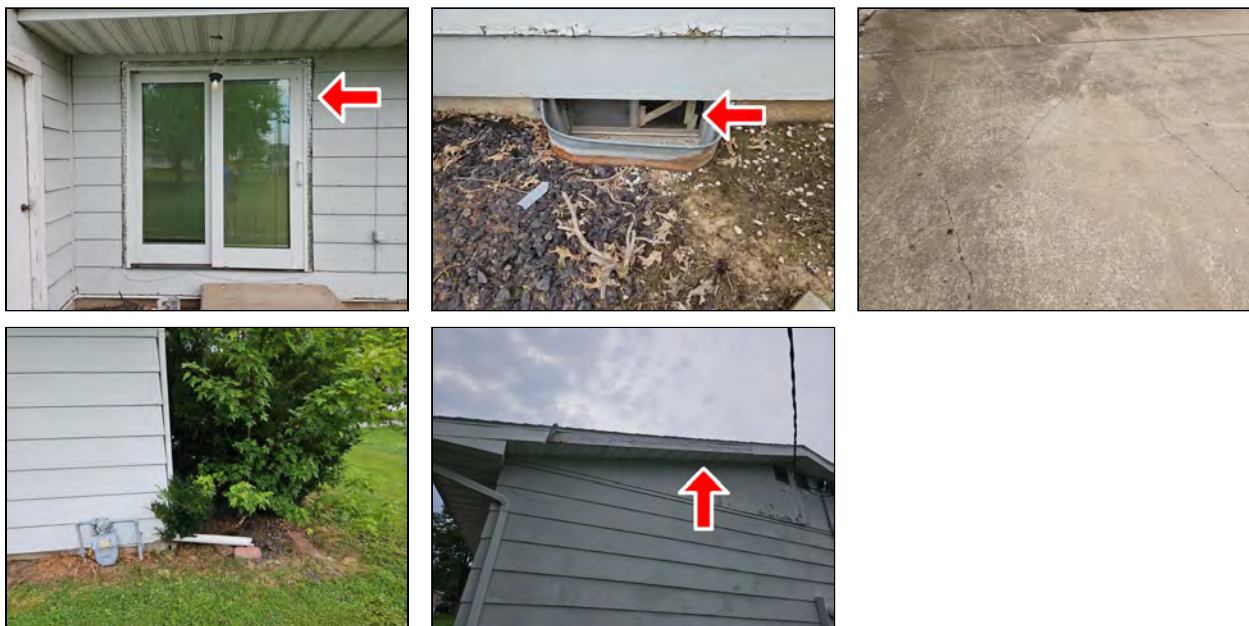
East side of the home

Deterioration of the siding was observed around the entire home.

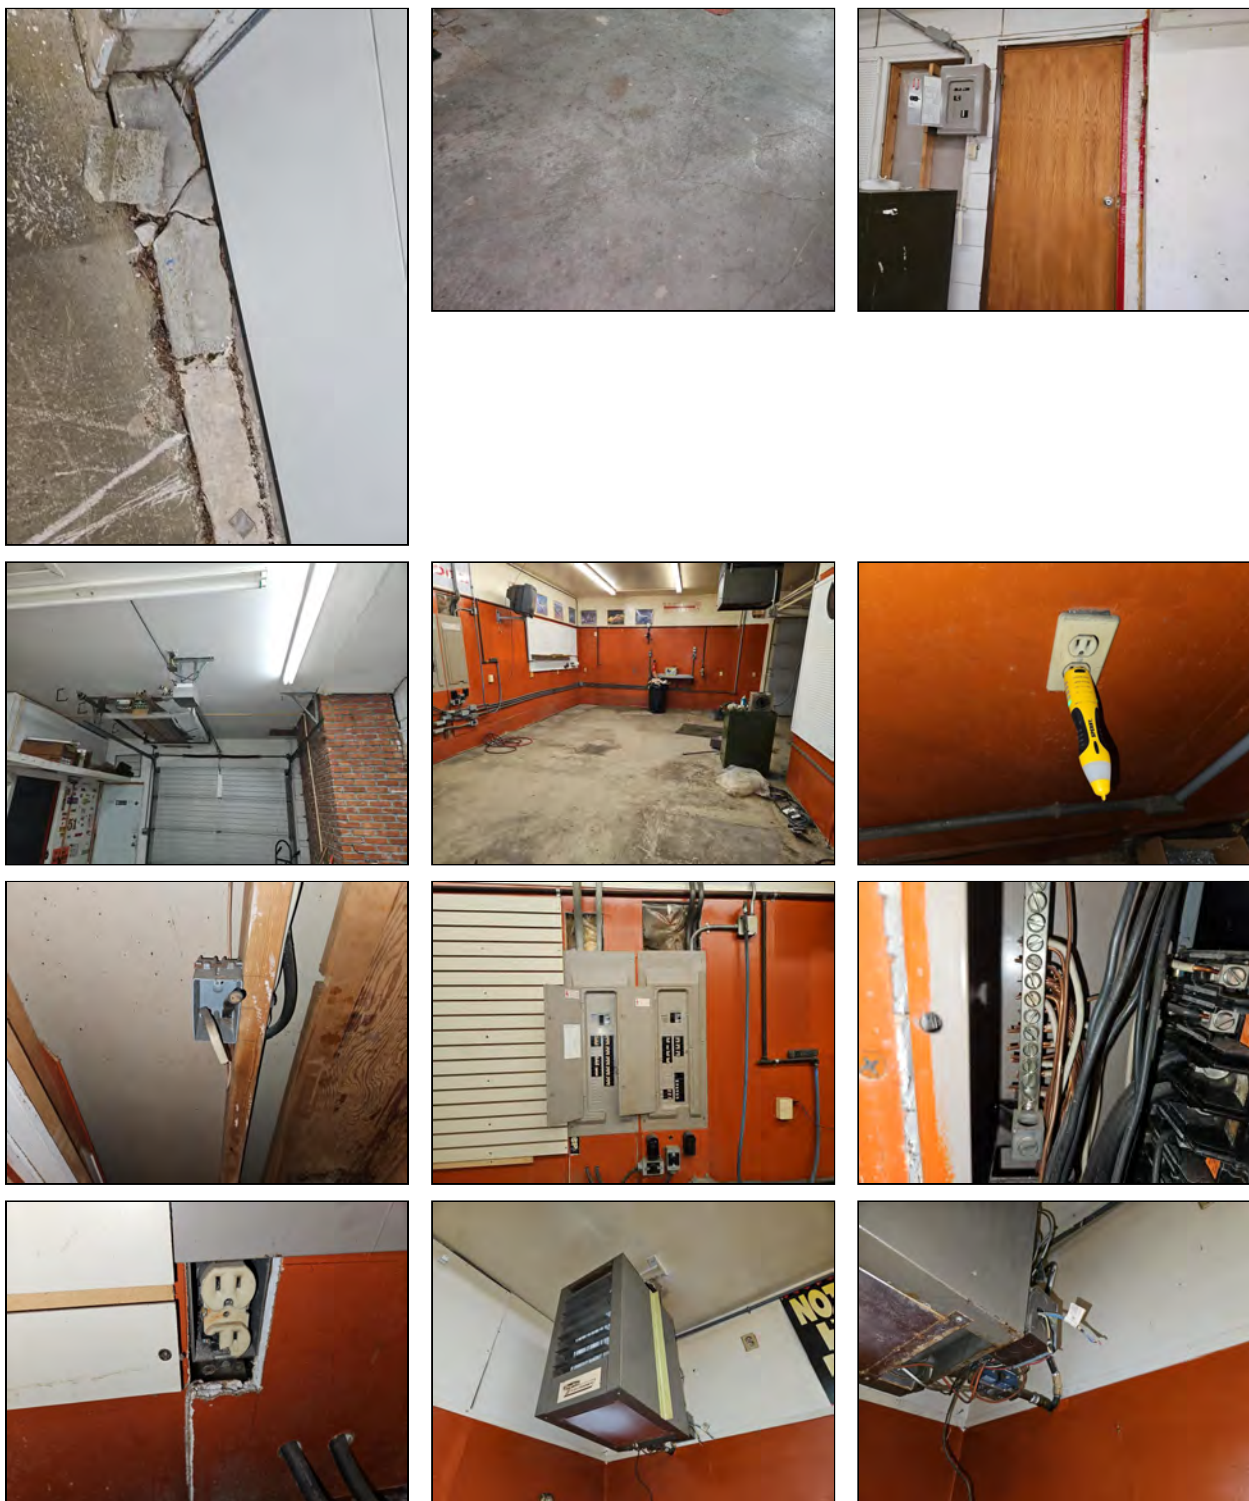
Improperly discontinued electrical circuits, damaged receptacles, and a lack of GFCI protection were observed in the garage. These conditions may present shock, fire, and safety hazards. Recommend further evaluation of the garage electrical system and correction of all identified deficiencies by a qualified licensed electrician.

The furnace was not operated. Exposed wires are sticking through the junction box. Recommend evaluation prior to usage.

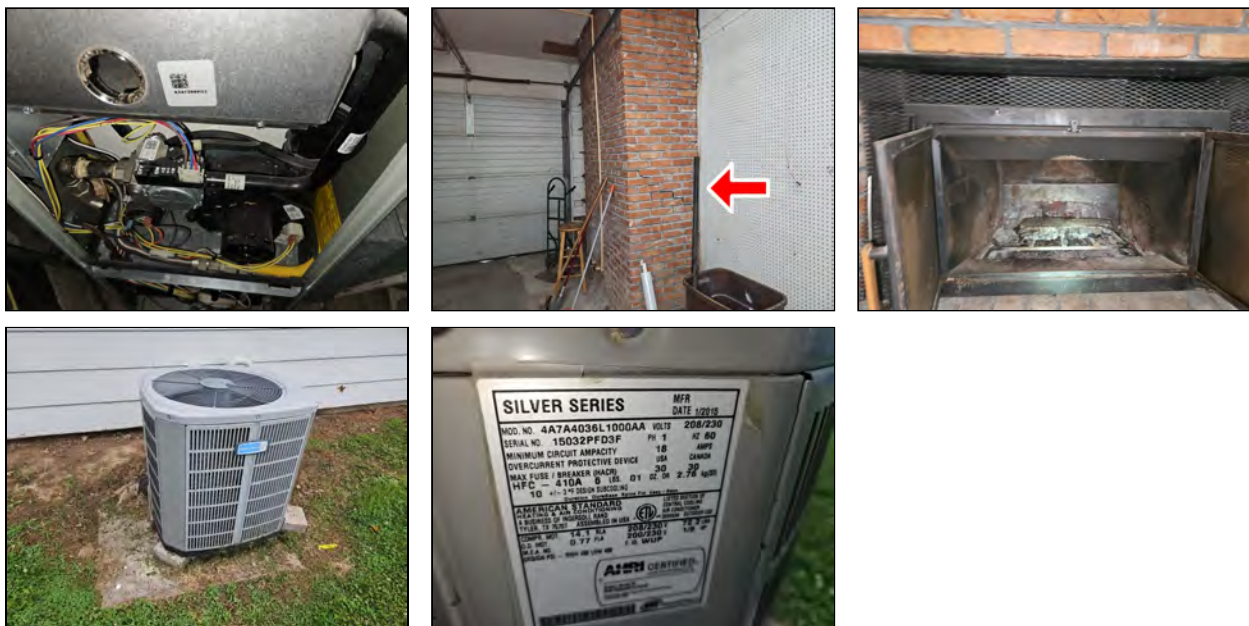
The AC did not operate when tested.

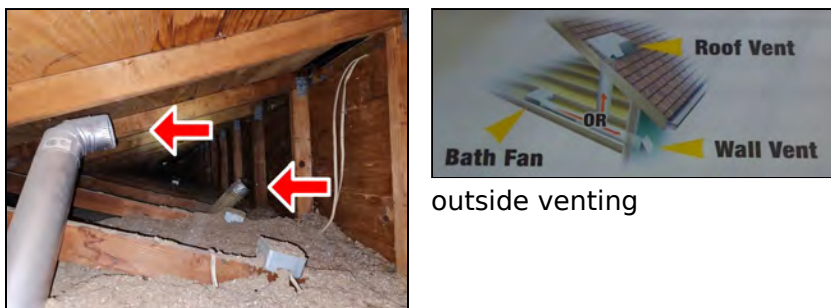
outside venting

The vent for the bathroom does not vent to the outside. Venting into the attic can cause moisture build up which can damage insulation and possibly promote mold growth.

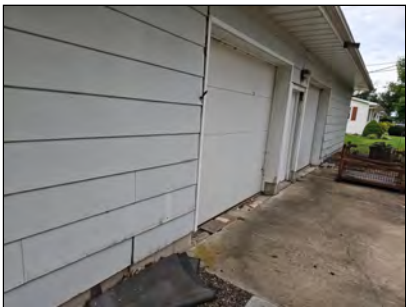
Front of garage

Deterioration of the siding was observed around the entire home.
