Inspection Report

Property Address:
26523 Route N
Monroe City MO 63456

Integrity Home Inspection

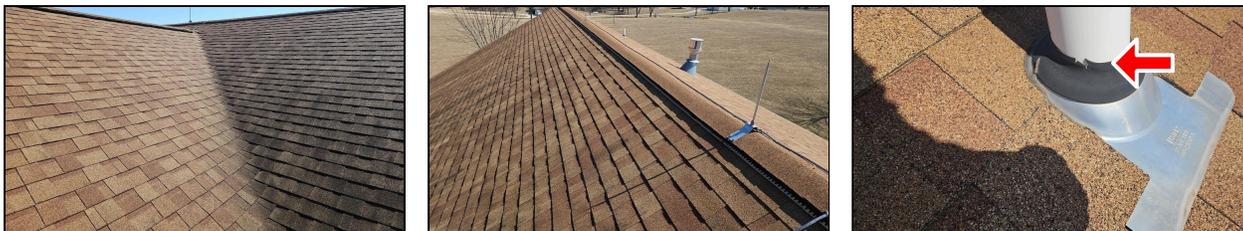
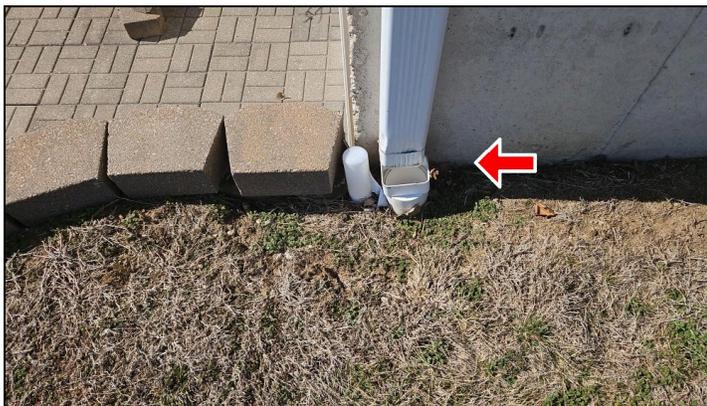
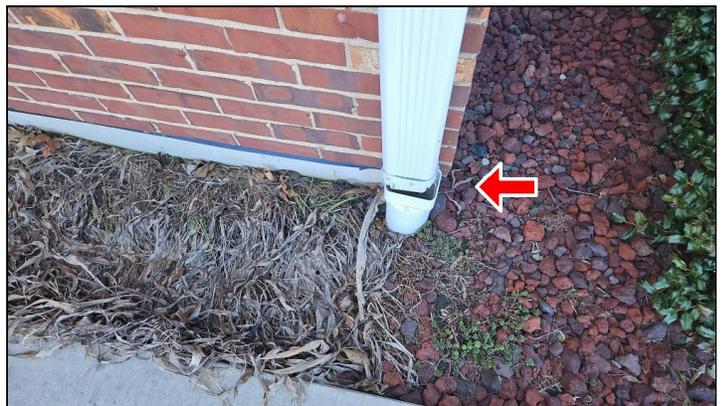
Se corner

Downspouts are disconnected from the underground drains (likely due to settling). Water could leak out of the open connection and cause water to run down along the foundation. Water settling by the foundation could cause settling of the foundation or could find its way into the basement/crawlspace or lower level of the building.

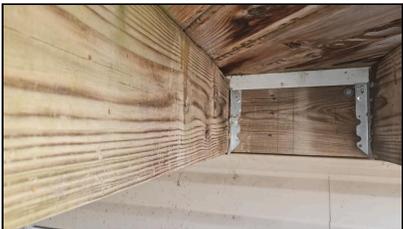
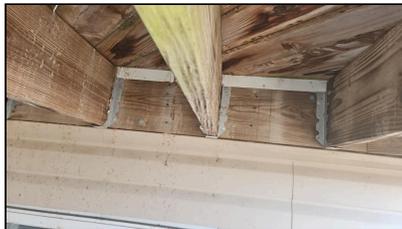
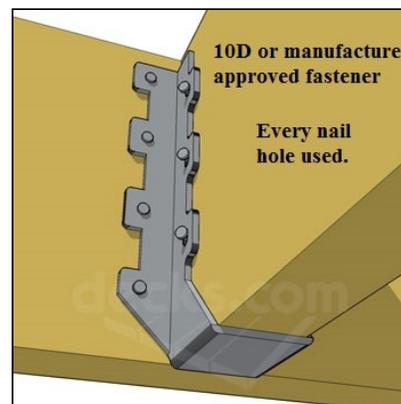
joist hangers

The deck band is not attached properly to the wall or band of the home. Improper fastener size (less than 1/2" or equivalent) and quantity (bolt spacing) could contribute to the deck separating from the home in the future.

(2) Damage was observed in a few locations on the deck.

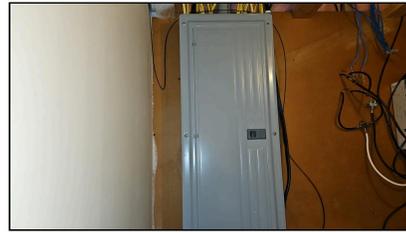
double tap ill.

VIOLATION

The number of conductors in a terminal is limited to that for which the terminal is designed and listed.
