## Property Inspection Report

LOCATED AT:  
16508 Hailey Ct  
Tyler, TX 75703

INSPECTED ON:  
Wednesday, February 11, 2026

Inspector, Dominic Cacciapaglia 22932  
B2K Inspections

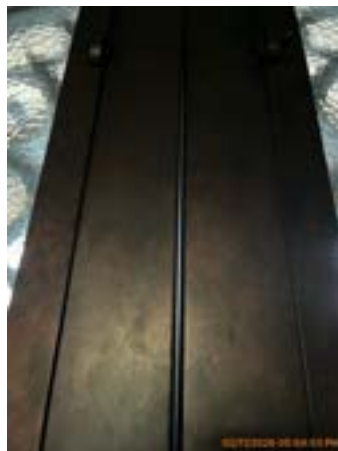
28: Front door doesn't seal tightly against weatherstripping when closed. Light seen through gap.

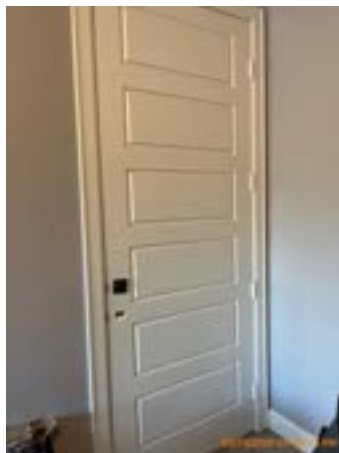
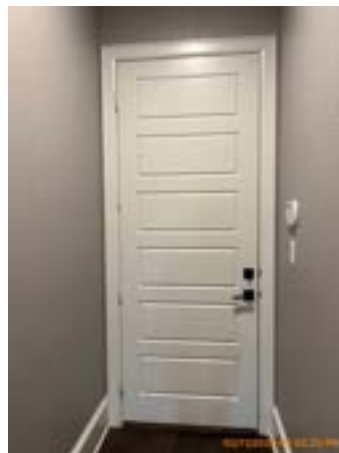
29: The both of the exterior doors between the house and the attached garage (garage man-doors) are not equipped with self-closing hinges. The purpose of these is to slow the spread of a fire from the garage to the house and to prevent gases such as car fumes and/or carbon monoxide from having a passage into the house by ensuring the door is closed while not in use.

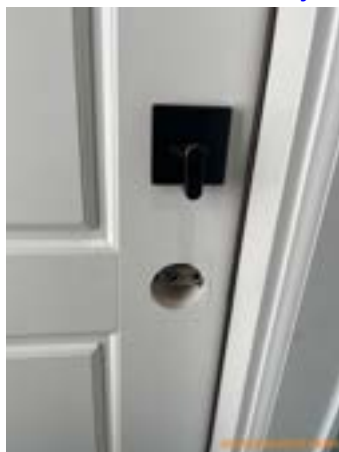
30: Door between laundry/bathroom and garage lacks a doorknob

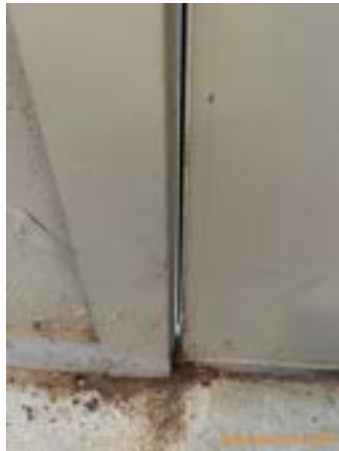
31: Multiple exterior doors have minor gaps where light can be seen through weather stripping

(Man cave, upstairs bedroom, detached garage etc).

We recommend all doors seal tightly to keep outside moisture/air out

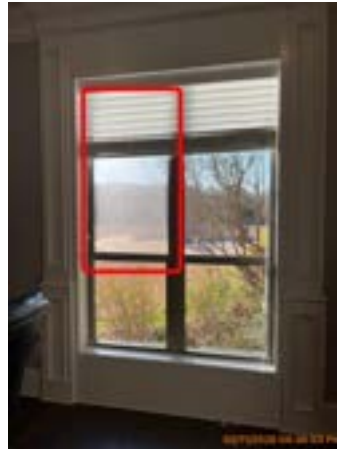
Office

35: Some windows show a speckled, iridescent effect. This is not a seal failure allowing condensation but rather the low-e (uv blocking) coating failure.

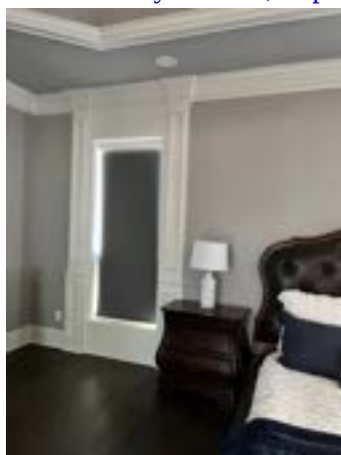
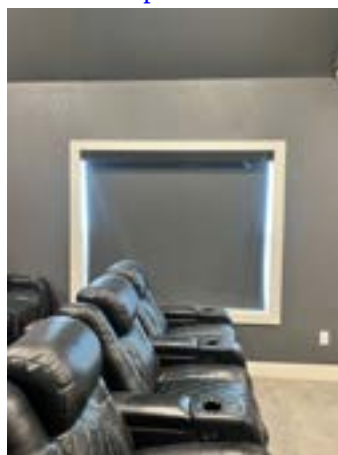
37: Unable to operate automatic blinds in theatre room and left side window of master bedroom.

Batteries may be dead, or proper remotes to operate were unable to be located

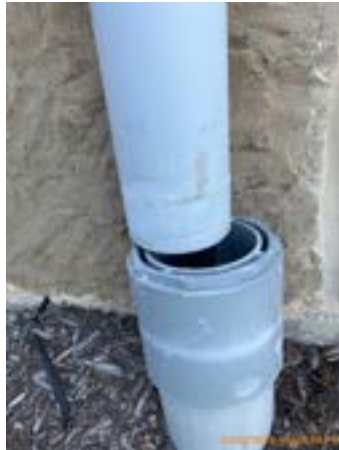
49: Conduit separated

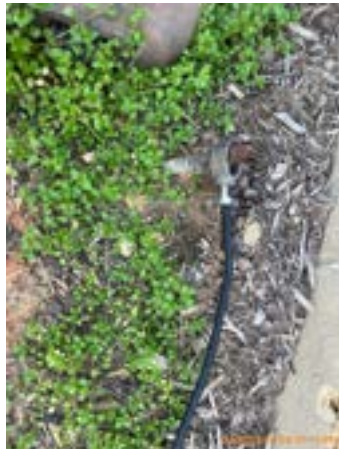
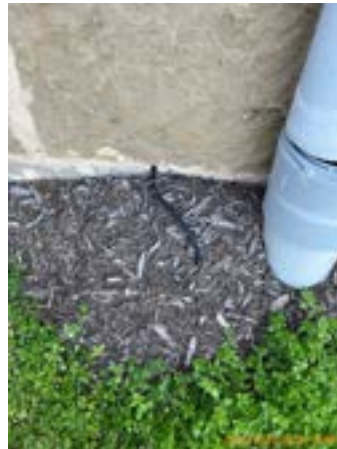
50: The earth ground is connected to a copper rod driven into the ground. A second appears to be buried nearby

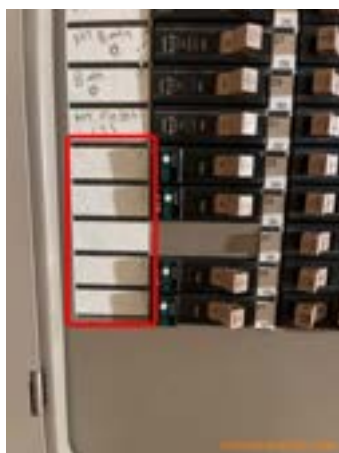
54: GENERAL: The service panel is not fully labeled.

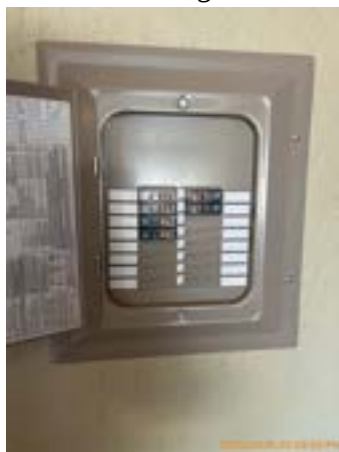
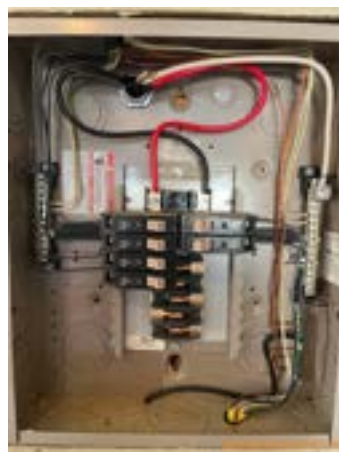
74: There is a subpanel present in the detached garage. All comments made below will be on this panel.

76: GENERAL: The sub panel is in good condition with circuitry installed and fused correctly.

77: GENERAL: There is room for additional breakers.

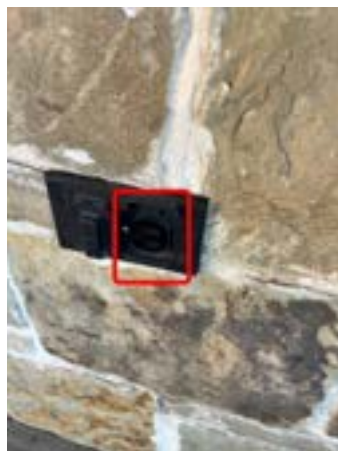
92: GFCI receptacles near pool lack outdoor covers

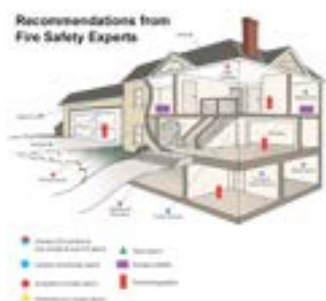
94: Smoke detectors not present in all areas required. (Mounts present, but detectors missing in two upstairs bedrooms)

One is required in each bedroom. One in each hallway adjacent to each sleeping area and at least one on each floor if more than one story. Alarm system connected detectors and heat detectors do not count toward the minimum.

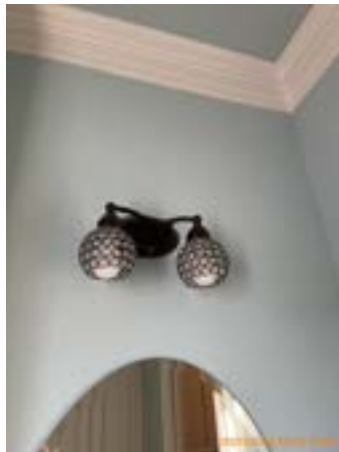
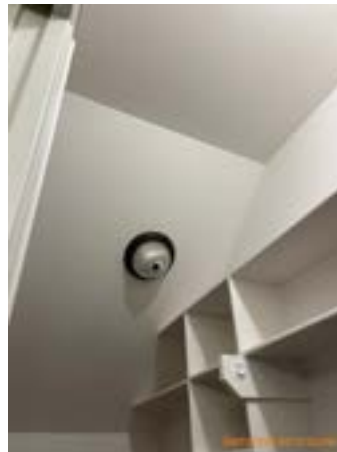
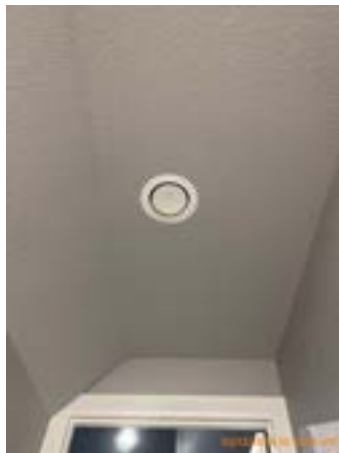
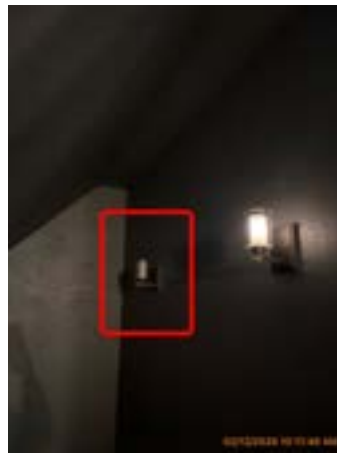
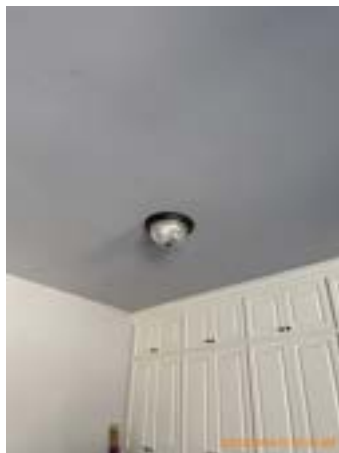
**98:** Some lights where inoperative at time of inspection.

Locations: bathroom between laundry room and garage, downstairs back right bedroom closet, stairway near theater, theater room, main garage

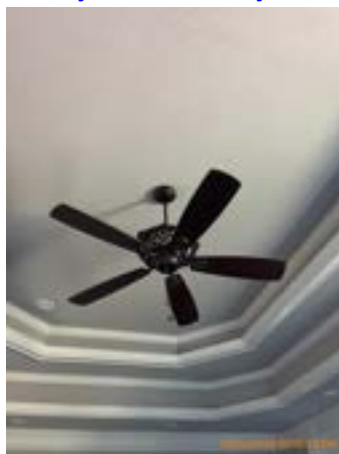
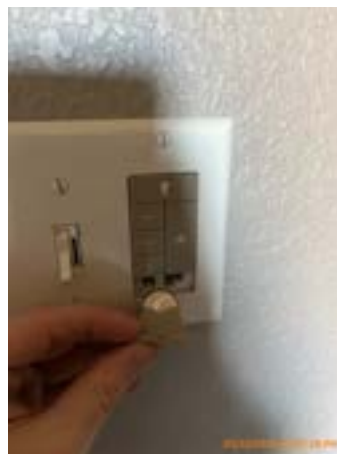
99: Ceiling fan/light in master bedroom were inoperative.  
Battery in control may be dead.

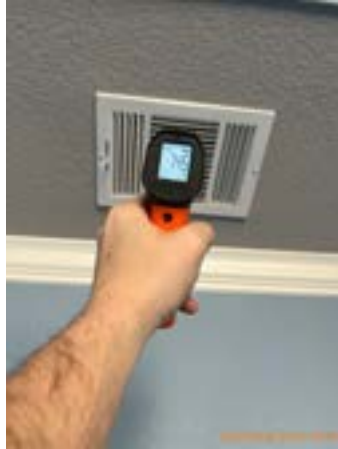
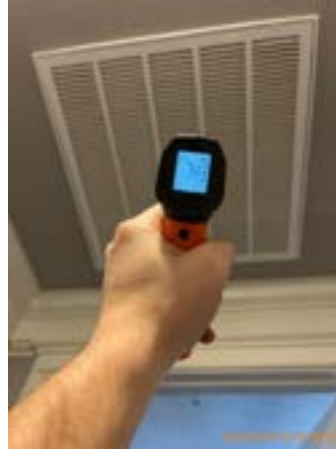
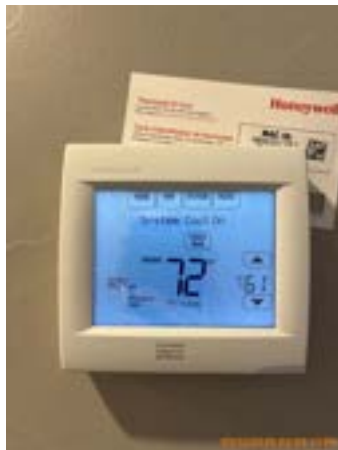
196: Failed to respond to user controls. Blower operated, but condensing unit did not turn on when thermostat was set to cool.

Recommend evaluation by specialist and repair as necessary.

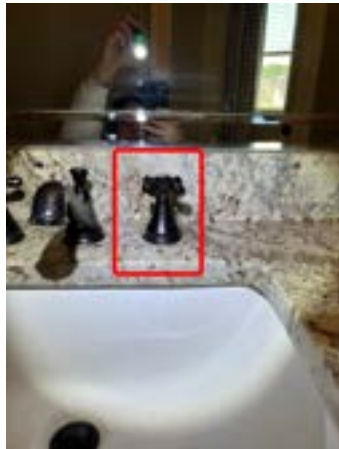
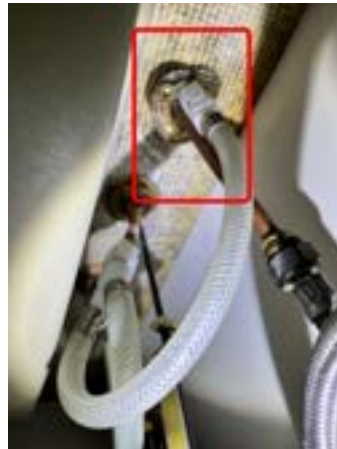
236: Cold water valve handle is loose where it should be secured to the countertop. (Upstairs right side bedroom en-suite bathroom)

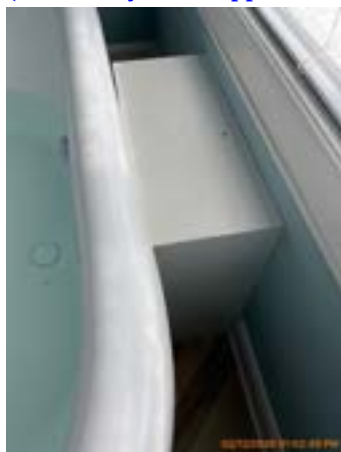
275: The hydrotherapy tub was not functional at the time of inspection. Recommend the tub be further evaluated and repaired, if necessary.

(There may be a tripped GFCI receptacle in finished space behind tub)

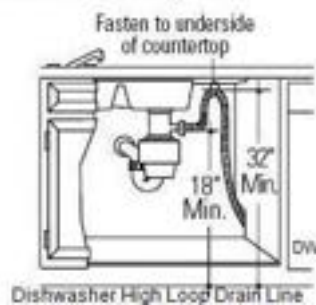
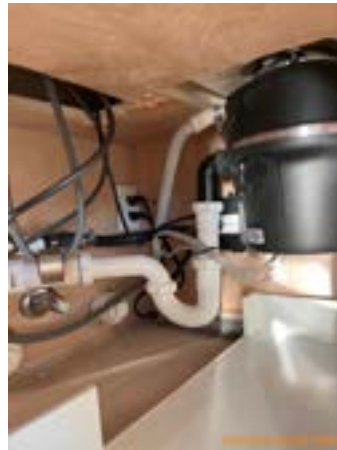
281: Dishwasher lacks air gap or backflow loop or the loop is not elevated high enough. This is considered a deficiency.

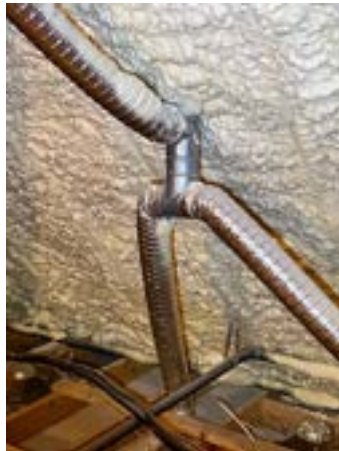
**291:** Three bathroom vent fan ducts share the same penetration through the roof.

Some jurisdictions forbid this sort of installation due to the possibility of backdrafting, unless each has a back-draft damper. Unable to determine if present

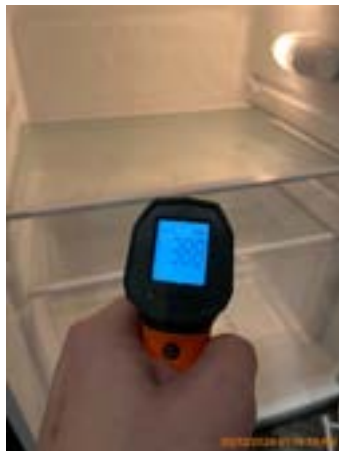
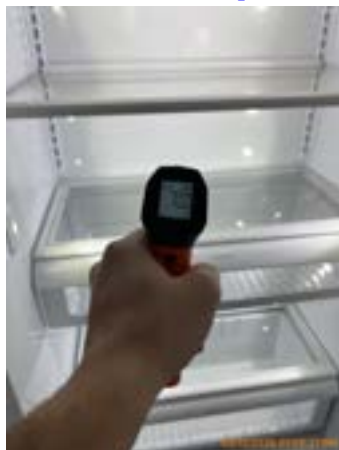
301: Refrigerator side of kitchen refrigerator was not cooling properly at the time of inspection.

Set to 33 F, but temp at 71 F

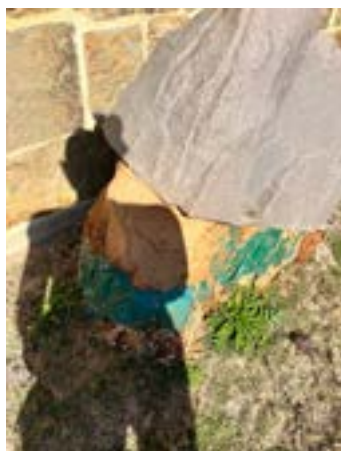
305: Cover for backflow preventer was completely filled with dirt (maybe from ants).  
Dirt should be cleared so valves are made accessible

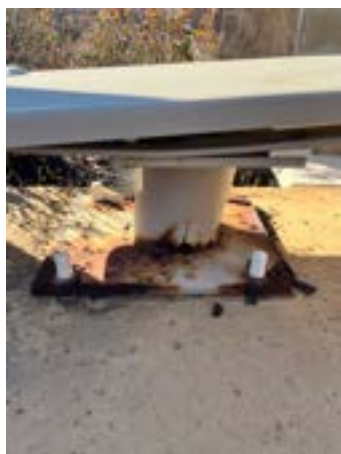
311: Diving board is rusted at the base.

Note that water slides and diving boards have a history of safety issues.

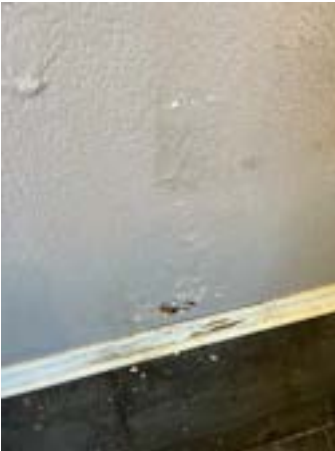
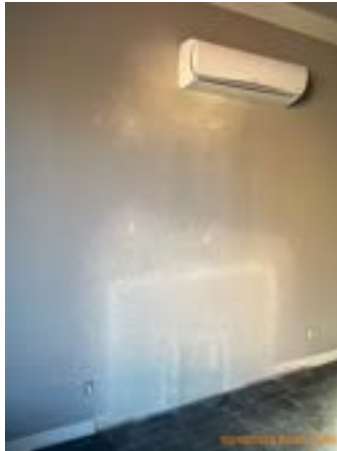
**s-21:** Wall in man cave showed signs of previous moisture damage on first day of inspection (subsequent to previous leakage of the mini split on this wall).

The wall was repaired during the second day of inspection (not subcontractors of B2K). Repair work appears to be satisfactory.

No evidence of active leak at time of inspection.

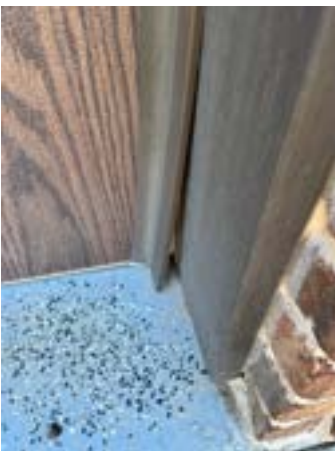
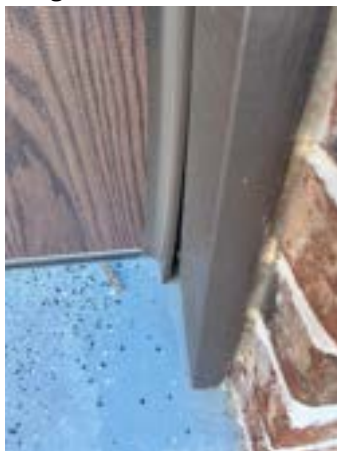
**s-23:** Lower ends of some weather strips coming loose near the overhead garage doors

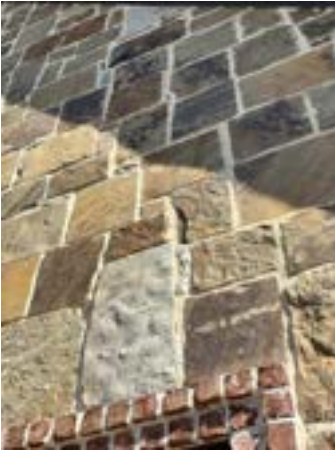
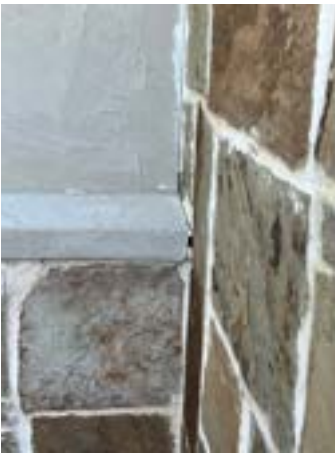
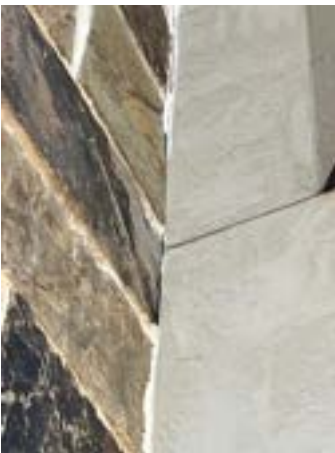
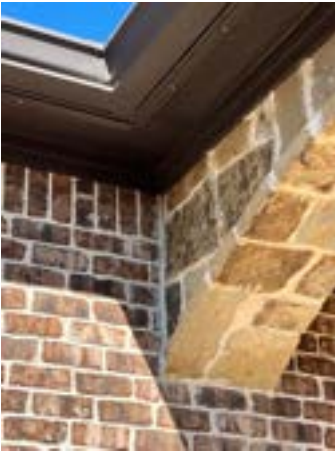
s-24: Minor cracks noted in areas. Grout could use repointing in these areas

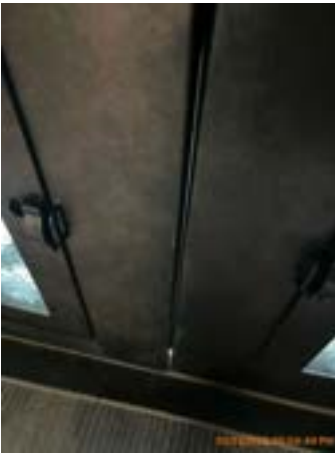
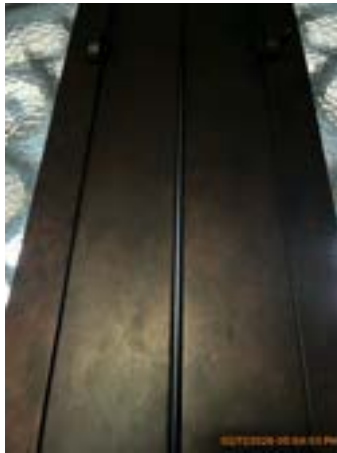
s-28: Front door doesn't seal tightly against weatherstripping when closed. Light seen through gap.

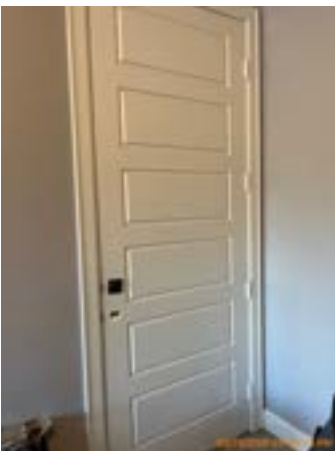
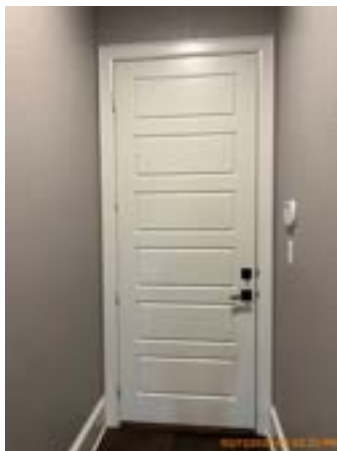
s-29: The both of the exterior doors between the house and the attached garage (garage man-doors) are not equipped with self-closing hinges. The purpose of these is to slow the spread of a fire from the garage to the house and to prevent gases such as car fumes and/or carbon monoxide from having a passage into the house by ensuring the door is closed while not in use.

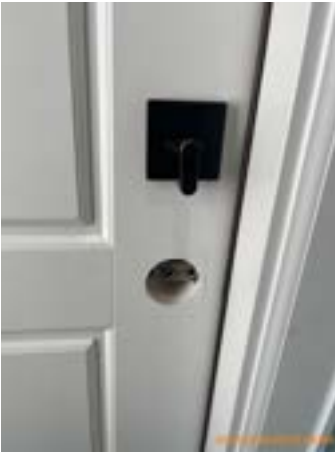
**s-30:** Door between laundry/bathroom and garage lacks a doorknob

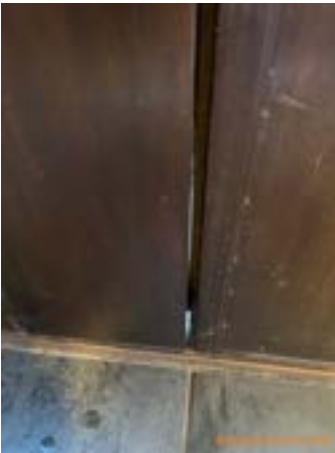
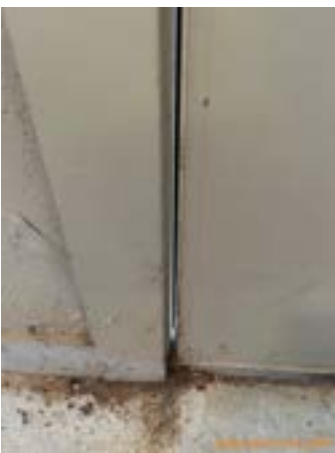
**s-31:** Multiple exterior doors have minor gaps where light can be seen through weather stripping (Man cave, upstairs bedroom, detached garage etc).  
We recommend all doors seal tightly to keep outside moisture/air out

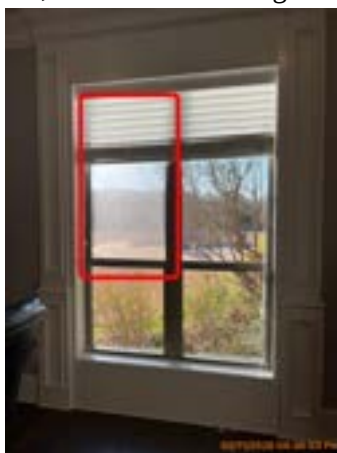
Master bedroom

s-35: Some windows show a speckled, iridescent effect. This is not a seal failure allowing condensation but rather the low-e (uv blocking) coating failure.

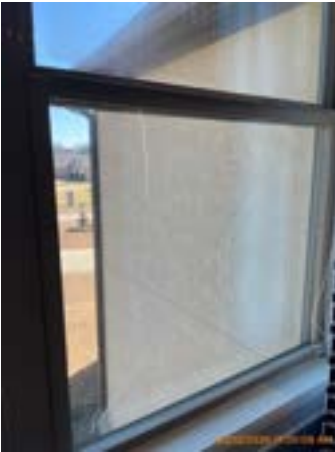
**s-36:** Window in upstairs right side bedroom has broken glazing

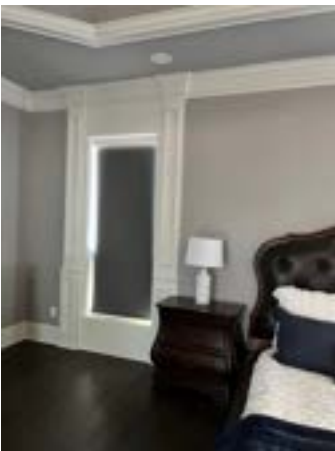
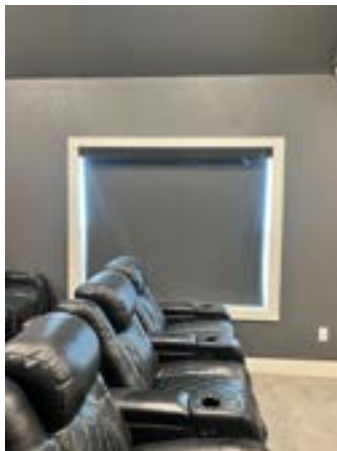
**s-37:** Unable to operate automatic blinds in theatre room and left side window of master bedroom. Batteries may be dead, or proper remotes to operate were unable to be located

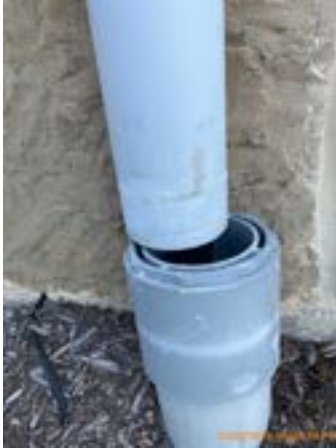
s-49: Conduit separated

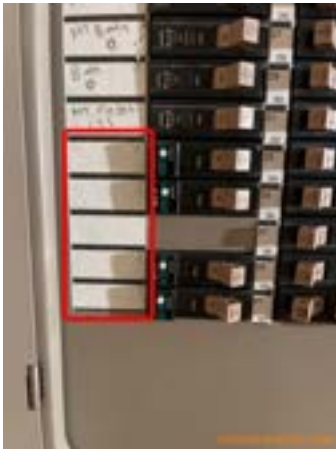
s-54: GENERAL: The service panel is not fully labeled.

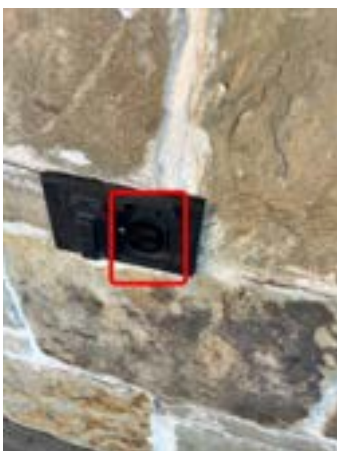
**s-89:** Receptacles in detached garage lack GFCI protection or failed to trip when tested.

failed to trip when tested. One lacks a cover.

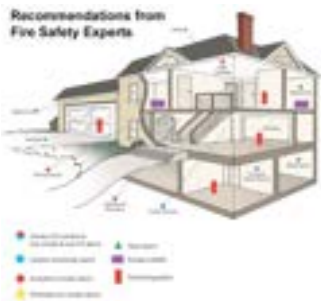
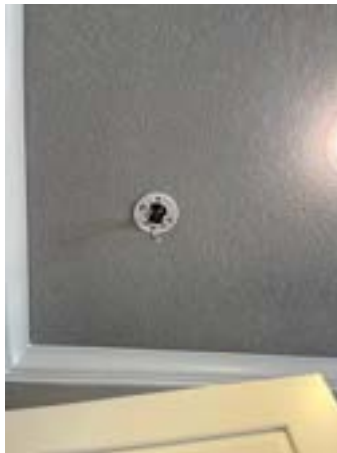
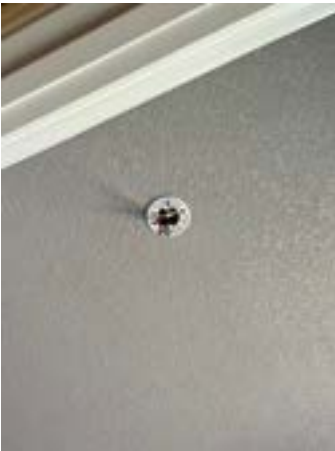
s-94: Smoke detectors not present in all areas required. (Mounts present, but detectors missing in two upstairs bedrooms)

One is required in each bedroom. One in each hallway adjacent to each sleeping area and at least one on each floor if more than one story. Alarm system connected detectors and heat detectors do not count toward the minimum.

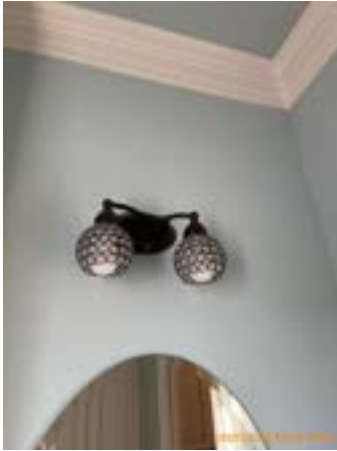
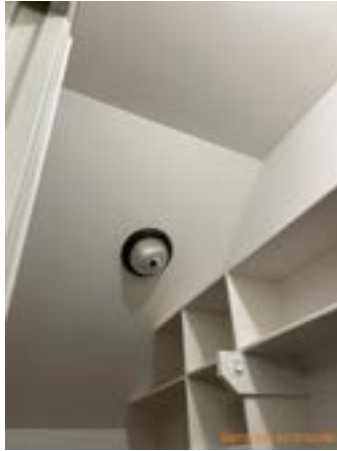
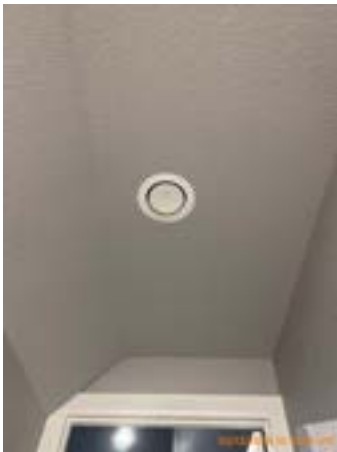
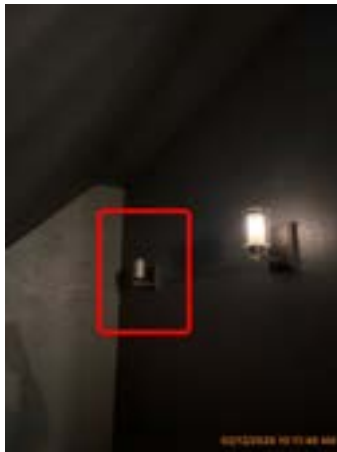
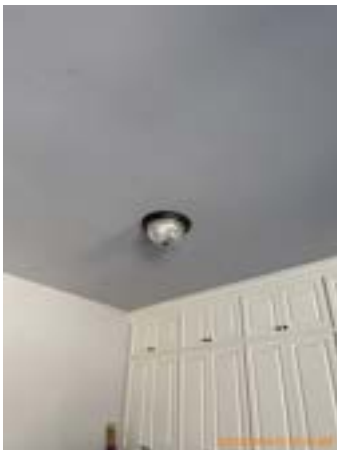
s-98: Some lights where inoperative at time of inspection.

Locations: bathroom between laundry room and garage, downstairs back right bedroom closet, stairway near theater, theater room, main garage

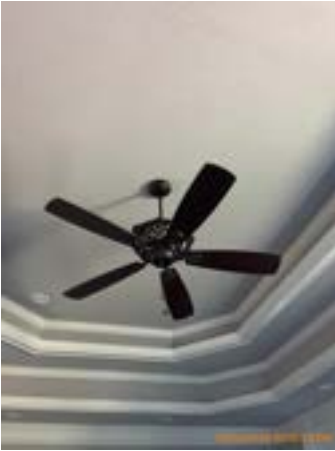
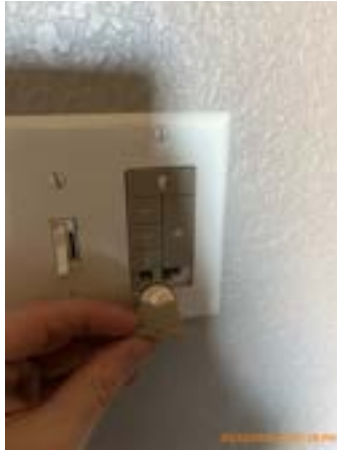
**s-99:** Ceiling fan/light in master bedroom were inoperative.  
Battery in control may be dead.

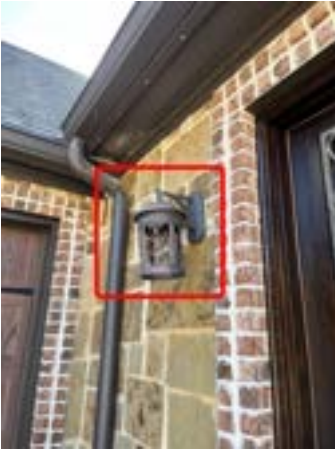
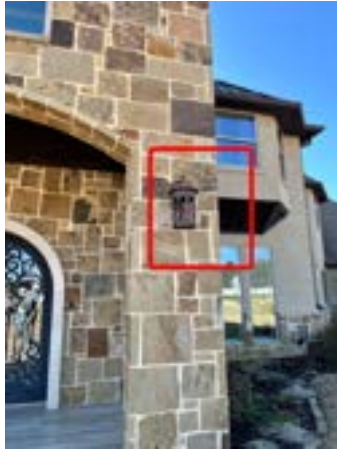
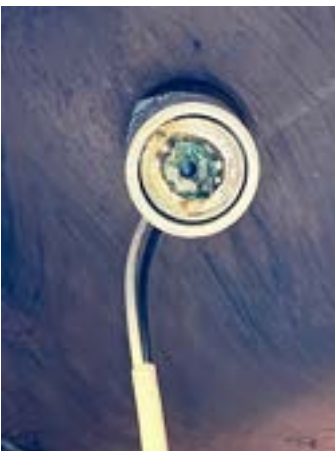
**s-100:** Some exterior lights were inoperative. Likely need new bulbs.  
Fixture at front porch appears it has the base of a broken bulb stuck in the socket

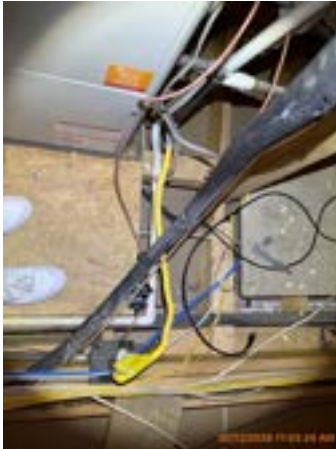
**s-142:** The fuel piping does not include a 'T' extension to collect condensation and debris, as is considered good practice. In the course of future upgrading or repair, a 'drip leg' should be added to the gas piping just ahead of the connector.

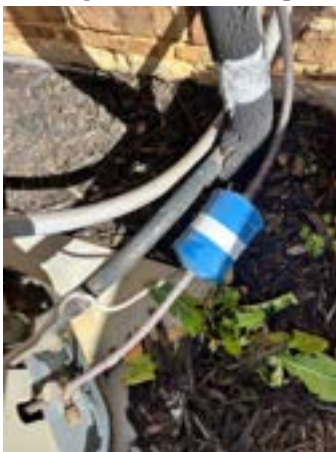
**s-176:** Insulation is deteriorated and missing from portions of the refrigerant lines in areas. We recommend that all missing insulation be replaced to increase energy efficiency.

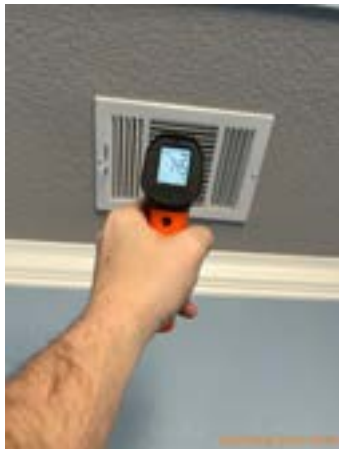
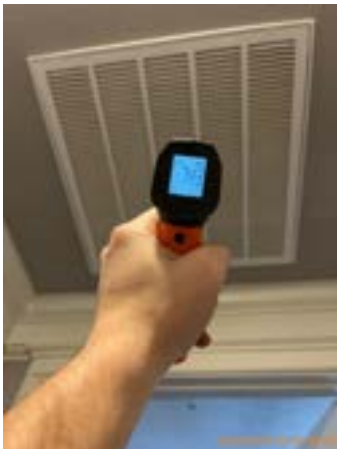
s-196: Failed to respond to user controls. Blower operated, but condensing unit did not turn on when thermostat was set to cool.

Recommend evaluation by specialist and repair as necessary.

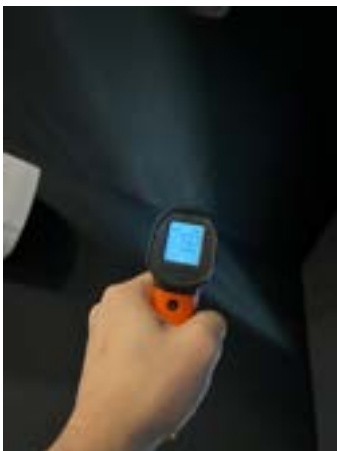
s-204: When set to cool, air blew from mini split but was not cooling  
Recommend evaluation by specialist

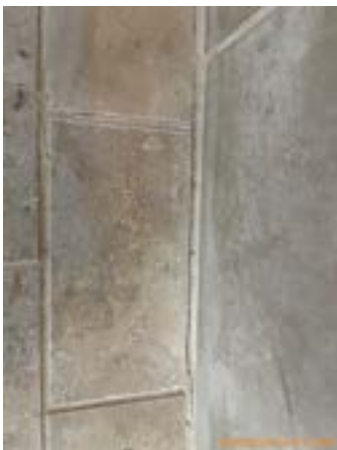
s-234: Minor cracks in grout and some cracked tiles noted in master shower

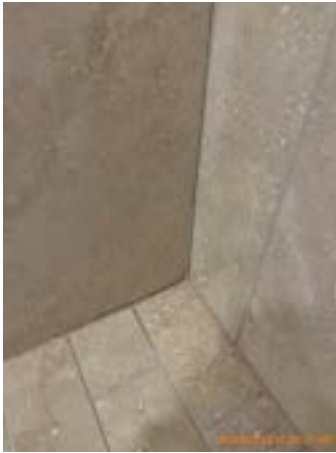
s-235: Minor cracks in grout of upstairs middle bedroom shower

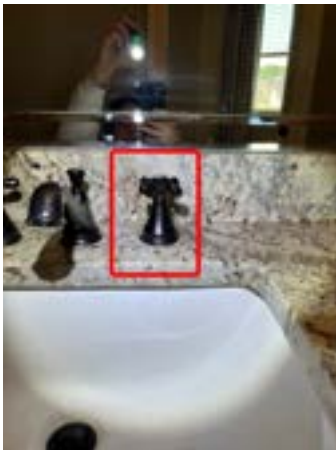
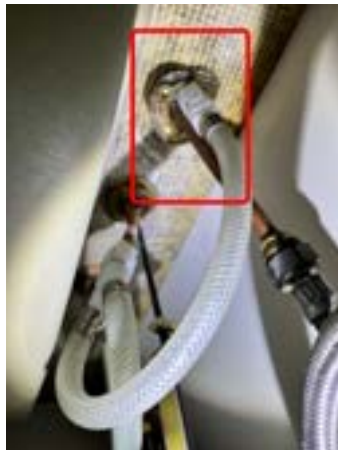
s-236: Cold water valve handle is loose where it should be secured to the countertop. (Upstairs right side bedroom en-suite bathroom)

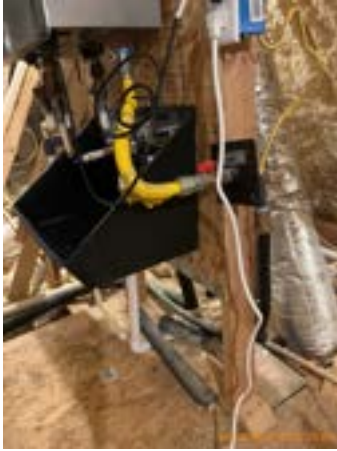
s-247: GAS SHUT-OFF VALVE: The gas piping does not include a sediment trap/drip leg installed downstream of the shutoff valve to collect condensation and debris. In the course of future upgrading or repair, a 'drip leg' should be added to the gas piping just ahead of the connector.

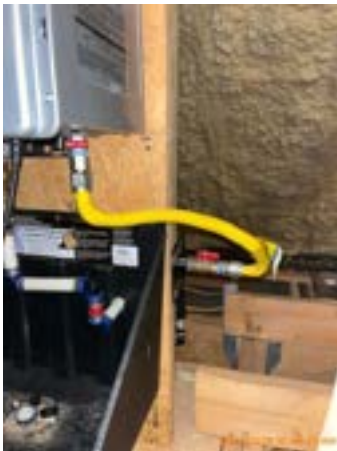
s-264: GAS SHUT-OFF VALVE: The gas piping does not include a sediment trap/drip leg installed downstream of the shutoff valve to collect condensation and debris. In the course of future upgrading or repair, a 'drip leg' should be added to the gas piping just ahead of the connector.

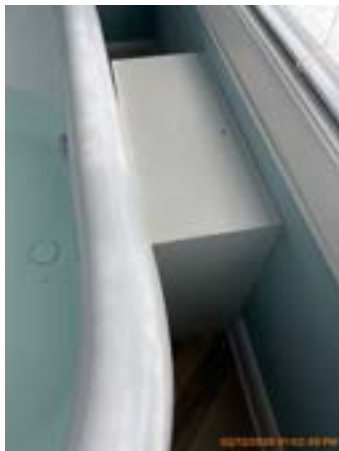
s-275: The hydrotherapy tub was not functional at the time of inspection. Recommend the tub be further evaluated and repaired, if necessary.

(There may be a tripped GFCI receptacle in finished space behind tub)

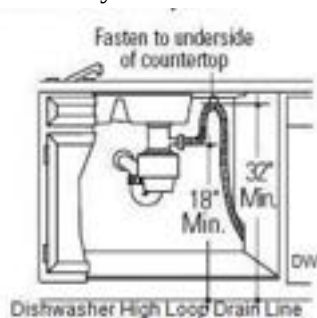
s-281: Dishwasher lacks air gap or backflow loop or the loop is not elevated high enough. This is considered a deficiency.

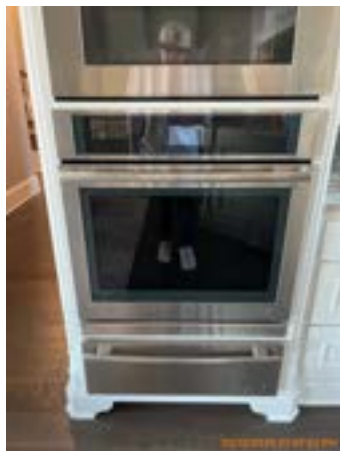
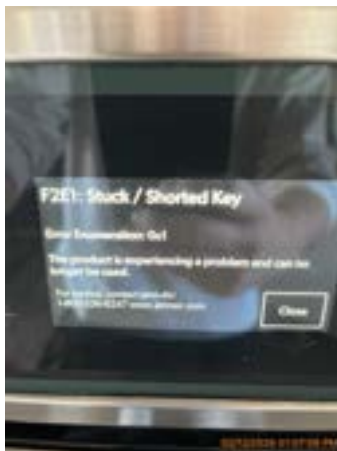
s-287: Left side oven was inoperative and had error code

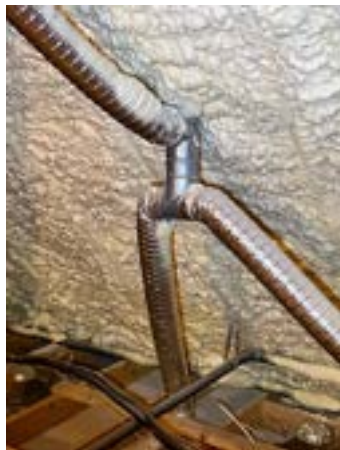
s-291: Three bathroom vent fan ducts share the same penetration through the roof.

Some jurisdictions forbid this sort of installation due to the possibility of backdrafting, unless each has a back-draft damper. Unable to determine if present

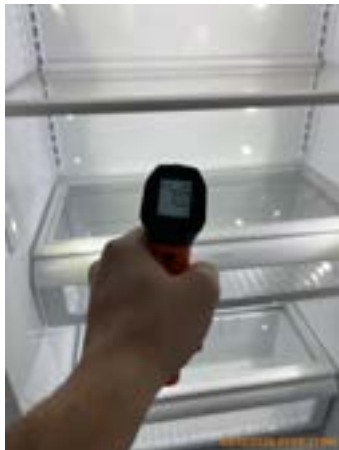
**s-301:** Refrigerator side of kitchen refrigerator was not cooling properly at the time of inspection.  
Set to 33 F, but temp at 71 F

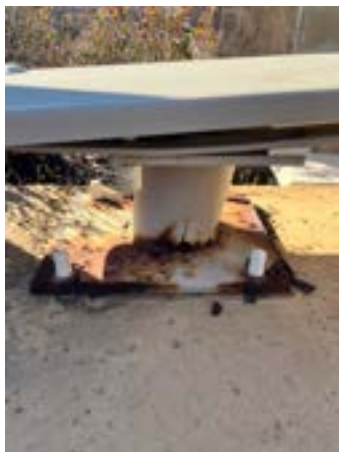
s-311: Diving board is rusted at the base.

Note that water slides and diving boards have a history of safety issues.
