**Service:** Full Home Inspection

**Prepared for:** Joan Dandridge

Site Address: 6053 Collins Road, Ellis Grove, IL, 62241

Service Date And Time: July 21, 2026 At 09:00 AM

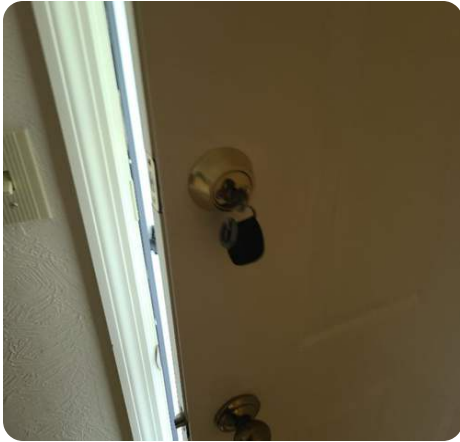
The double-keyed deadbolts, which require a key to unlock from both sides, can pose a fire safety hazard by restricting quick egress during an emergency. It is recommended to replace them with single-keyed deadbolts or other safe locking mechanisms. A qualified locksmith can evaluate and perform the necessary replacement.

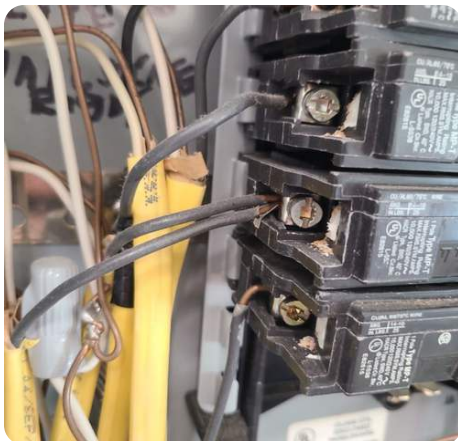
The double tapped breaker issue involves two wires being connected to a breaker designed for a single wire. This can lead to overheating, creating a fire hazard. It is recommended to have a qualified electrician evaluate and repair this issue by installing a separate breaker for each wire to ensure safety and proper function of the electrical panel.

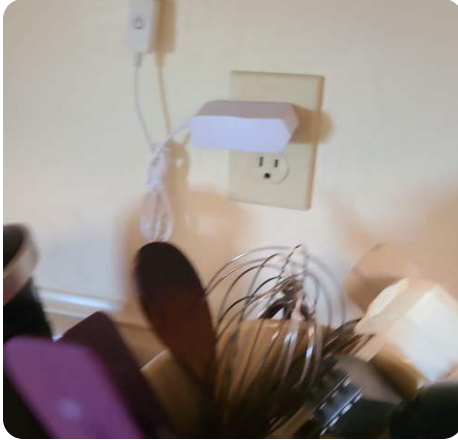
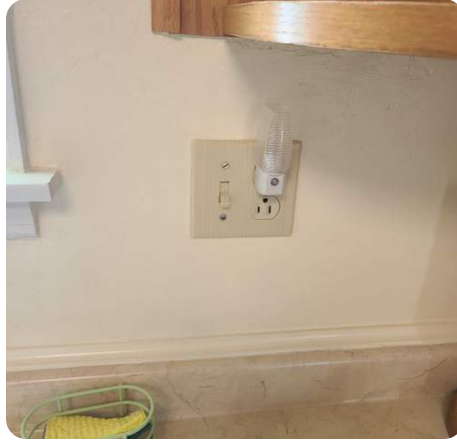
**10 Missing GFCI Protection (Kitchen Counter)**

Kitchen countertops require Ground-Fault Circuit Interrupter (GFCI) protection for electrical receptacles. GFCI protection was not found for some counter-level receptacles, indicating a potential electrical shock hazard. We recommend that a qualified electrician evaluate the circuits and install proper GFCI protection to improve safety.

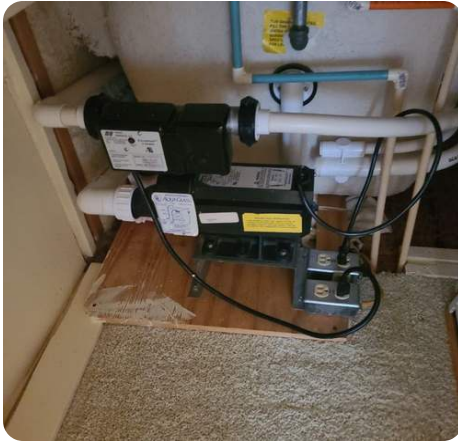
**11 Missing GFCI For Jetted Tub**

A jetted tub is missing Ground Fault Circuit Interrupter (GFCI) protection. It is recommended to have a qualified electrician install a GFCI outlet near the tub for improved safety. GFCIs help protect against electric shocks in areas where water is present. Evaluate and repair by installing a GFCI outlet to ensure proper electrical safety measures are in place.

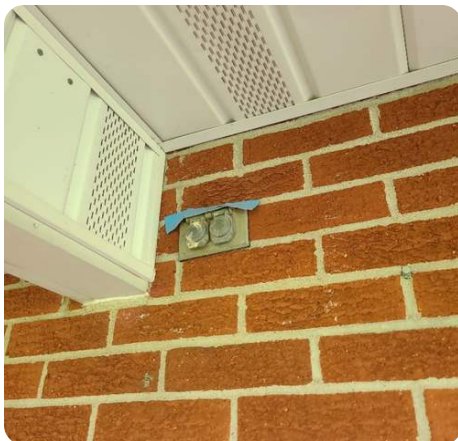
**12 Missing GFCI Protection (Exterior)**

The GFCI (Ground Fault Circuit Interrupter) protection is absent for the exterior electrical outlets. GFCI outlets are essential for safeguarding against electric shock risks, particularly in wet or damp locations like the exterior. It is advised to install GFCI outlets for safety and to meet electrical codes. Contact a qualified electrician to assess and set up the required GFCI protection.

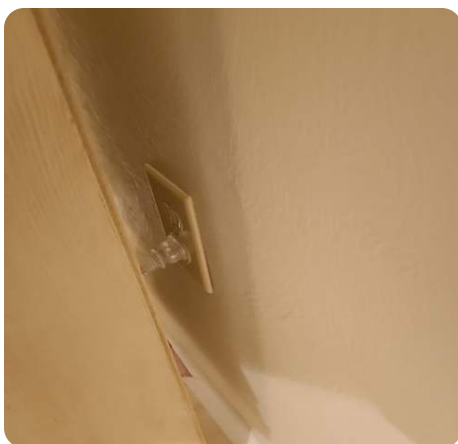
**13 Missing GFCI Protection (Bathroom)**

All receptacles in the bathroom lack GFCI (Ground-Fault Circuit Interrupter) protection, which is a safety concern in locations with exposure to water. GFCI protection is a standard safety feature that helps prevent electrocution. Recommend a qualified electrician evaluate and upgrade the bathroom receptacles to meet current safety standards.

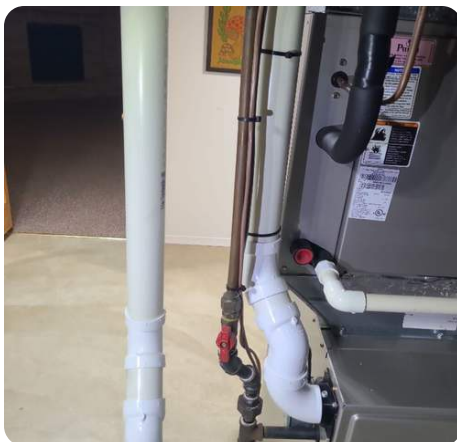
The copper propane gas line is not recommended for gas supply as it may not be approved for gas distribution. It is recommended to have a licensed plumber evaluate and replace the copper gas line with an appropriate material for gas supply, such as black steel or CSST piping.

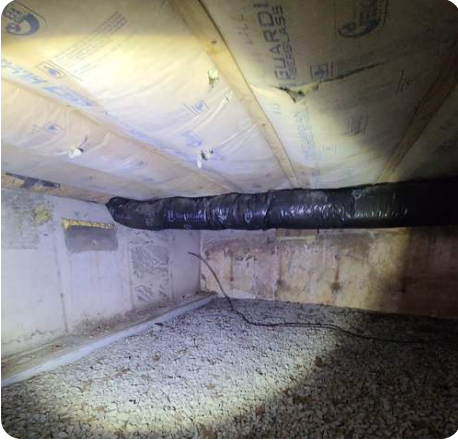
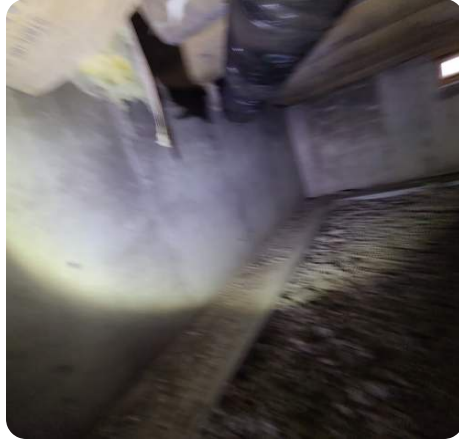
The batts in the crawl space are installed backwards. This can reduce their effectiveness in providing insulation. We recommend evaluating and reinstalling the batts with the vapor barrier facing the appropriate direction to ensure maximum insulation efficiency. A qualified insulation contractor should be consulted for this repair.

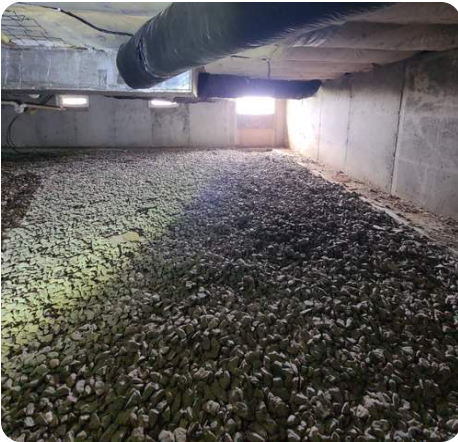
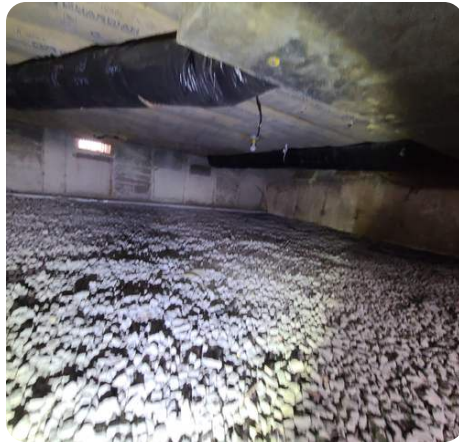
**22 No Vapor Barrier**

The structure crawl space lacks a vapor barrier. It is suggested to install a vapor barrier or Moist-Stop if any dampness occurs in the crawl area. A vapor barrier covering the soil can help reduce moisture in this area and the structure. This item is commonly available at most home improvement or hardware stores.

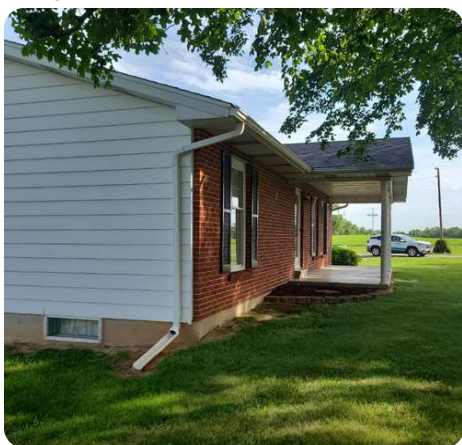
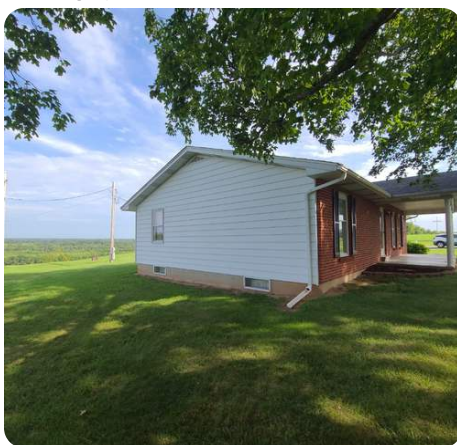
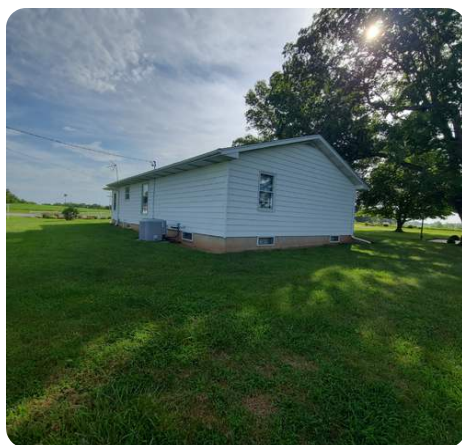
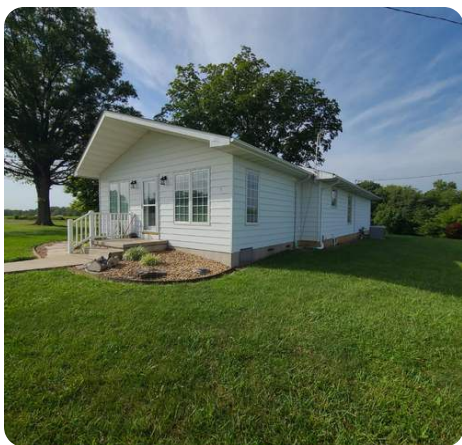
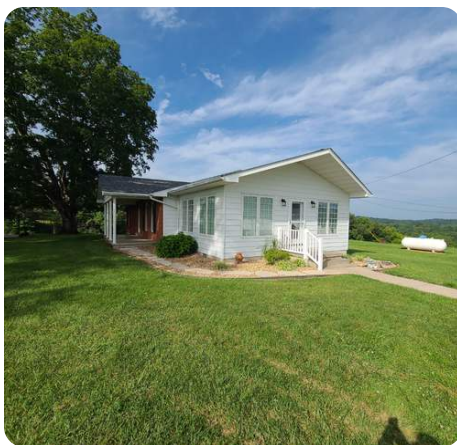
The visible siding and trim appear functional and are providing the intended moisture protection at this time. The condition of the walls behind the siding could not be determined during this non-invasive inspection. Regular monitoring, particularly after severe weather, is recommended to identify any damage or wear and help maintain the home's exterior integrity.

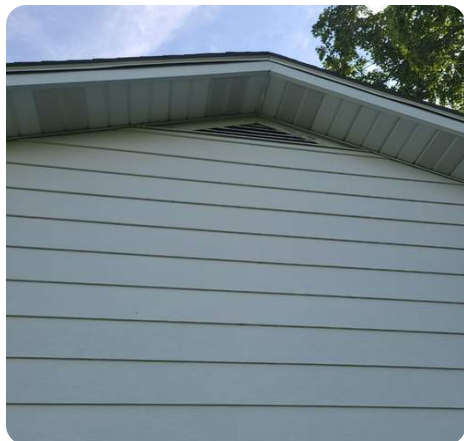
The exterior fascia boards, soffits, and trim appear to be in functional condition. However, because some areas are elevated and cannot be closely inspected, there may be issues that are not visible from the ground. Regular monitoring and maintenance are recommended to ensure these components continue to perform as intended.

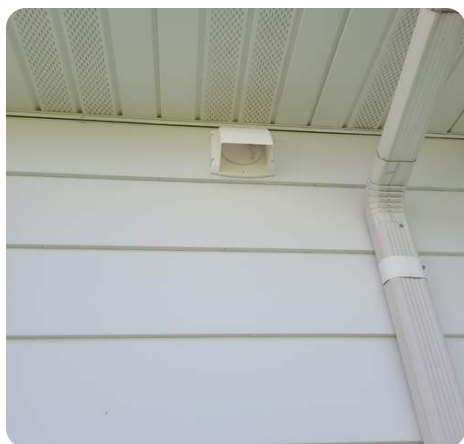
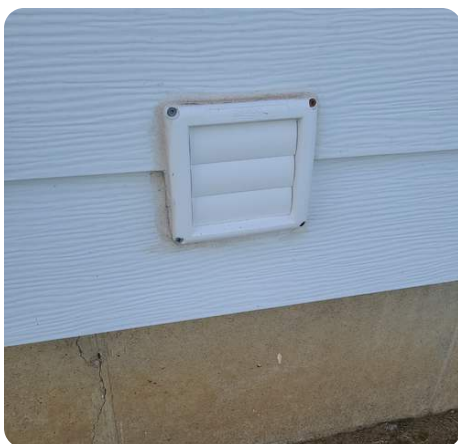
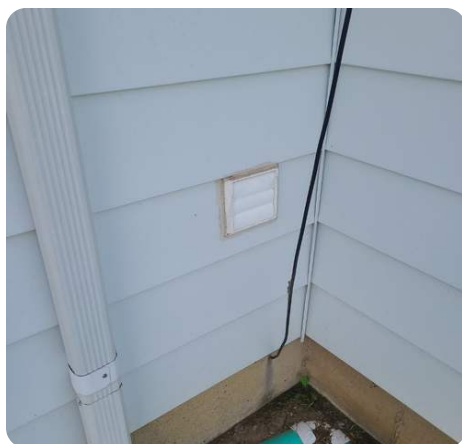
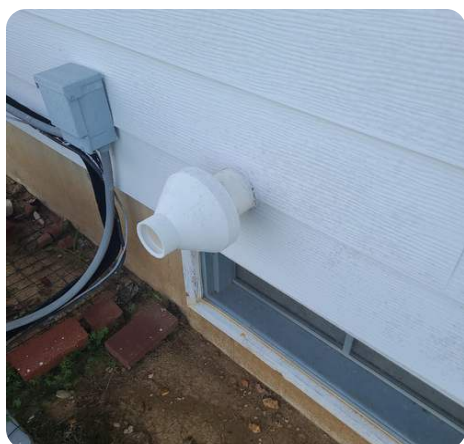
The exterior vents and siding penetrations appeared functional at the time of inspection. Routine monitoring and maintenance are recommended to ensure they remain clear, undamaged, and operating efficiently. Regular visual checks and cleaning help maintain proper ventilation and prevent potential problems.

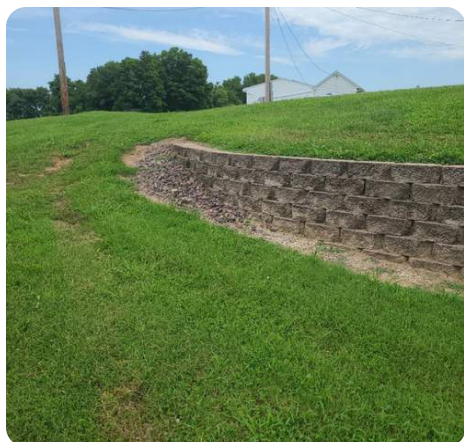
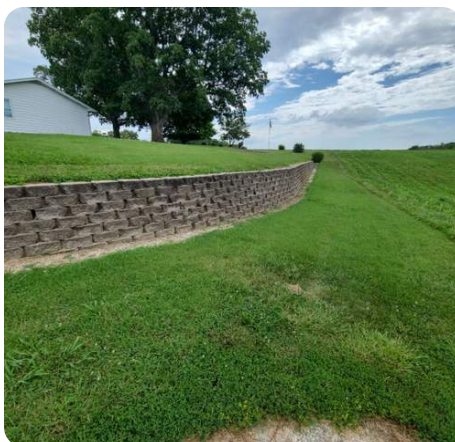
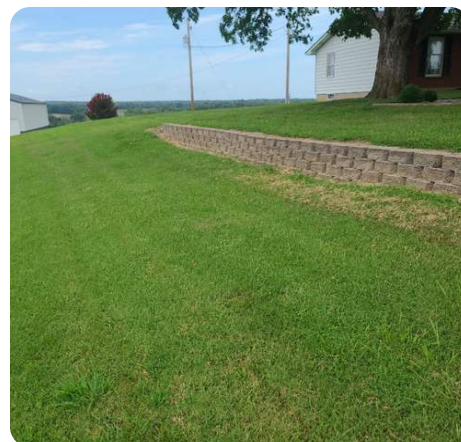
The retaining walls appeared serviceable at the time of inspection. Regular monitoring and maintenance are recommended to ensure they continue to perform as intended and to address any potential issues early.

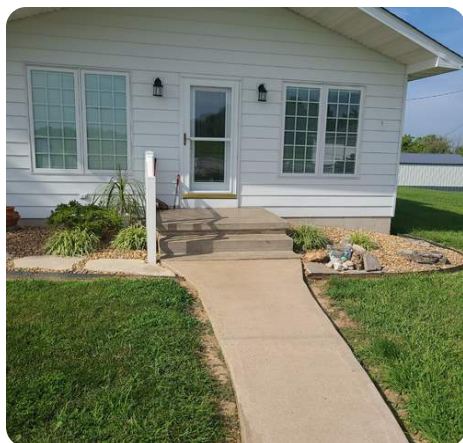
The railings/guardrails were evaluated to assess their safety and condition. This included verifying that the railings are at appropriate heights and free of hazards.

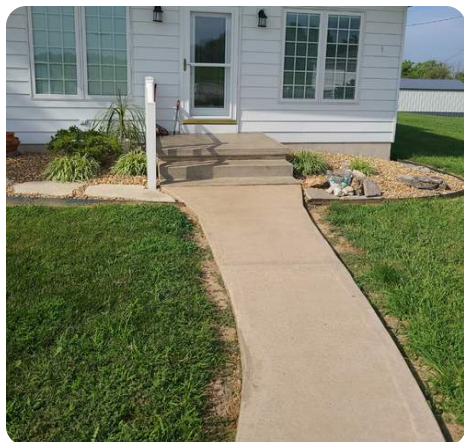
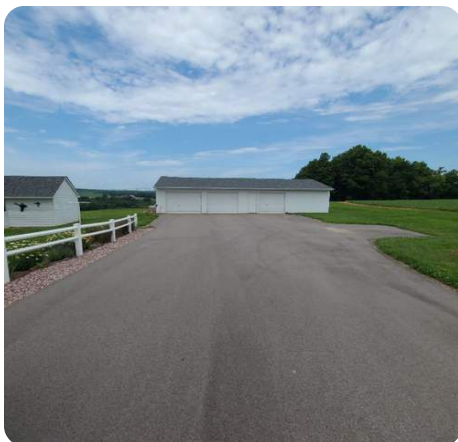
The inspection of the walkways and driveway included checking for cracks, uneven surfaces, and proper drainage to prevent standing water.

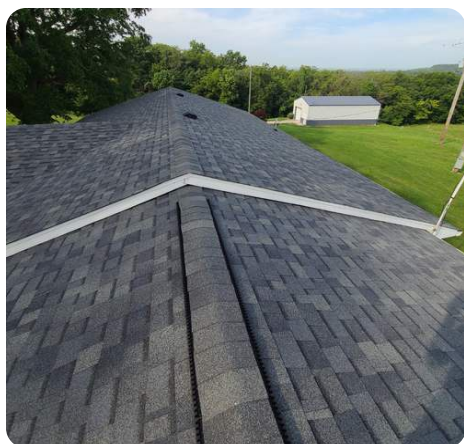
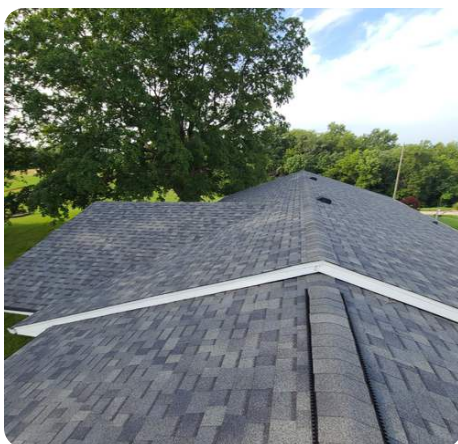
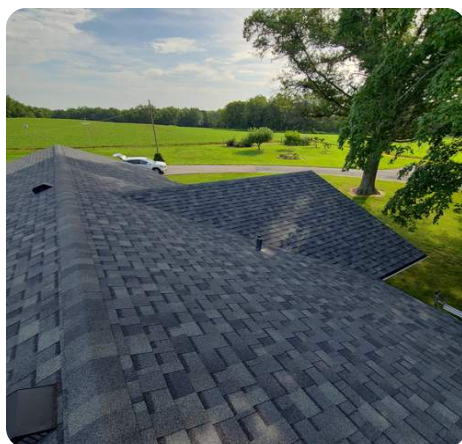
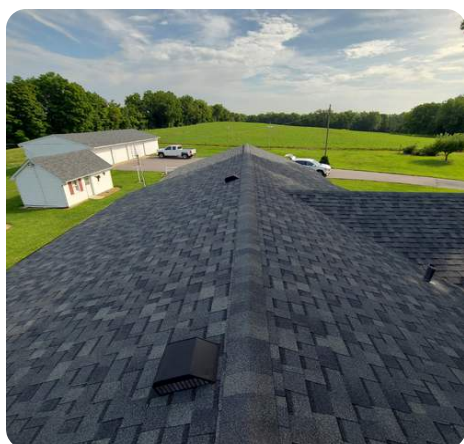
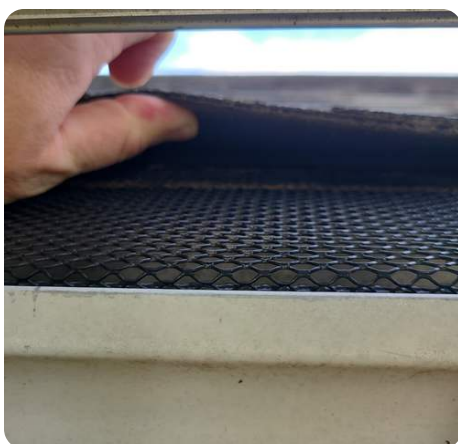
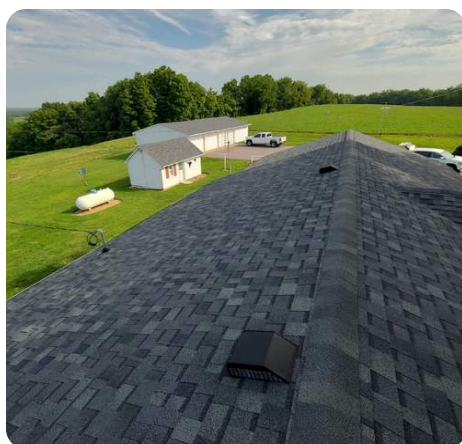
At the time of inspection, the roof covering was observed to be free of visible signs of wear, damage, or deterioration. The roof covering was functioning as expected, based on visible conditions.

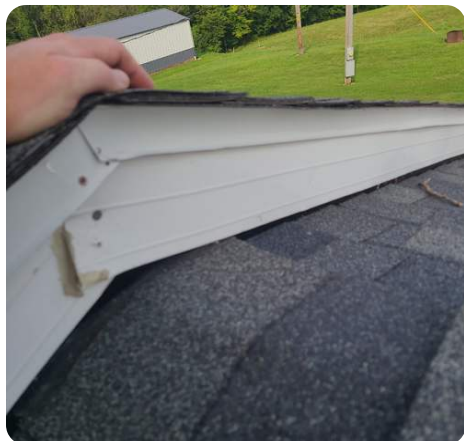
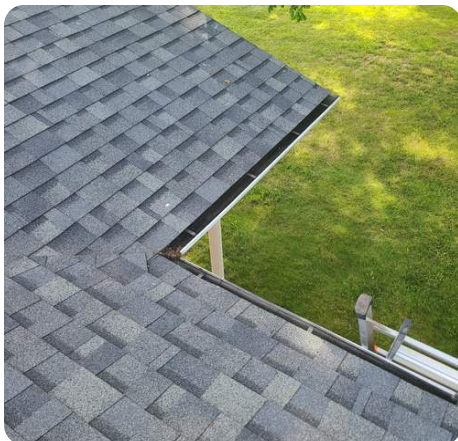
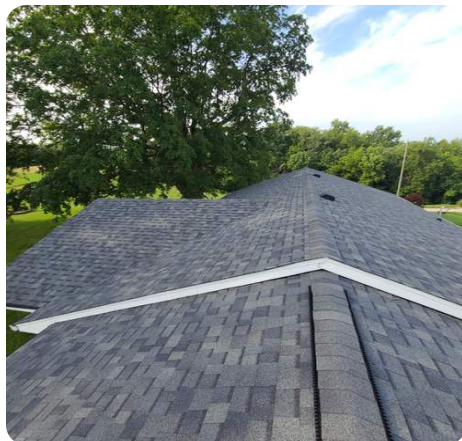
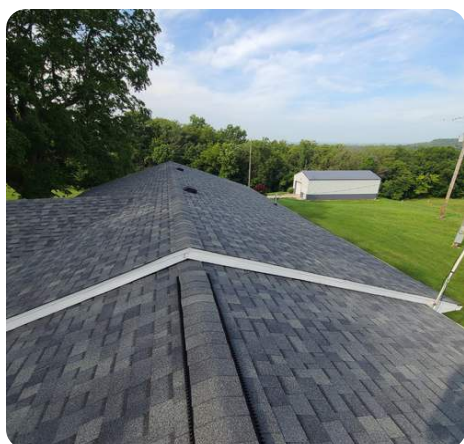
The roof's flashing and valleys were evaluated to ensure they were properly installed and in good condition. This included an examination for signs of rust, cracks, or any separations that could lead to water intrusion. The areas around chimneys, vents, and intersections were checked to ensure they were sealed correctly.

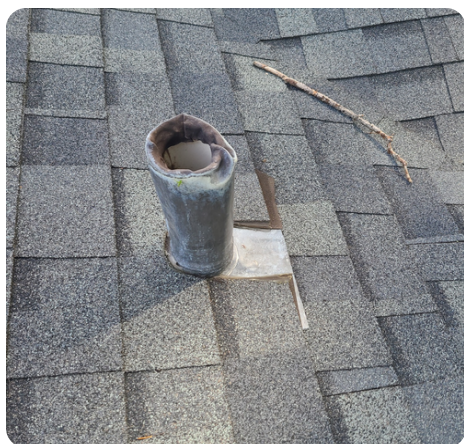
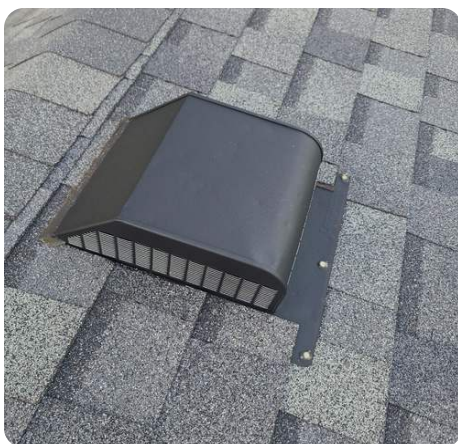
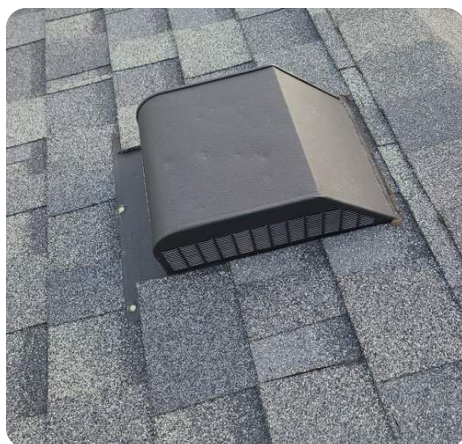
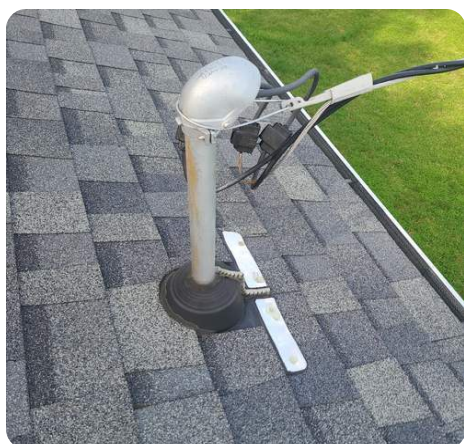
All accessible roof penetrations, such as roof vents, vent covers, and plumbing vents were inspected and appeared to be free of defects. This includes the related flashing.

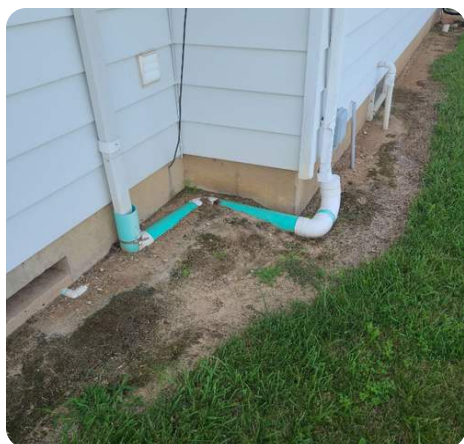
The effectiveness of the buried drains cannot be determined. It is recommended to further evaluate the buried drains by a qualified drainage specialist to ensure proper functioning and prevent any potential drainage issues.

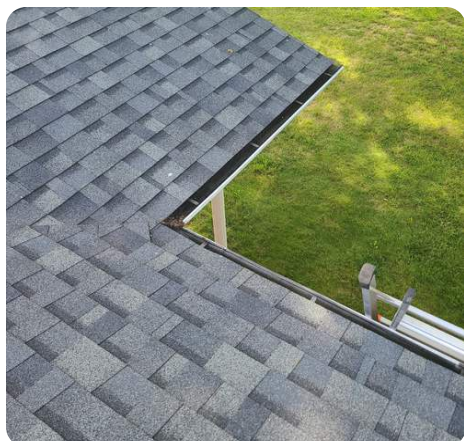
#### Gutter Guards Observed

The gutter guards are currently installed on the gutters, designed to prevent debris from clogging them. This can help maintain proper drainage and prevent potential water damage. Periodically checking and cleaning the gutter guards is recommended to ensure they are functioning effectively.

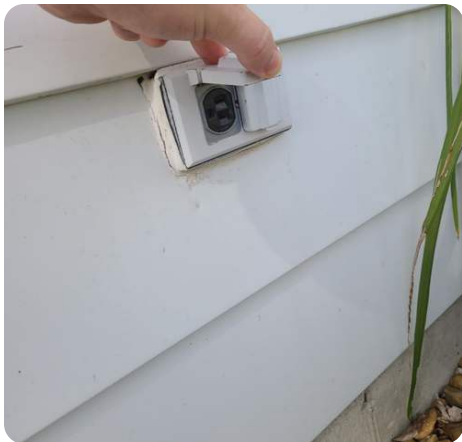
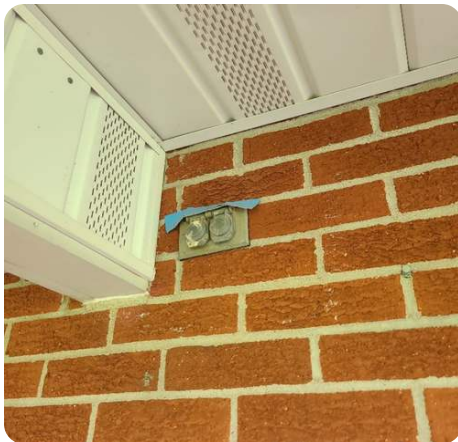
#### Missing GFCI Protection (Exterior)

The GFCI (Ground Fault Circuit Interrupter) protection is absent for the exterior electrical outlets. GFCI outlets are essential for safeguarding against electric shock risks, particularly in wet or damp locations like the exterior. It is advised to install GFCI outlets for safety and to meet electrical codes. Contact a qualified electrician to assess and set up the required GFCI protection.

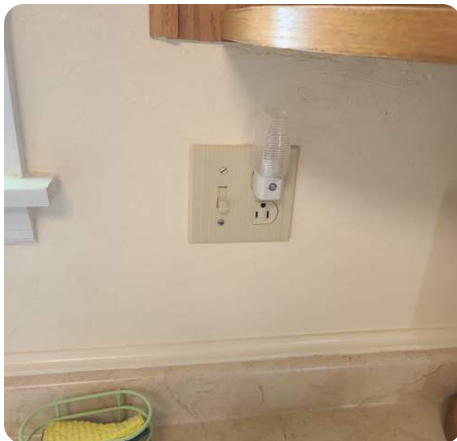
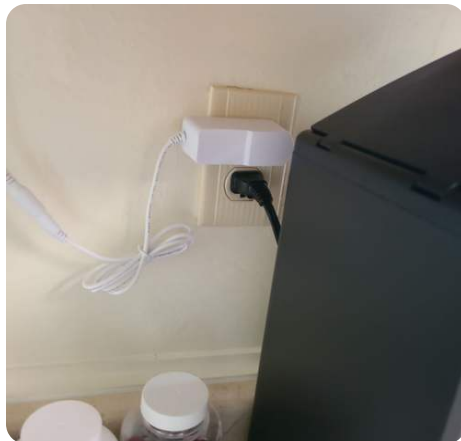
### Missing GFCI Protection (Kitchen Counter)

Kitchen countertops require Ground-Fault Circuit Interrupter (GFCI) protection for electrical receptacles. GFCI protection was not found for some counter-level receptacles, indicating a potential electrical shock hazard. We recommend that a qualified electrician evaluate the circuits and install proper GFCI protection to improve safety.

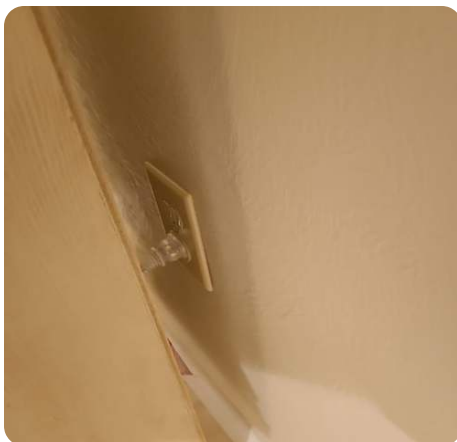
### Missing GFCI Protection (Bathroom)

All receptacles in the bathroom lack GFCI (Ground-Fault Circuit Interrupter) protection, which is a safety concern in locations with exposure to water. GFCI protection is a standard safety feature that helps prevent electrocution. Recommend a qualified electrician evaluate and upgrade the bathroom receptacles to meet current safety standards.

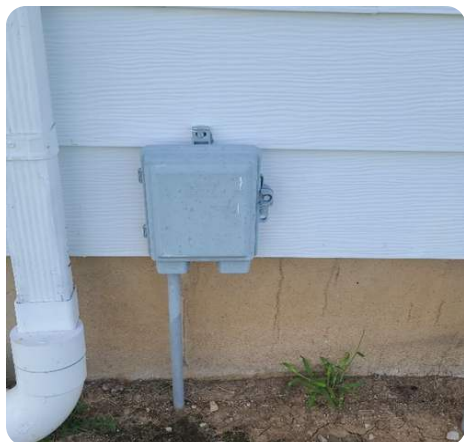
Evaluation of low-voltage wiring and communication lines is not within the scope of a commercial inspection. It is recommended to consult a qualified low-voltage wiring specialist for detailed assessment and maintenance, if needed.

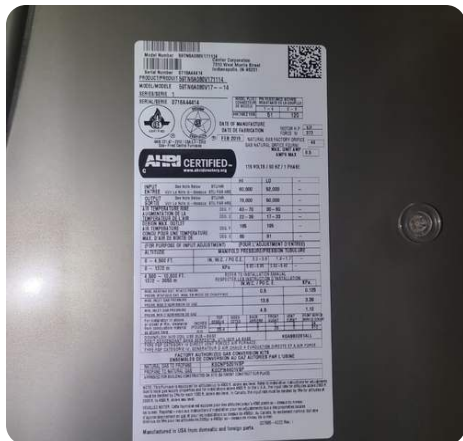
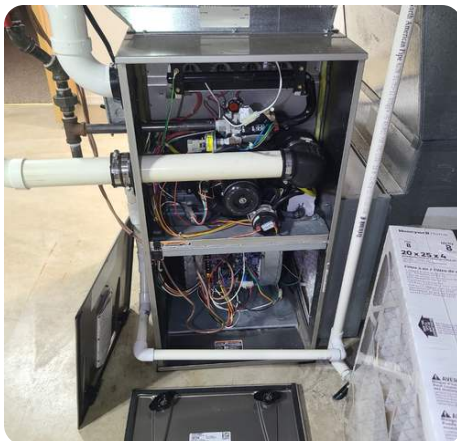
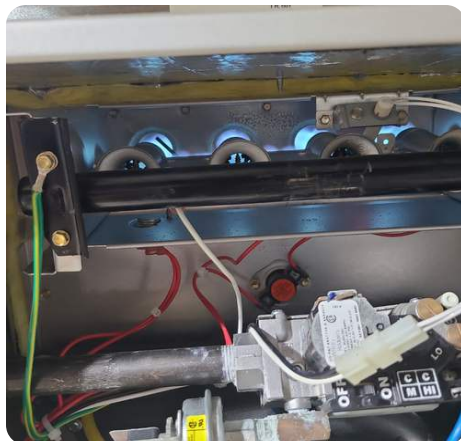
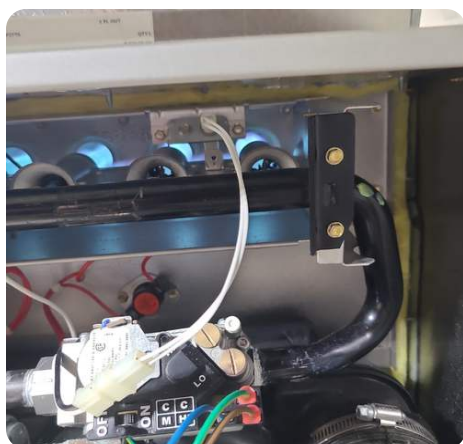
Carrier unit manufactured in FEB 2016 (Model: 59TN6A080V171114, Serial: 0716A44414) with a heating size of 80,000 BTU/hr input and a 3.5-ton nominal airflow rating. Routine evaluation and servicing by a qualified licensed HVAC contractor are recommended to ensure proper operation, safety, and system longevity.

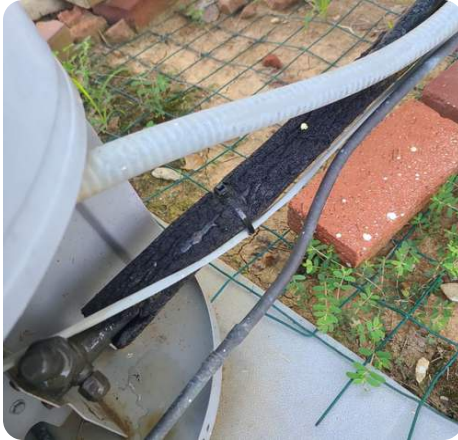
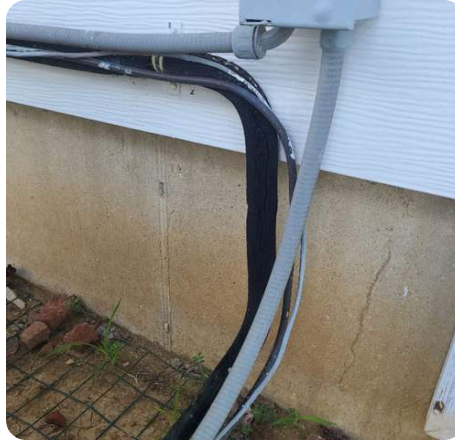
#### Deteriorated Insulation Around Refrigerant Line

The insulation around the refrigerant line is deteriorated. This issue is commonly found on older HVAC systems due to wear and tear. It is recommended that the insulation be evaluated and repaired to prevent energy loss and potential efficiency issues. A qualified HVAC technician should repair or replace the insulation to ensure the system operates efficiently.

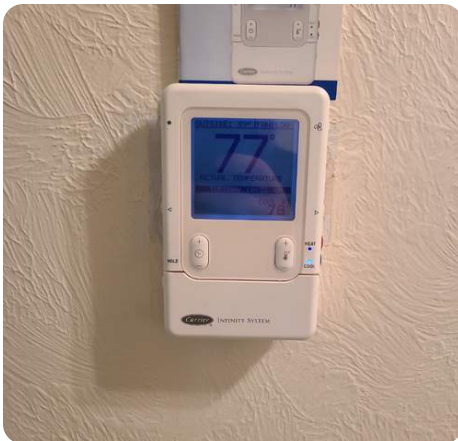
The controls appeared to be serviceable at the time of inspection.

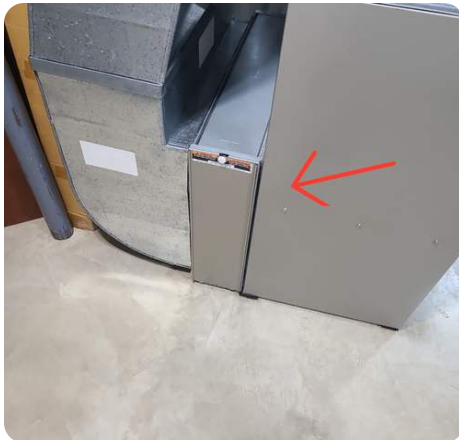
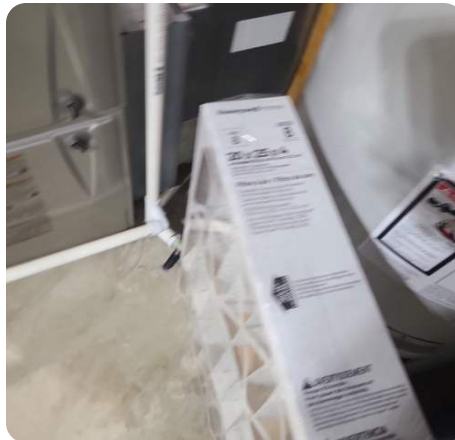
The distribution systems appeared to be serviceable at the time of inspection.

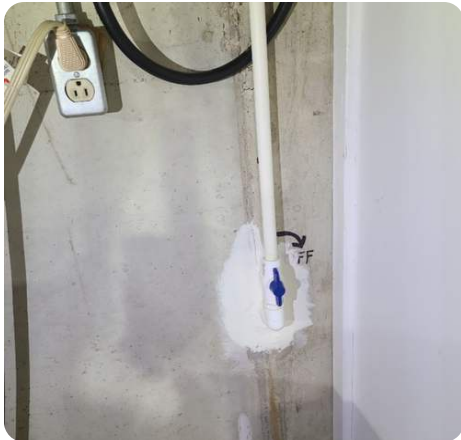
📍 Location: Basement

The main water shutoff appeared to be serviceable at the time of inspection.

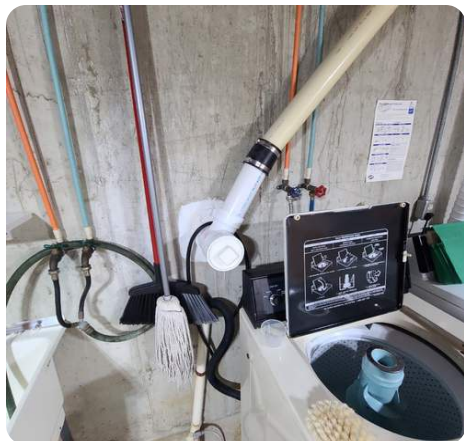
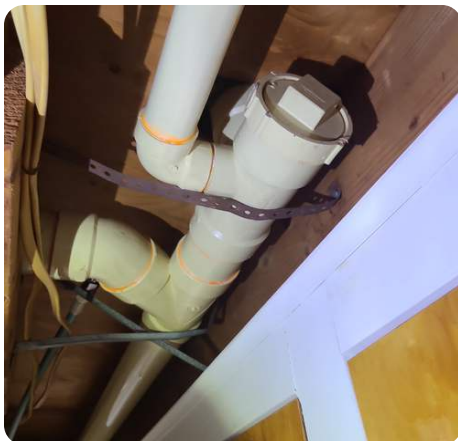
The sewer line clean out in the basement is recommended to be easily accessible and identifiable. It is beneficial for maintenance and inspection purposes. Make sure the clean out cap is securely in place to prevent any leaks or odors. If not already present, consider adding a label or marker for clear identification.

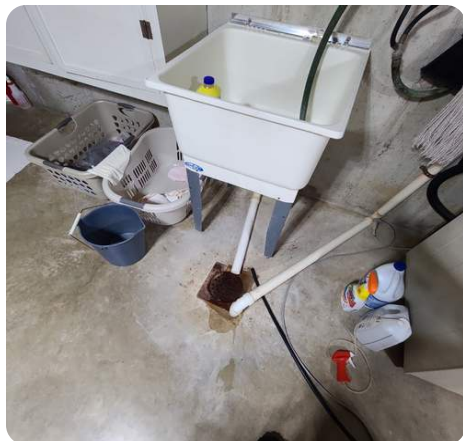
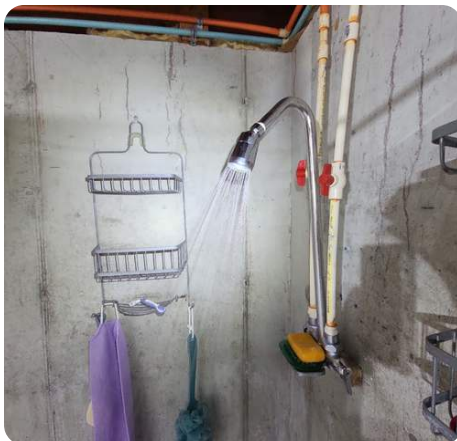
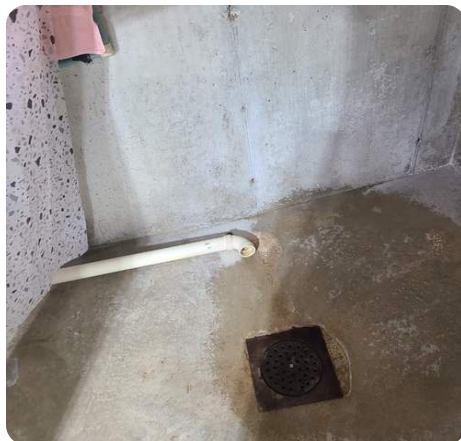
The basement shower and sinks are draining directly into the floor drain is not ideal as it can lead to potential drainage issues and sewer odors. It is recommended to have a licensed plumber evaluate and reroute the drainage to the main sewer line for proper disposal of wastewater. This setup can also cause backups and clogs if not addressed.

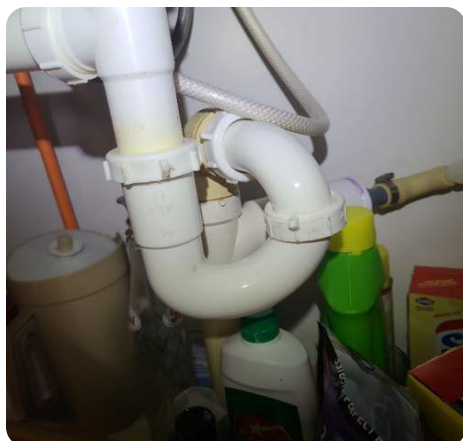
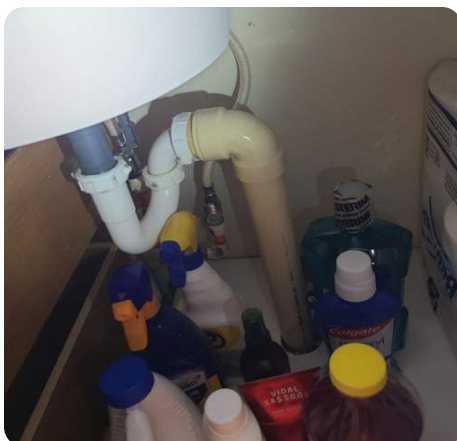
## Visual Inspection Of Drain Pipes

This is a visual examination of the exterior piping. We recommend questioning the seller regarding their knowledge of any slow draining or other plumbing-related issues.

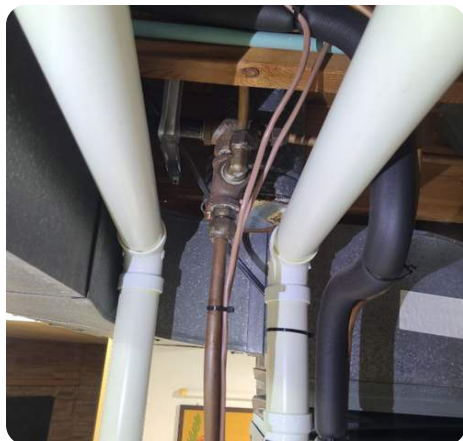
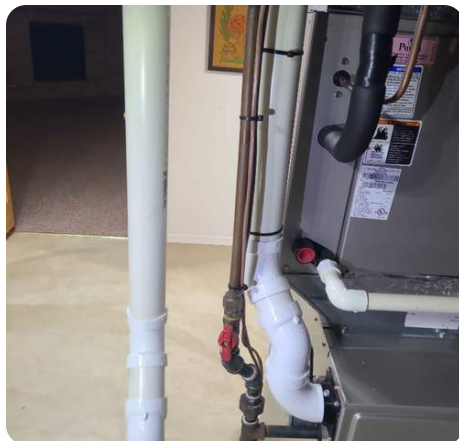
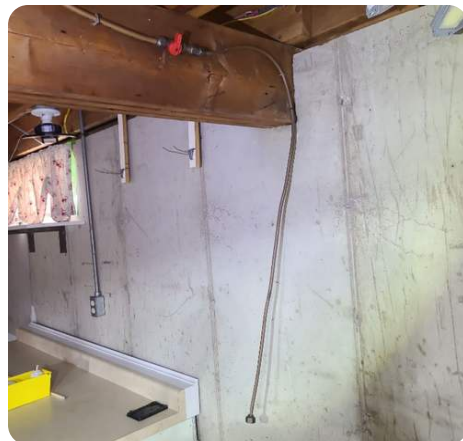
The copper propane gas line is not recommended for gas supply as it may not be approved for gas distribution. It is recommended to have a licensed plumber evaluate and replace the copper gas line with an appropriate material for gas supply, such as black steel or CSST piping.

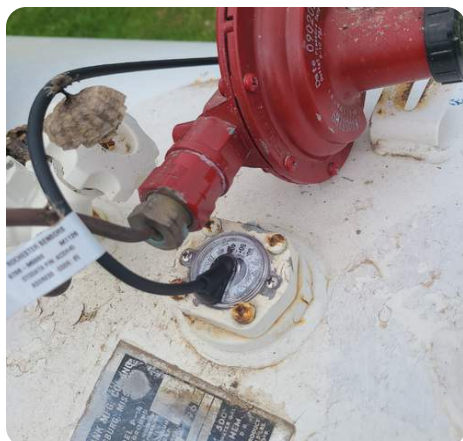
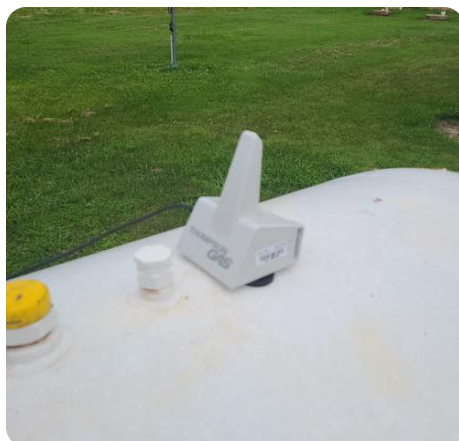
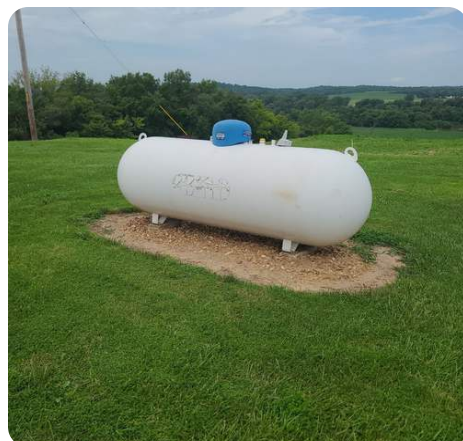
There is a propane storage tank located near the house. It is recommended to have the tank periodically inspected by a qualified plumber or gas technician to ensure proper functioning and safety standards are met.

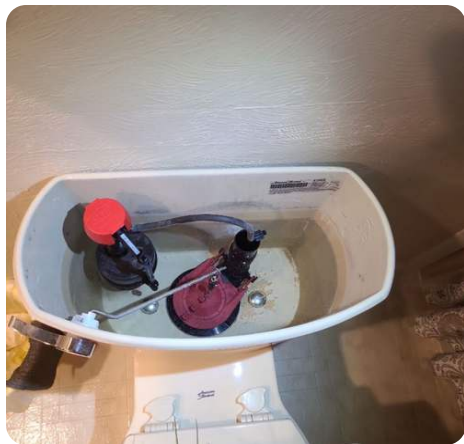
### Toilets Inspection General Information

The toilets were flushed and inspected for cracks, leaks, and serviceability. The toilets should be inspected periodically for indications of cracking in the toilet bowl, tank, or base. Also, periodic replacement of flapper valves and water towers should be expected as typical homeowner maintenance.

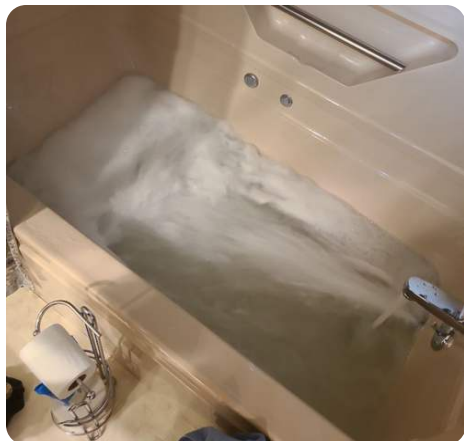
The jetted tub was evaluated and found to be in functional condition. It is recommended to operate the jet functions periodically to ensure proper functionality and prevent any potential clogs. Regular maintenance of the jet system will help in extending its lifespan and enjoying a relaxing bathing experience.

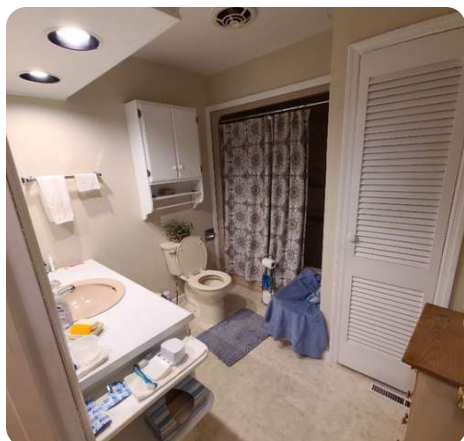
### Water Exposed Areas

Routine preventive maintenance should include applying and maintaining caulking in and around tubs and shower surrounds to prevent moisture penetration behind tub and shower wall/floor cover materials.

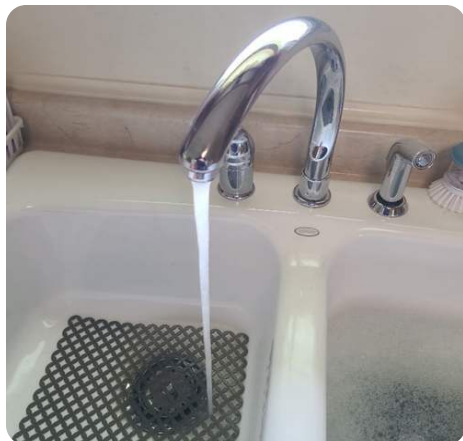
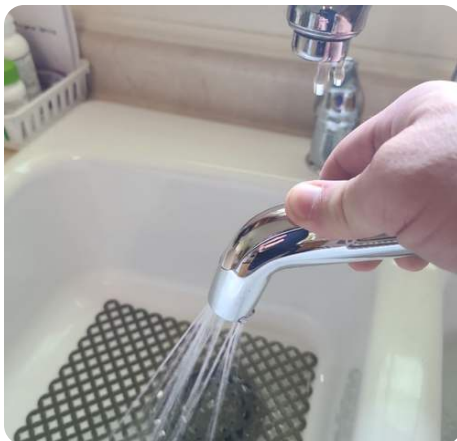
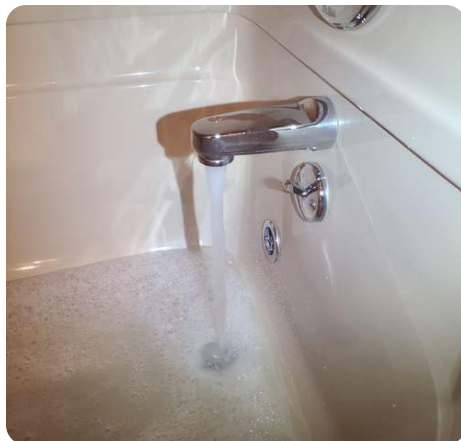
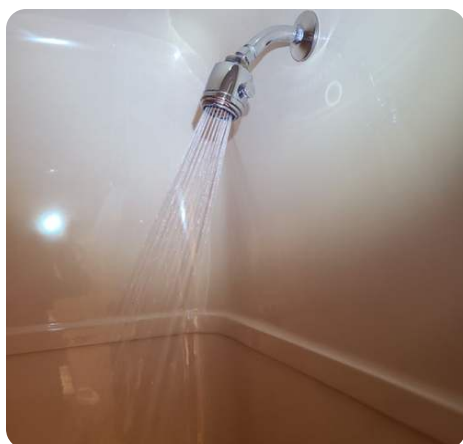
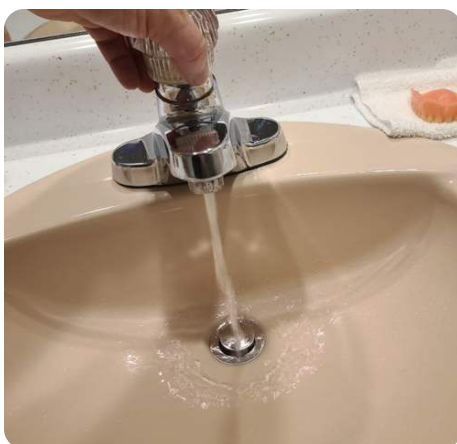
### Plumbing Fixtures Maintenance Information

Routine preventive maintenance and/or replacement of fixtures is needed periodically. Faucets and valves have a typical life expectancy of 5-15 years. General wear, depending on the quality of fixture, is expected. Preventative measures, such as the installation of a soft water or water conditioning unit is recommended.

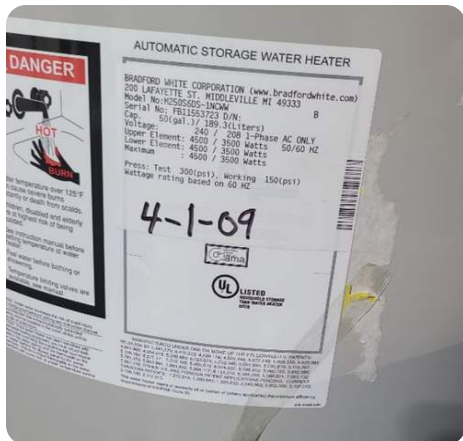
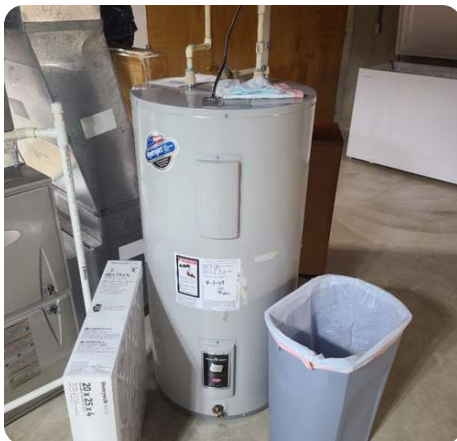
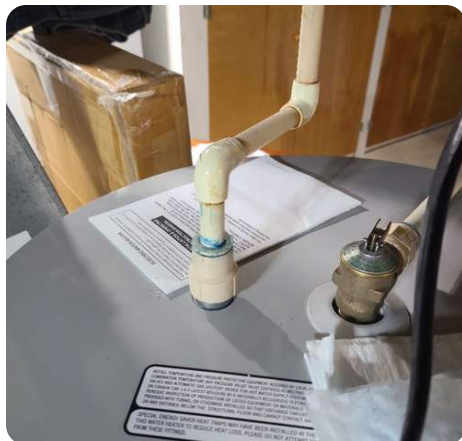
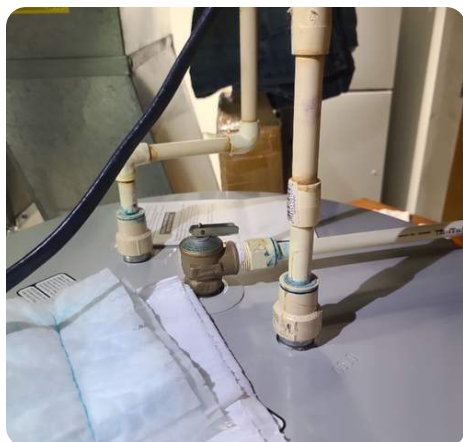
The Bradford White electric water heater (Model: M250S6DS-1NCWW, Serial: FB11553723) has a 50-gallon capacity, and a manufacture date of February 2009 (installed 4-1-09). Given its age, the unit has exceeded its typical expected service life. While currently operational, future replacement should be budgeted for, and routine annual evaluation by a licensed plumber is recommended to ensure safe, continued performance.

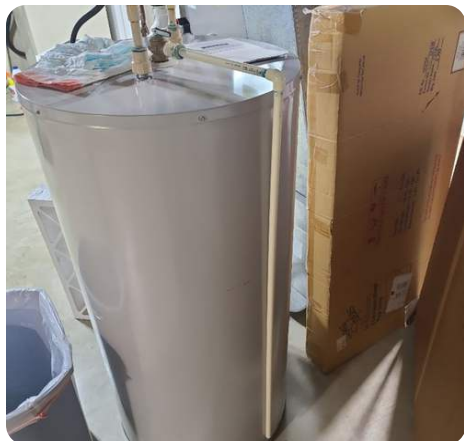
### TPR Valve And Discharge Pipe

The water heater's temperature/pressure relief valve is equipped with an approved discharge pipe. The pipe serves the purpose of preventing someone from being sprayed with scalding water in the event that the valve were to discharge. These components were in satisfactory condition at the time of the inspection.

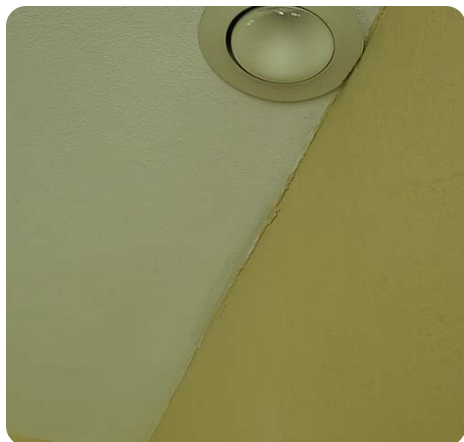
### Tape Separation/Crack

📍 Location: Main Entry

The tape separation/crack is observed. It is recommended to evaluate and repair the affected areas to prevent further damage. A qualified drywall professional can repair the tape separation and cracks to ensure a seamless finish.

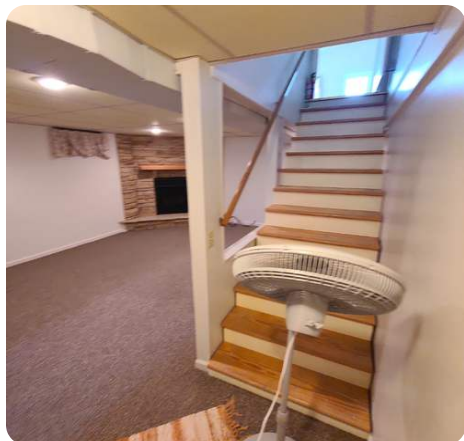
### Steps, Stairways, And Railings Evaluated

The steps, stairways, and railings were visually inspected for signs of damage, wear, or instability. To ensure continued safety, regular inspections and maintenance are recommended to address any potential issues that may develop over time.

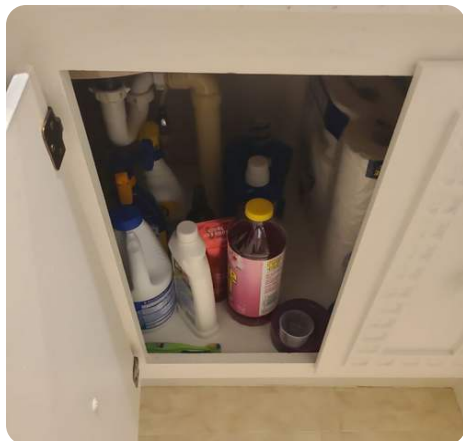
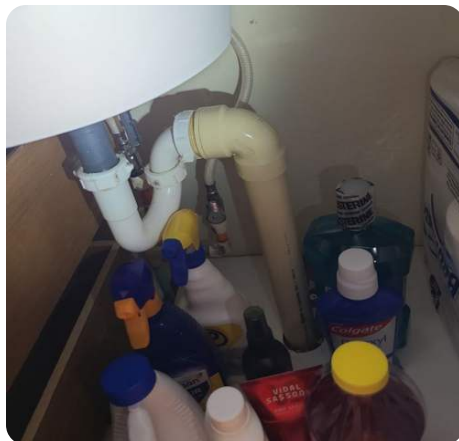
Stored items were found under the sinks and in cabinets throughout the home at the time of the inspection, which may have hindered a complete visual inspection. Further evaluation is recommended when access can be gained.

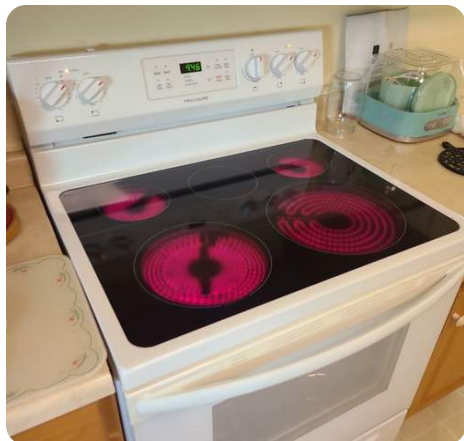
An on / off test was performed to determine if the cooktop was functioning. Periodic cleaning and maintenance is recommended for continued use.

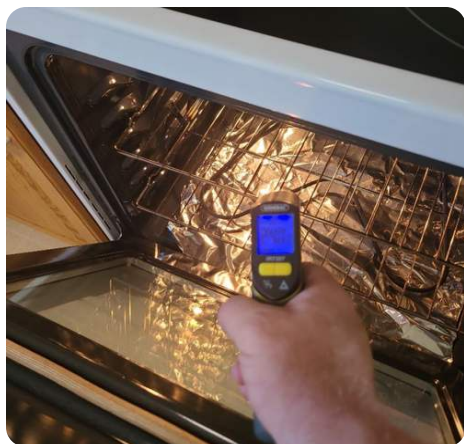
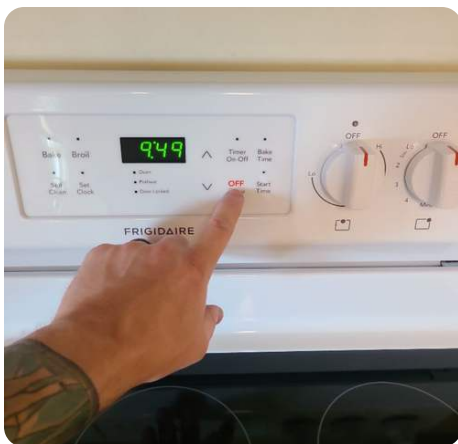
Oven Tested ✓ Functional

The bake function of the oven was tested and found to be functional at the time of the inspection. This is an on/off test conducted on the oven.
