**Service:** Full Home Inspection

**Prepared for:** Joan Dandridge

Site Address: 6053 Collins Road, Ellis Grove, IL, 62241

Service Date And Time: July 21, 2026 At 09:00 AM

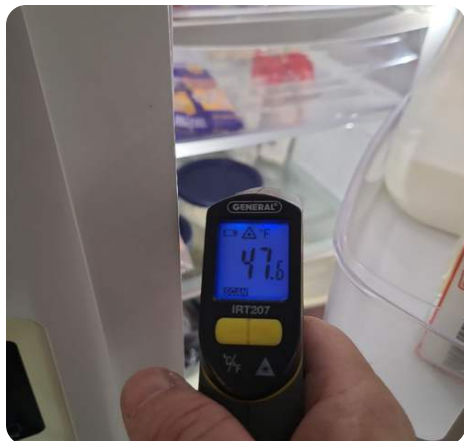
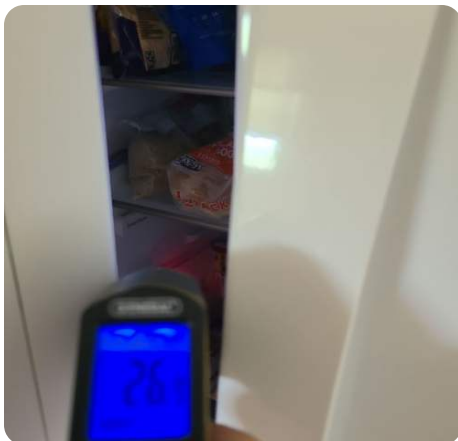
The interior of the refrigerator and freezer were cold when opened and functional at the time of inspection.

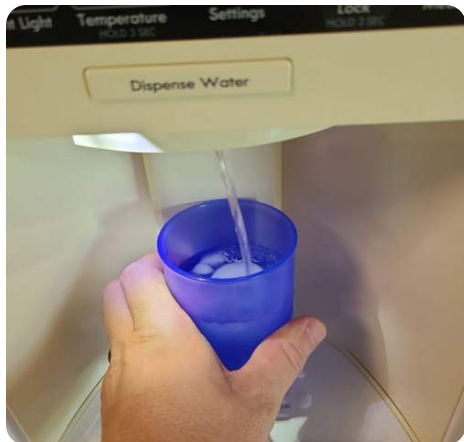
### Water Dispenser Functionality

The water dispenser on the refrigerator was found to be functional. It is always recommended to regularly check and clean the water dispenser to ensure proper operation and maintain water quality.

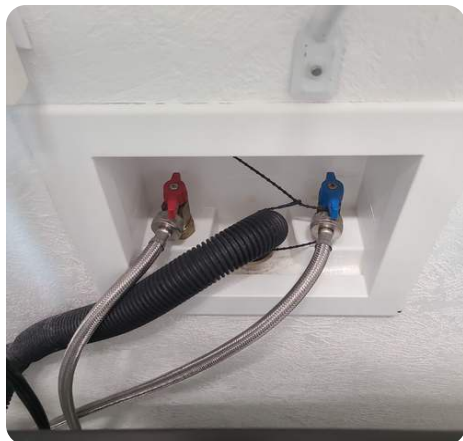
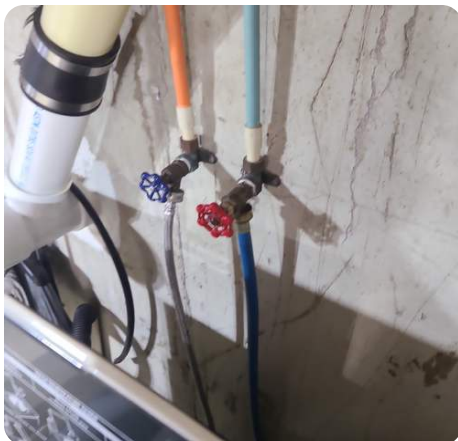
### Washer Tested

📍 Location: Basement, Laundry Room

An rinse cycle was performed on the washing machine, which appeared to be in functional condition at the time of the inspection. There were no visible water leaks at the washing machine hook-up valves or drain during testing. This inspection does not cover the full range of washing machine settings or the ability to wash clothes.

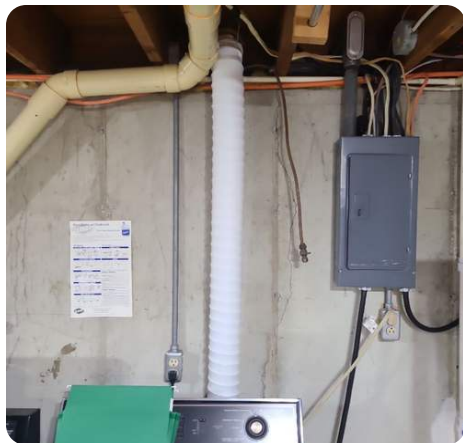
#### Improper Dryer Vent Material

Location: Basement

The dryer vent system is constructed with improper material. It is recommended to use only rigid or flexible metal venting material for the dryer exhaust. Improper materials such as plastic or foil can be a fire hazard due to their flammability. The issue should be addressed promptly by a qualified HVAC technician to ensure proper ventilation and reduce the risk of fire.

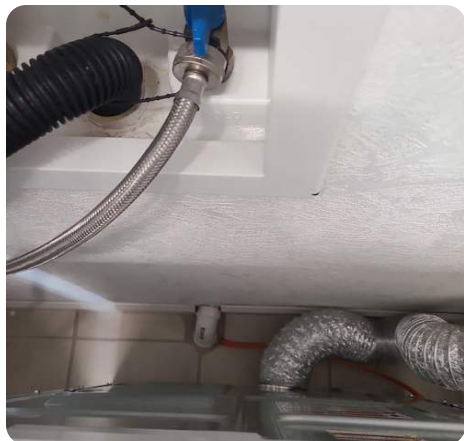
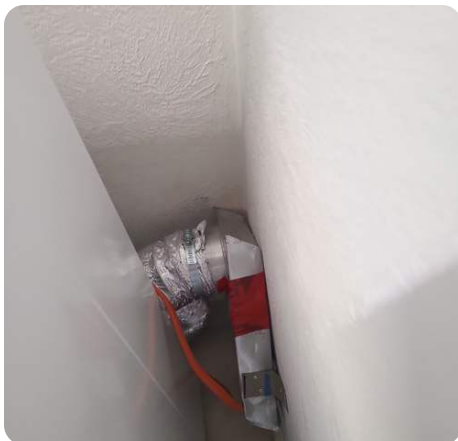
**Dryer Tested**

An on/off test was performed on the clothes dryer. The interior temperature of the dryer responded to the controls. The inspector is not able to dry clothes or conduct a full test of all the settings.

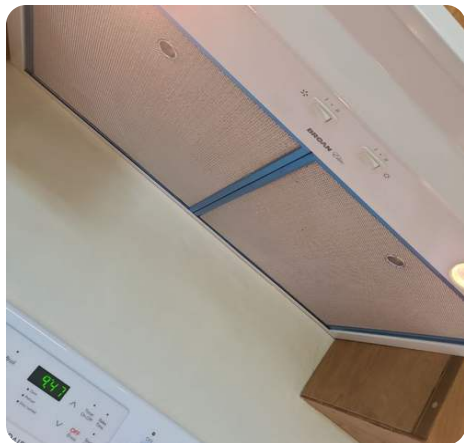
**Recirculating Vent Inspection**

The recirculating vent for the range has been tested and is functional.

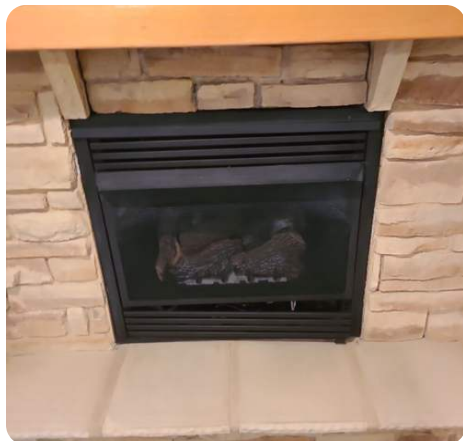
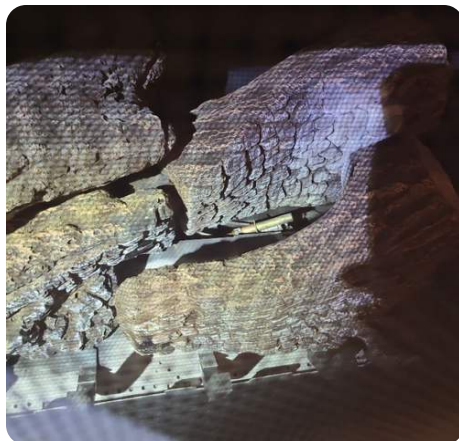
**Gas Log Not Tested Due To Unlit Pilot**

The gas log was not tested during the inspection as the pilot was not lit. It is recommended to have a qualified HVAC technician or a licensed chimney sweep evaluate the fireplace prior to closing.

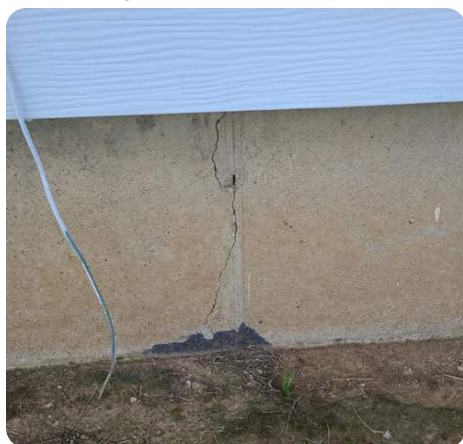
### Hairline Crack

A hairline crack (less than 1/16") was noted in the concrete stem wall. This is a common, typically cosmetic condition resulting from normal concrete shrinkage during the curing process or minor settling, and is not a current structural concern. It is recommended that the crack be sealed with a suitable concrete sealant to prevent moisture intrusion and monitored periodically for changes in width or length. If the crack widens (e.g. , Becomes wider than 1/8"), shows signs of water seepage, or other signs of structural distress (such as sticking doors or sloping floors) develop, a qualified structural engineer or foundation specialist should be consulted for a professional evaluation.

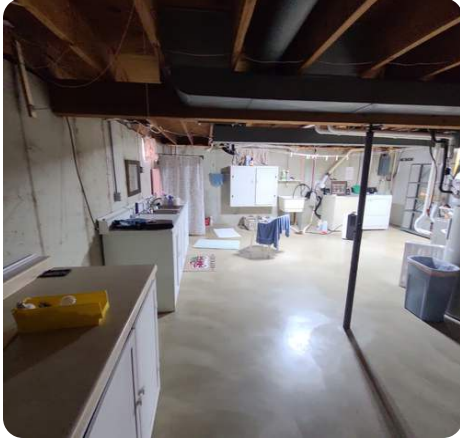
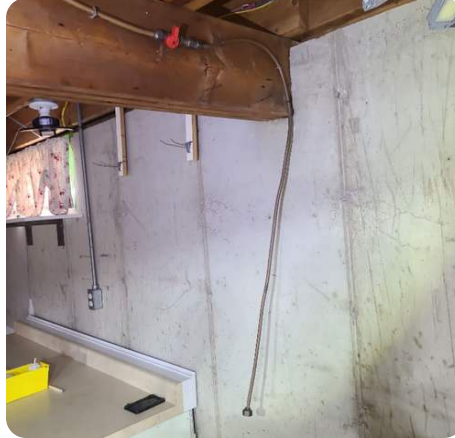
### Beams, Columns, And Posts Evaluated

The visible and accessible beams, columns, and posts were evaluated during the inspection. It is important to note that some structural components are often not fully visible during a standard home inspection. Based on the areas that were accessible, all inspected structural elements appeared to be in functional condition at the time of the evaluation.

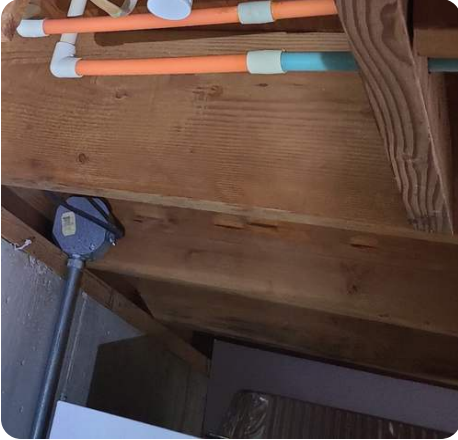
Joists and framing members are typically concealed within the construction and are not fully visible during a standard home inspection. However, the accessible portions that were inspected appeared to be in satisfactory condition, with no significant issues or concerns identified at the time of the evaluation.

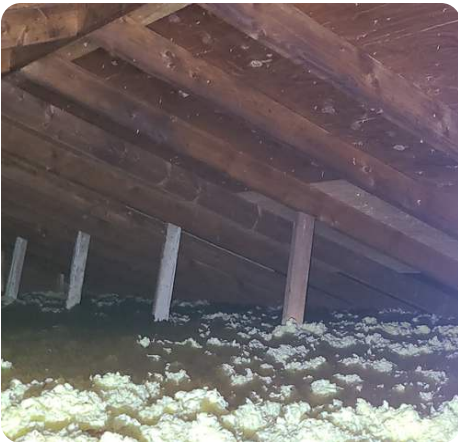
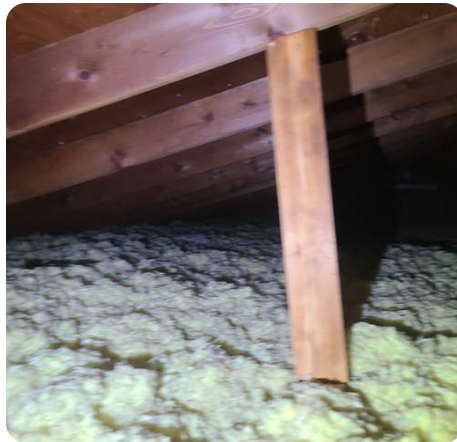
The inspector examined the accessible roof structure, including rafters, and sheathing, within the attic.

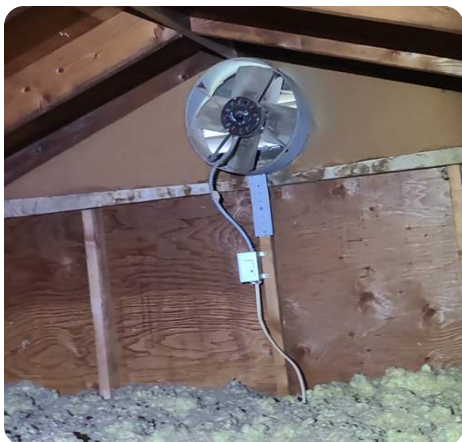
The powered vent fan in the attic is not functioning. It is recommended to evaluate and repair the fan to ensure proper ventilation in the attic. Proper attic ventilation helps in preventing moisture buildup and prolongs the life of the roof. A qualified electrician or HVAC technician can assess and repair the powered vent fan to maintain good air circulation.

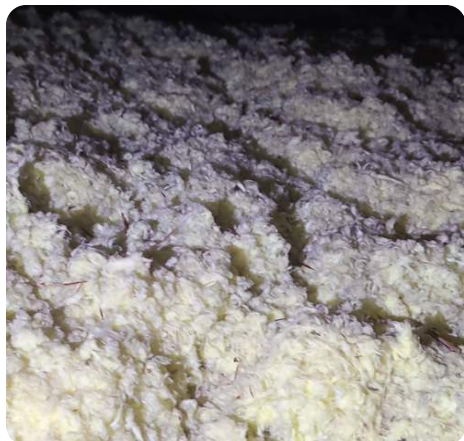
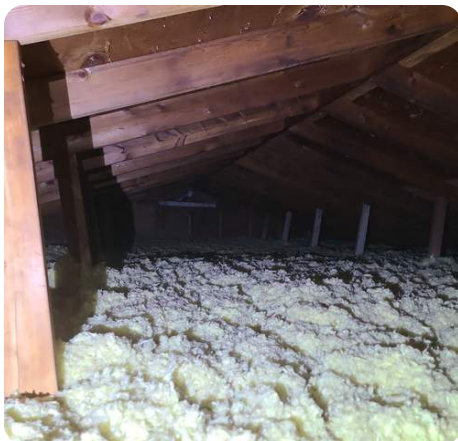
**Insulation Functionality Evaluation**

**Functional**

The insulation in the attic appears to be functional. It is recommended to regularly inspect the insulation for any signs of damage or settling which could affect its effectiveness over time.

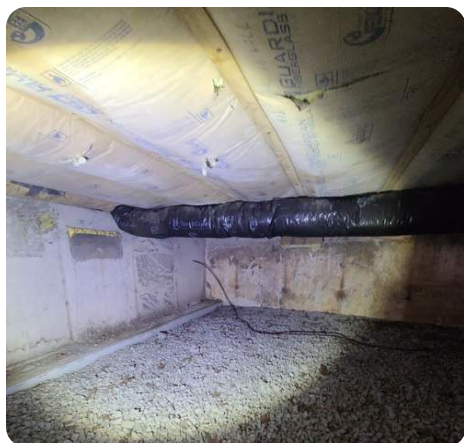
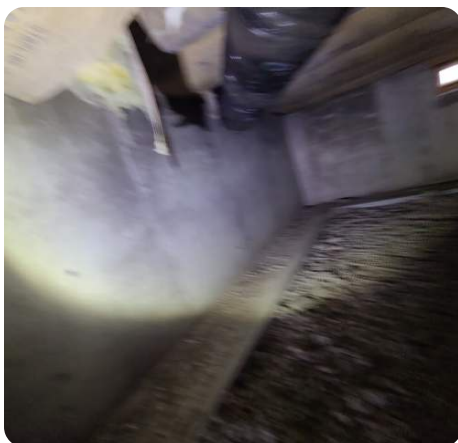
The batts in the crawl space are installed backwards. This can reduce their effectiveness in providing insulation. We recommend evaluating and reinstalling the batts with the vapor barrier facing the appropriate direction to ensure maximum insulation efficiency. A qualified insulation contractor should be consulted for this repair.

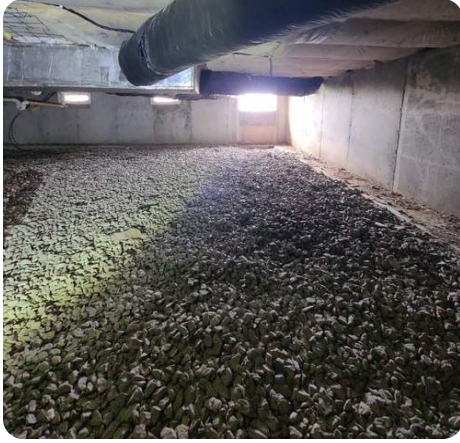
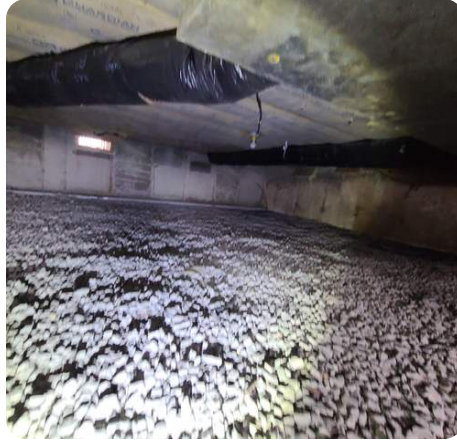
#### No Vapor Barrier

The structure crawl space lacks a vapor barrier. It is suggested to install a vapor barrier or Moist-Stop if any dampness occurs in the crawl area. A vapor barrier covering the soil can help reduce moisture in this area and the structure. This item is commonly available at most home improvement or hardware stores.
