Home Inspection Report

PROPERTY INSPECTED:
2175 Quaethem Drive
Wildwood, MO 63005

Date of Inspection: 03/23/2026

Inspection No. 551034-13856

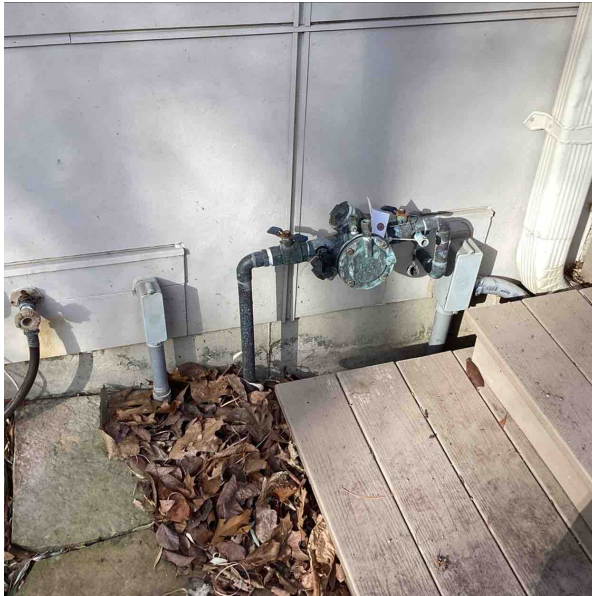
2.5.1 Sprinkler system back flow preventer location: Exterior Back (**Exterior Back**)

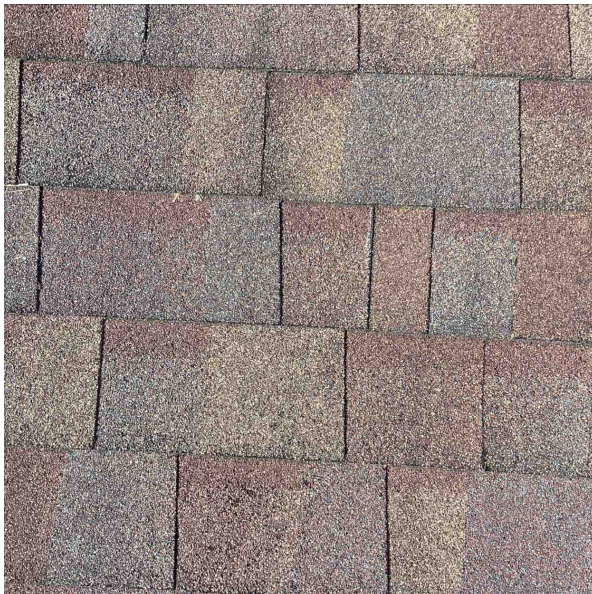
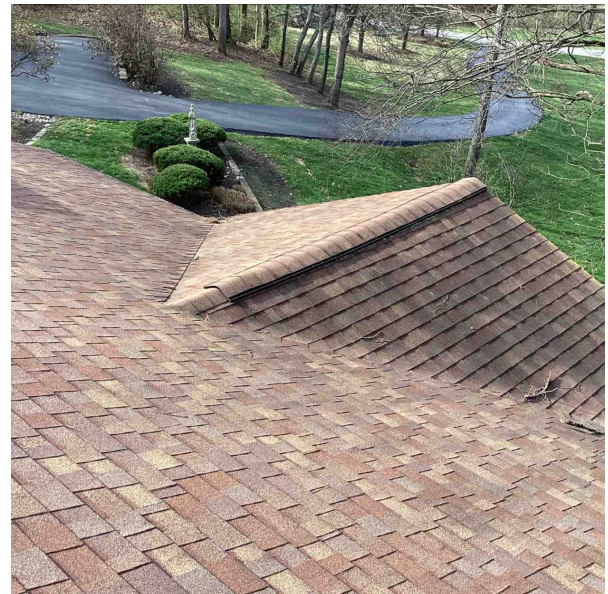
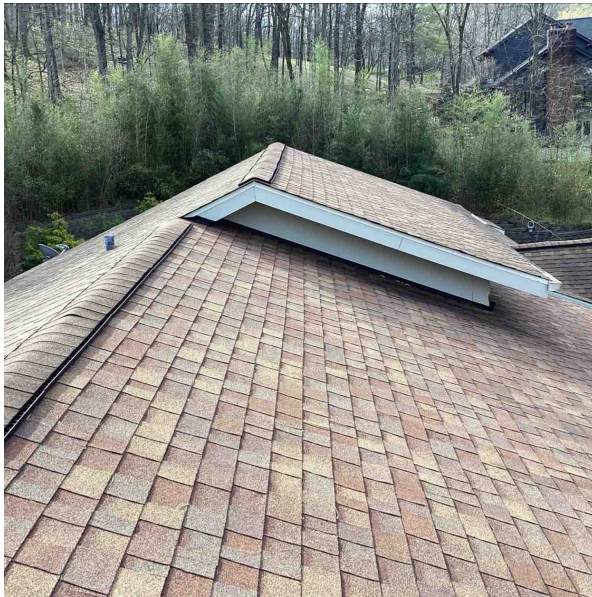
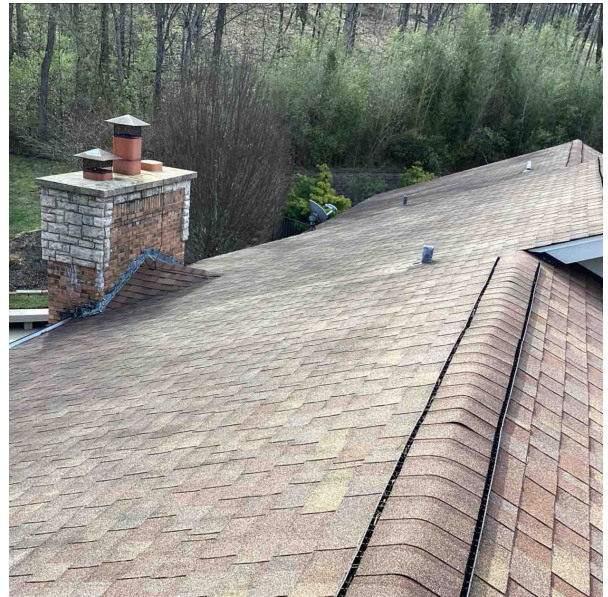
• Asphalt shingles showing signs relative to age and wear. The roof appears to be in serviceable condition at this time. Serviceable life for this type of roof covering is estimated at around 20-30 years but cannot be predicted.

4.4.4 There are branches, sticks and leaves on roof. Remove tree debris off roof to prevent accelerated shingle deterioration and damage.

4.4.5 Staining present on the roof covering is an indication of an algae or fungal growth which can prematurely age the shingle, but is of minimal concern. A qualified contractor can clean the roof covering if desired.

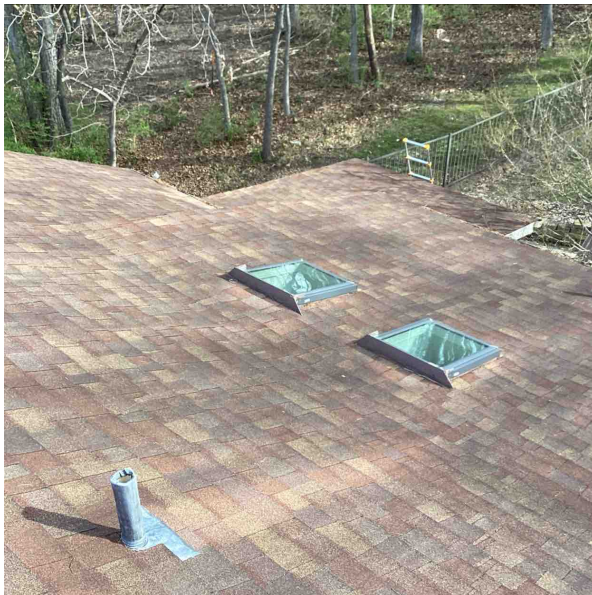
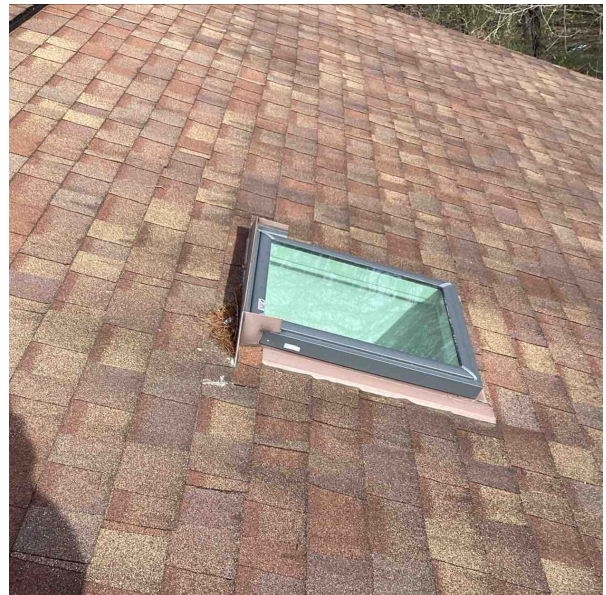
4.8.2 Monitor skylights frequently for early signs of failure. Skylights can be susceptible to water penetration. No signs of moisture entry were identified at the time of inspection.

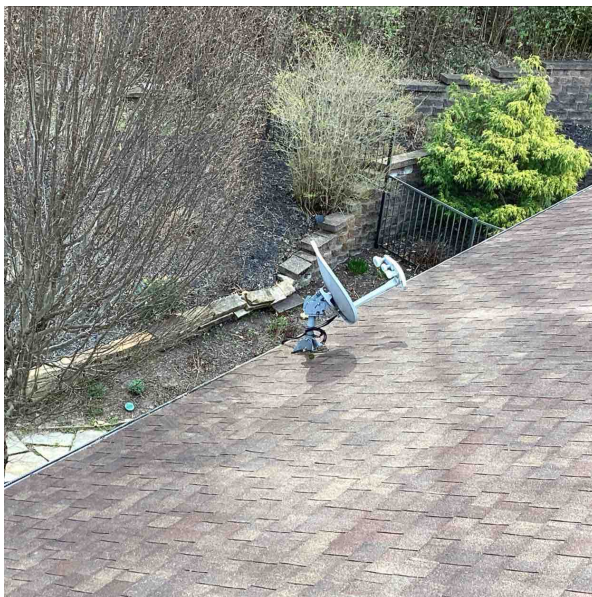
4.8.3 Monitor satellite dishes frequently for early signs of failure. Fasteners that penetrate the shingles and roof sheathing are susceptible to water penetration if not properly installed and / or caulked.

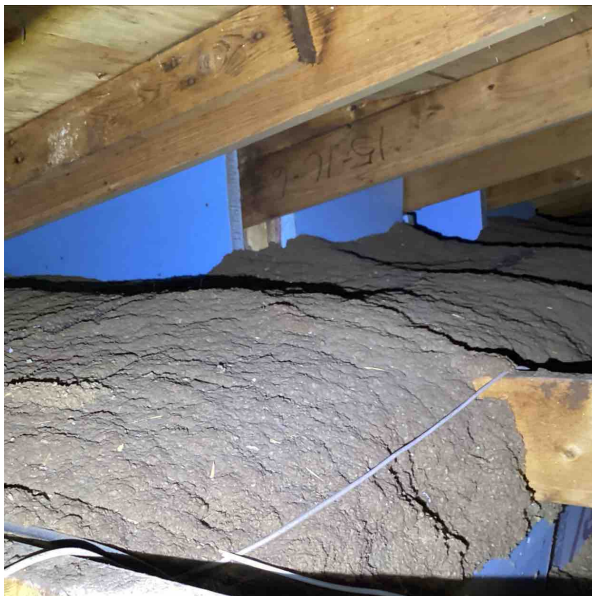
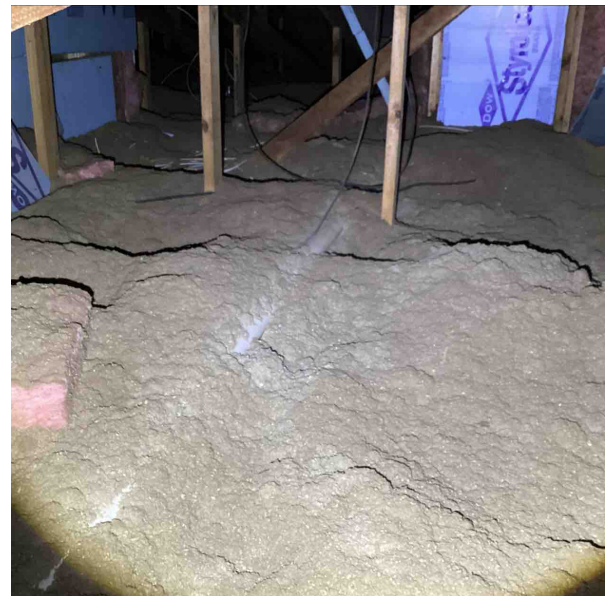
5.3.3 Approximate Insulation Depth:4-6"

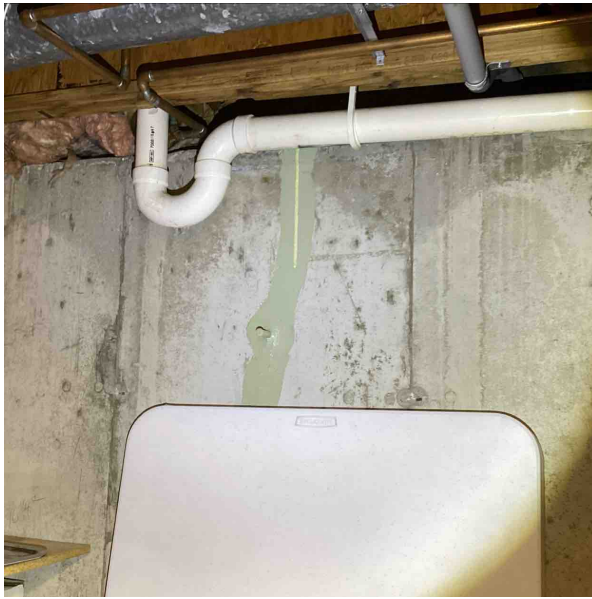
(Mechanical/Utility Room)

7.3.2 There is evidence of previous waterproofing / repair to the foundation / structure. The work appears to be professionally done and performing as intended. Inquire with the seller and / or contractor regarding documentation of the scope of work performed and associated warranties, if applicable.

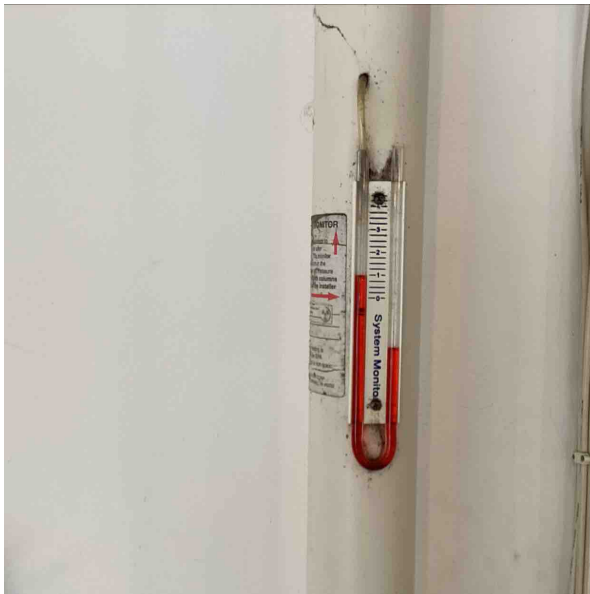
7.9.2 Radon Mitigation system has been installed and the fan was operational. Manometer was identified and was offset, showing negative pressure was present (which is correct). Periodically monitor this manometer. If the level of liquid is even, contact a contractor/mitigation company for service. **(Garage)**

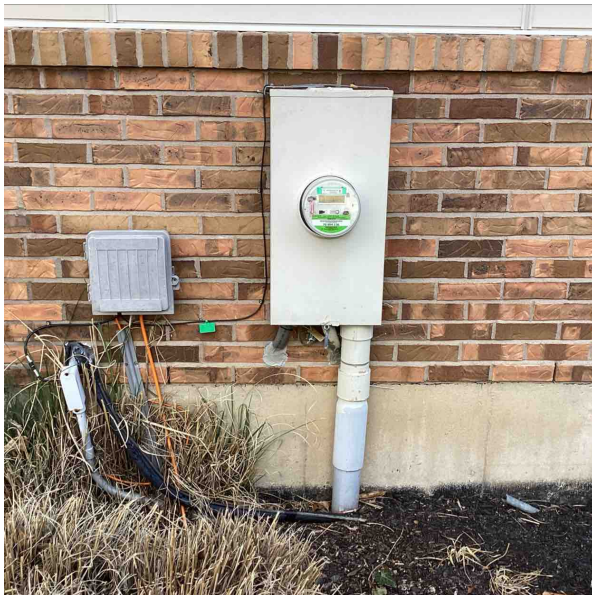
8.3.2 The electric meter and service entrance located: Exterior Front (**Exterior Front**)

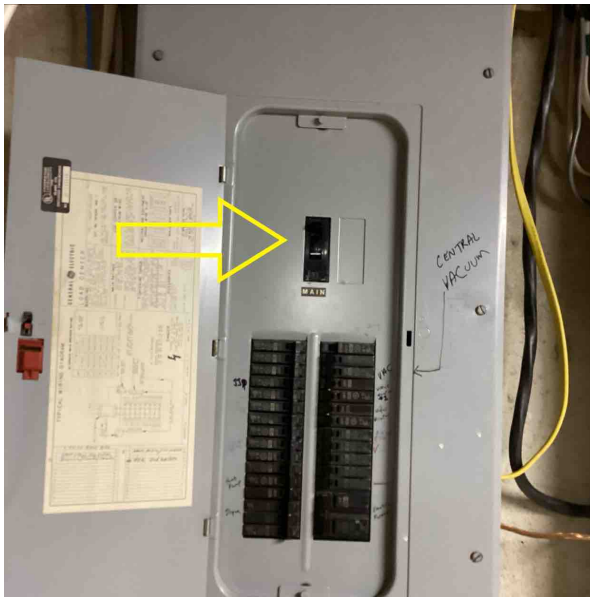
8.5.2 Main disconnect location: top breaker in the panel. **(Mechanical/Utility Room)**

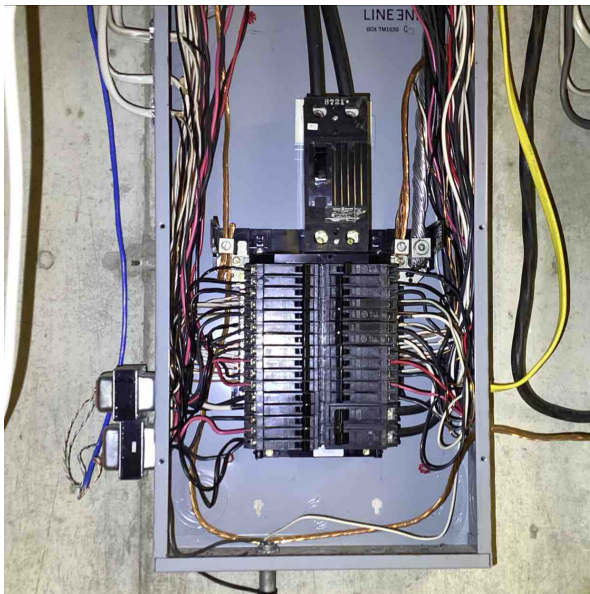
• The distribution panel is in serviceable condition. **(Mechanical/Utility Room)**

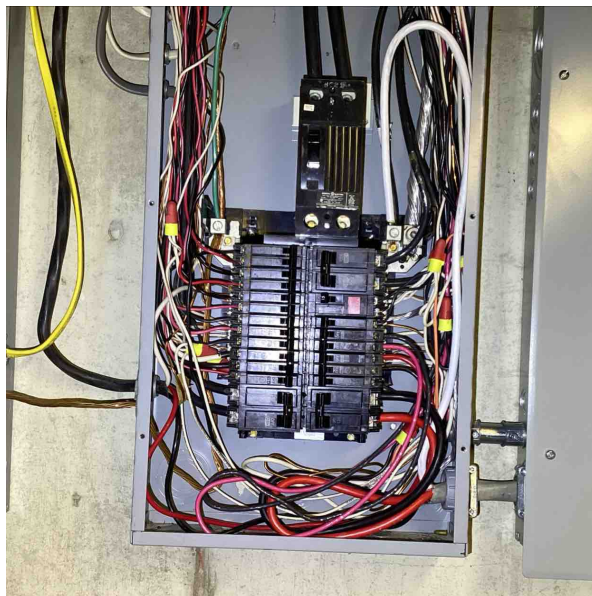
- 200 amp main electrical service panel was identified.
- The distribution panel is in serviceable condition. **(Mechanical/Utility Room)**

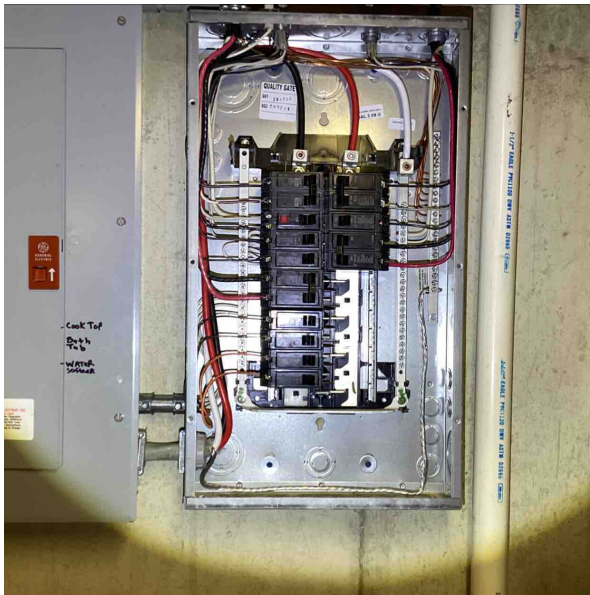
8.7.3 Sub-Panel location: Mechanical room

Sub-Panel service size: 125 amps (**Mechanical/Utility Room**)

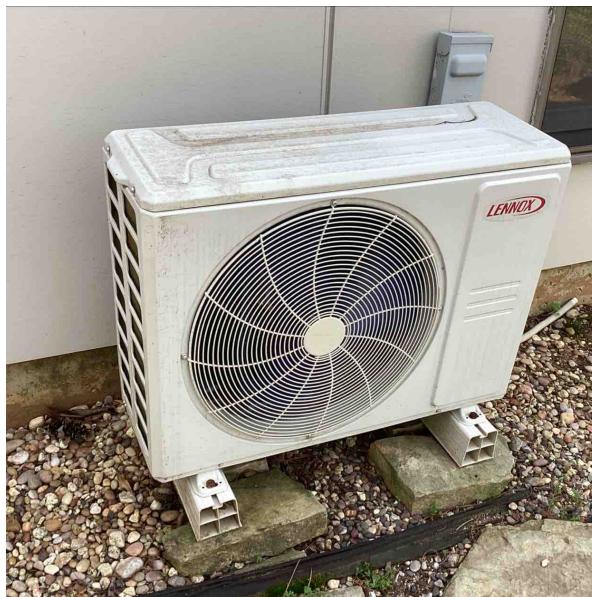
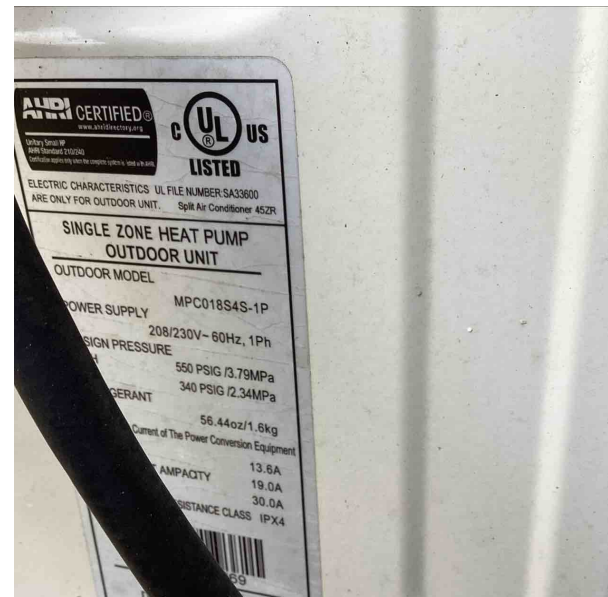
9.5.1 Model-Lennox

Traditional Heat pump system(s) identified. The cooling mode of the heat pump system was not tested due to exterior temperatures being below 60F. Recommend further evaluation when temperatures allow, and the general heating mode was operational. Have the system(s) serviced prior to each heating/cooling season.

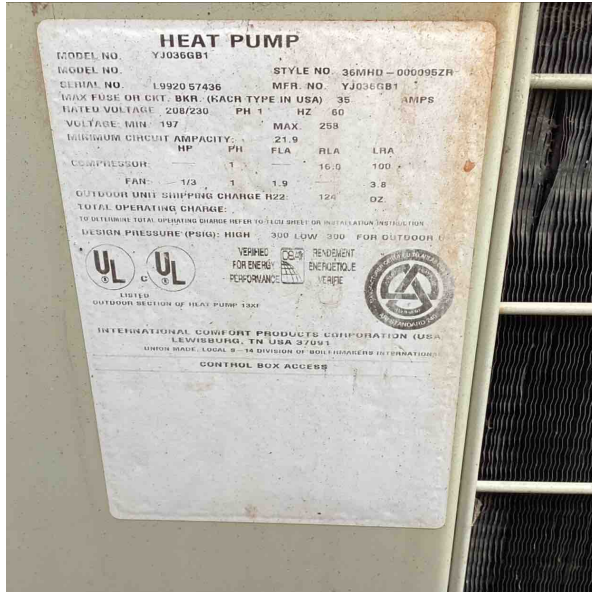
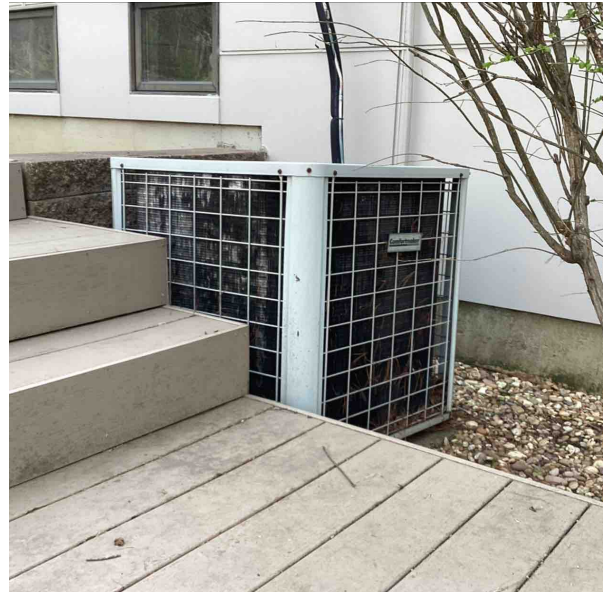
9.5.2 Model-Comfortmaker 1999

9.5.3 The heat pump has exceeded its typical life expectancy. You may want to consider getting a home protection plan and/ or budget for the eventual replacement. **(Exterior Left)**

9.5.4 The condenser fins are damaged. Have a qualified HVAC contractor evaluate to determine of scope of repairs needed for improved operation. **(Exterior Left)**

Traditional Heat pump system(s) identified. The cooling mode of the heat pump system was not tested due to exterior temperatures being below 60F. Recommend further evaluation when temperatures allow, and the general heating mode was operational. Have the system(s) serviced prior to each heating/cooling season. (Exterior Left)

9.5.3 The heat pump has exceeded its typical life expectancy. You may want to consider getting a home protection plan and/ or budget for the eventual replacement. (Exterior Left)

9.5.4 The condenser fins are damaged. Have a qualified HVAC contractor evaluate to determine of scope of repairs needed for improved operation. (Exterior Left)

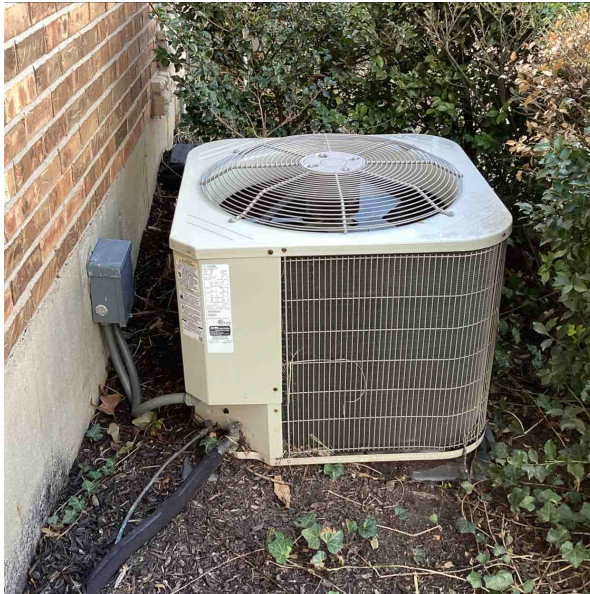
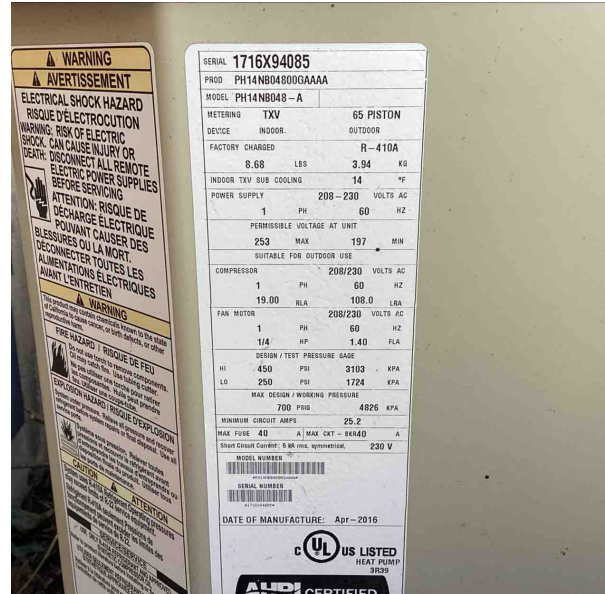
9.6.3 Model-Payne 2016

Split AC system(s) identified. The system(s) was/were not tested due to low exterior temperatures. Testing AC when the temperature is below 60 degrees can cause system failure. Further investigate operational status and service, as needed, when temperatures permit. Have the system serviced annually prior to each cooling season thereafter. (Exterior Front)

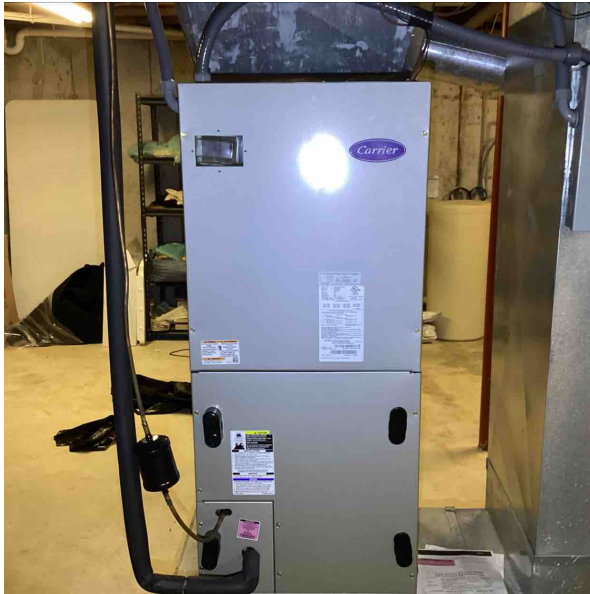
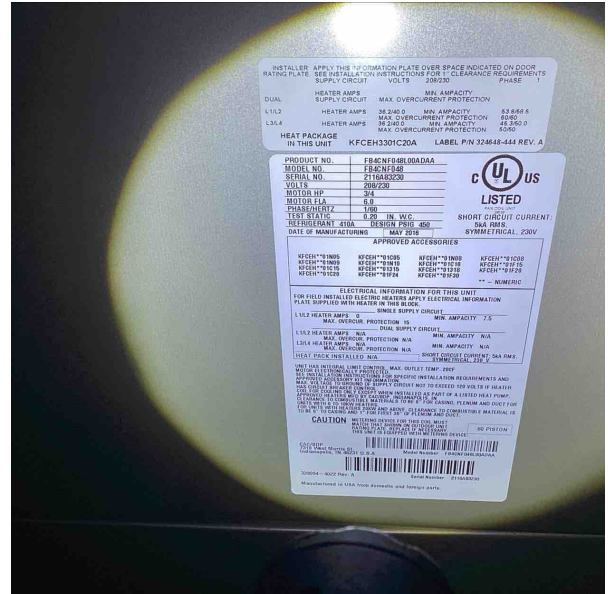
9.7.3 Model- Carrier 2016

Forced air furnace(s) identified and was operational at the time of inspection. Have the system(s) serviced annually prior to each heating season. **(Mechanical/Utility Room)**

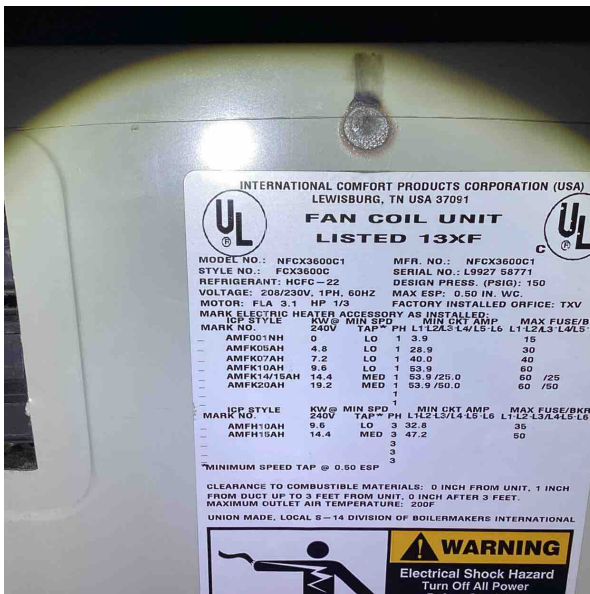
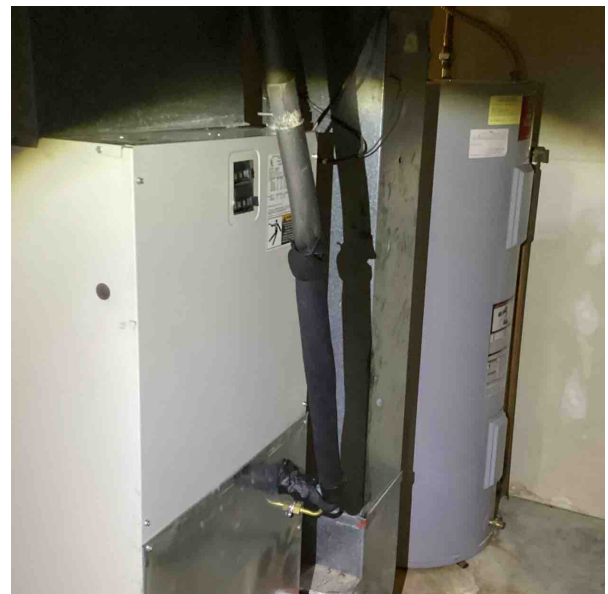
9.7.4 Model- ICP 1999

Forced air furnace(s) identified. Defer to the Gas / Mechanical Inspection report. Have the system(s) serviced annually prior to each heating season. **(Left Side Mechanical Room)**

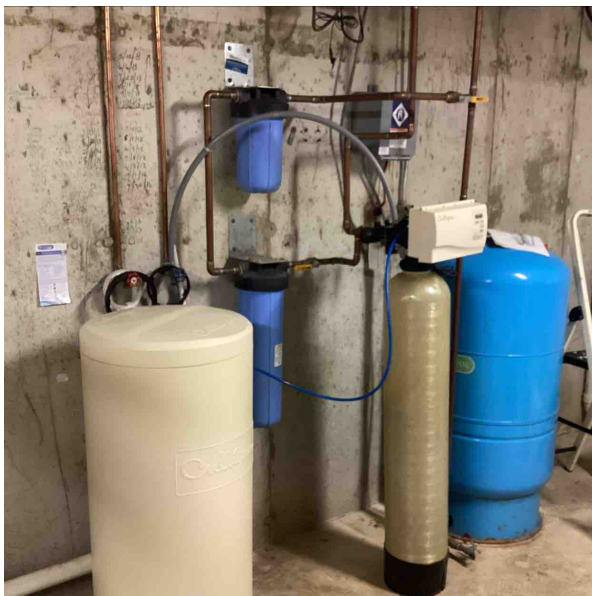
10.3.1 Water softener systems and their associated components are beyond the scope of the inspection and were not tested or inspected. The system should be monitored and regularly evaluated by a qualified professional to ensure proper operation.

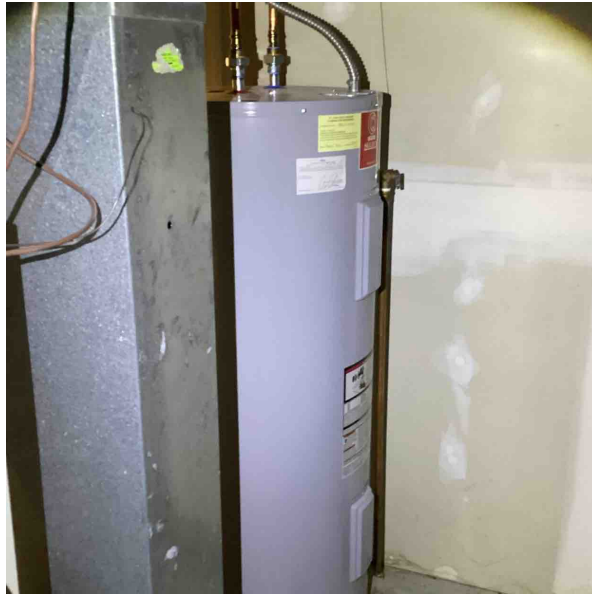
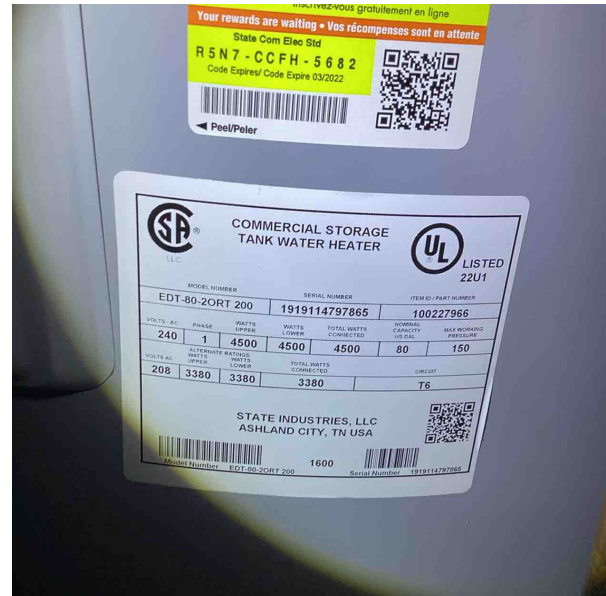
Water Heater size: 80 Gallons

Water heater identified and is operational. (Left Side Mechanical Room)
