Date: 6-15-18 REV 1-20-21
Project: 18108 and 18107 -
213th Ave Ct E.
File #: 20-0016 Rev

**Re: Geological Assesment- Landslide Hazard Geotechnical Report
18108 and 18107 213th Ave Ct. E
Orting, WA. 98360
Parcel # 0519341042**

This report summarizes the results of our geotechnical report for the Parcel # 0519341042 (Vacant Land) near the town of Orting, WA. The investigation was performed after verbal notification to proceed was received from Mr. Hicks. The location of the site is shown relative to the surrounding area on the vicinity map located in Appendix I.

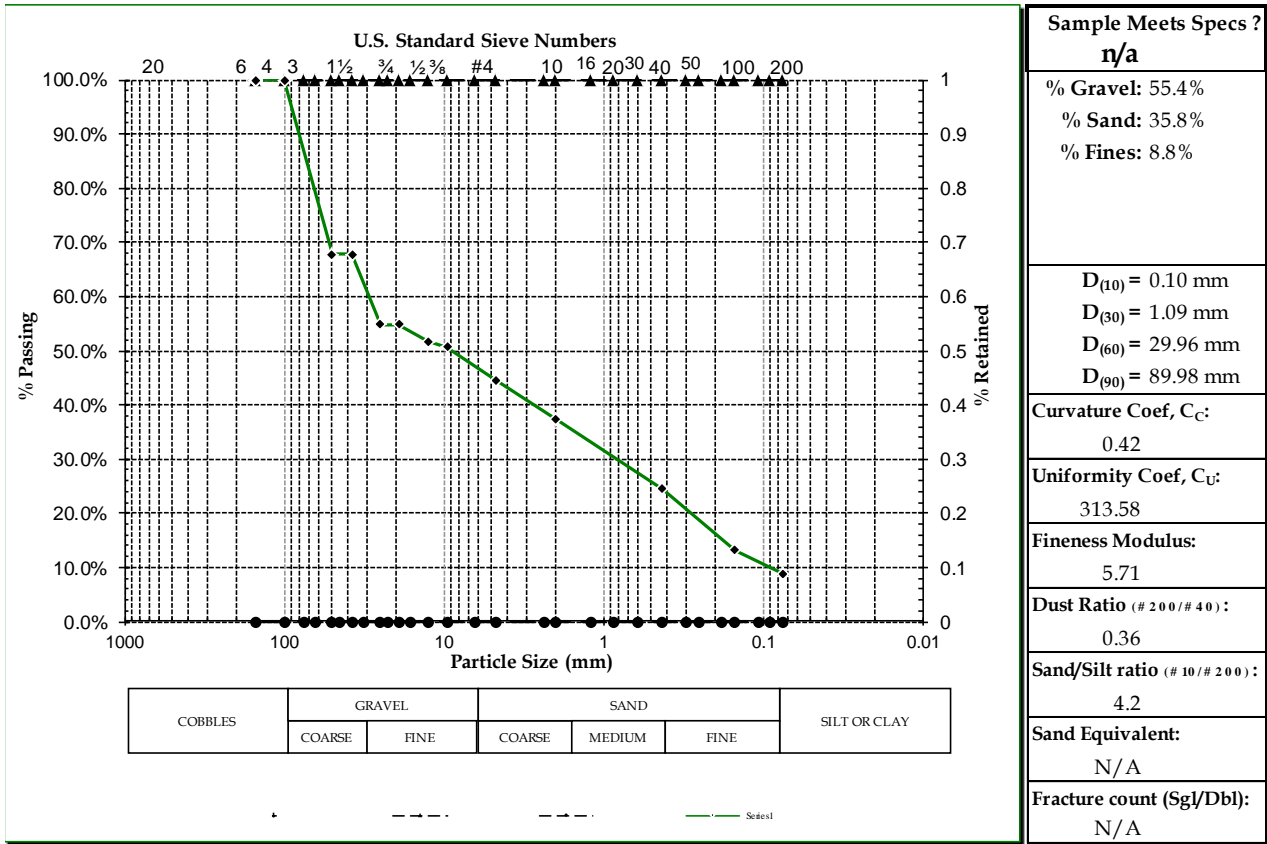
Date Received: 5/12/18	Sample Description: TH-1 - 5' BSG	Source: TH-1 - 5' BSG	Unified Soils Classification System: GP-GM, Poorly graded Gravel with Silt and Sand
Project: 182XX 213th Ave Ct E	Location: TH-1 - 5' BSG	Sample #: 18-0026A	Specifications: No Specs

Coarse Aggregate		Actual Cumulative	Interpolated Cumulative	Specs		Fine Aggregate		Actual Cumulative	Interpolated Cumulative	Specs	
Sieve Size US	Metric	Percent Passing	Percent Passing	Max	Min	Sieve Size US	Metric	Percent Passing	Percent Passing	Max	Min

6.00"	150.00	100.0%	100.0%			#4	4.75	44.6%	44.6%		
4.00"	100.00	100.0%	100.0%			#8	2.360		38.4%		
3.00"	75.00		83.9%			#10	2.000	37.5%	37.5%		
2.50"	63.00		76.1%			#16	1.180		30.7%

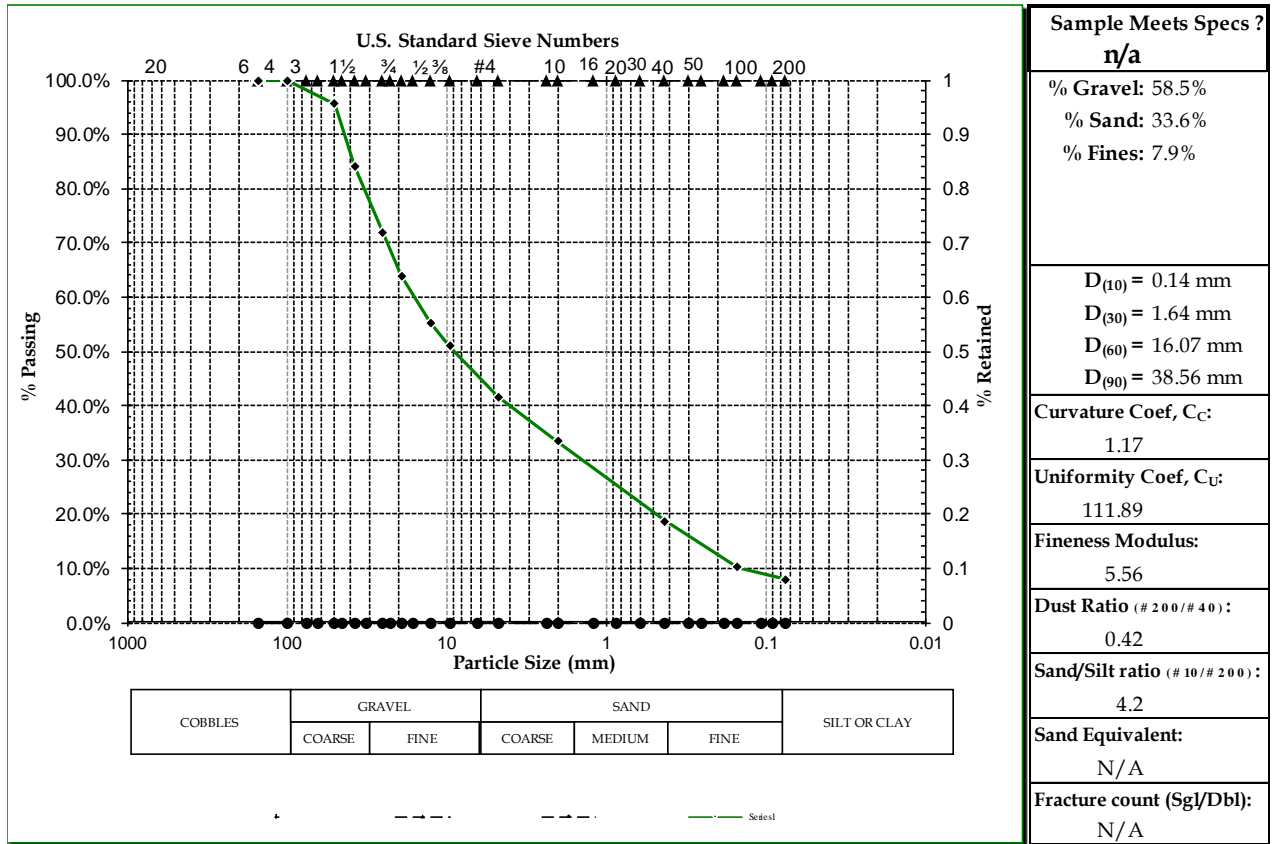
Date Received: 5/12/18	Sample Description: TH-2 - 4' BSG	Source: TH-2 - 4' BSGGW-GC, Well-graded Gravel with Silty Clay and Sand	Unified Soils Classification System:
Project: 182XX 213th Ave Ct E	Location: TH-2 - 4' BSG	Sample #: 18-0026B	Specifications: No Specs

Coarse Aggregate		Actual Cumulative	Interpolated Cumulative	Fine Aggregate		Actual Cumulative	Interpolated Cumulative		
Sieve Size	Percent Passing	Percent Passing	Specs Max	Specs Min	Sieve Size	Percent Passing	Percent Passing	Specs Max	Specs Min
US	Metric				US	Metric			
6.00"	150.00	100.0%			#4	4.75	41.6%	41.6%	
4.00"	100.00	100.0%			#8	2.360	33.3%	34.4%	
3.00"	75.00	97.8%			#10	2.000	25.7%	25.7%	
2.50"	63.00	96.7%			#16	1.180	20.3%	20.3%	
2.00"	50.00	95.5%			#20	0.850	18.6%	18.6%	
1.75"	45.00	91.0%			#30	0.600	14.8%	14.8%	
1.50"	37.50	84.2%			#40	0.425	11.1%	11.1%	
1.25"	31.50	78.3%			#50	0.300	10.2%	10.2%	
1.00"	25.00	71.8%			#60	0.250	8.9%	8.4%	
7/8"	22.40	68.4%			#80	0.180	7.9%	7.9%	
3/4"	19.00	63.9%			#100	0.150			
5/8"	16.00	59.9%			#140	0.106			
1/2"	12.50	55.3%			#170	0.090			
3/8"	9.50	51.0%			#200	0.075			
1/4"	6.30	44.6%

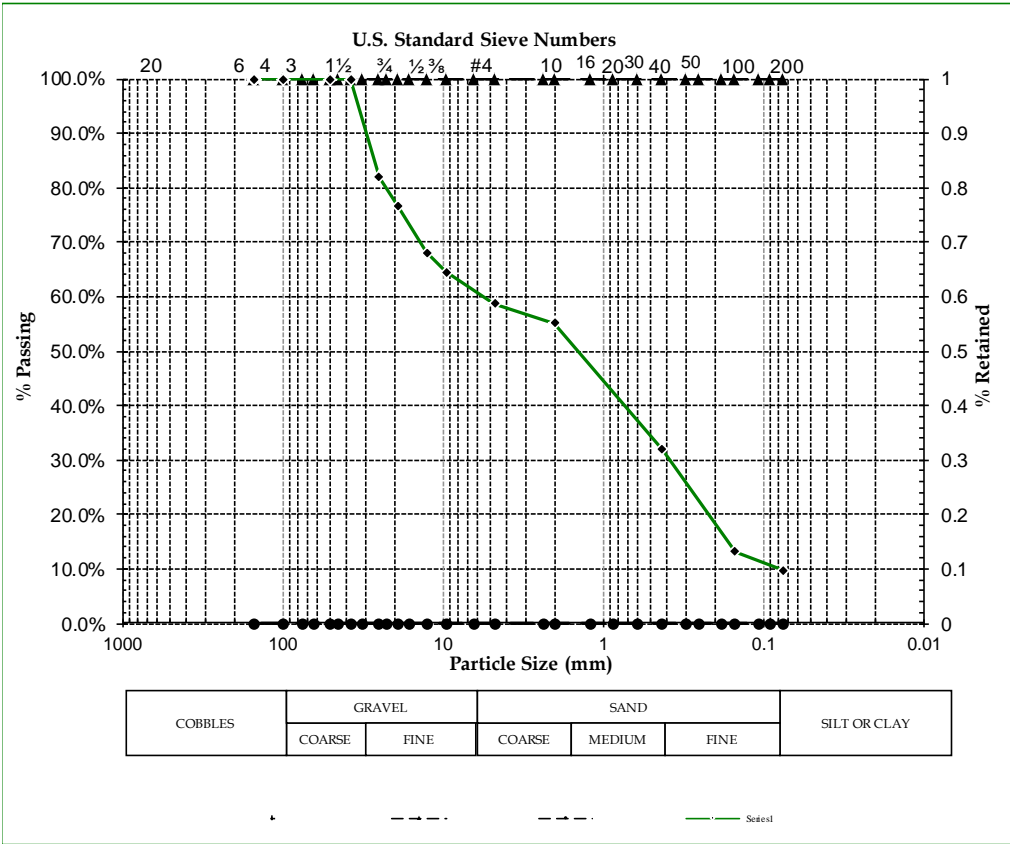
Date Received: 5/12/18	Sample Description: TH- 5 - 3' BSG	Source: TH- 5 - 3' BSG	Unified Soils Classification System: SP-SM, Poorly graded Sand with Silt and Gravel
Project: 182XX 213th Ave Ct E	Location: TH- 5 - 3' BSG	Sample # 18-0026C	Specifications: No Specs

Sample Meets Specs ? n/a
% Gravel: 41.3%
% Sand: 48.9%
% Fines: 9.8%
D ₍₁₀₎ = 0.08 mm
D ₍₃₀₎ = 0.40 mm
D ₍₆₀₎ = 5.81 mm
D ₍₉₀₎ = 30.33 mm
Curvature Coef, C _c : 0.34
Uniformity Coef, C _u : 73.49
Fineness Modulus: 4.31
Dust Ratio (# 200/# 40): 0.31
Sand/Silt ratio (# 10/# 200): 5.6
Sand Equivalent: N/A
Fracture count (Sgl/Dbf): N/A

Coarse Aggregate		Actual	Interpolated	Specs		Fine Aggregate		Actual	Interpolated	Specs	
Sieve Size	Metric	Percent Passing	Percent Passing	Max	Min	Sieve Size	Metric	Percent Passing	Percent Passing	Max	Min
6.00"	150.00	100.0%	100.0%			#4	4.75	58.7%	58.7%		
4.00"	100.00	100.0%	100.0%			#8	2.360		55.6%		
3.00"	75.00		100.0%			#10	2.000	55.1%	55.1%		
2.50"	63.00		100.0%			#16	1.180		43.0%		
2.00"	50.00	100.0%	100.0%			#20	0.850		38.2%		
1.75"	45.00		100.0%			#30	0.600		34.5%		
1.50"	37.50	100.0%	100.0%			#40	0.425	31.9%	31.9%		
1.25"	31.50		91.3%			#50	0.300		23.4%		
1.00"	25.00	81.9%	81.9%			#60	0.250		20.0%		
7/8"	22.40		79.6%			#80	0.180		15.2%		
3/4"	19.00	76.7%	76.7%			#100	0.150	13.1%	13.1%		
5/8"	16.00		72.7%			#140	0.106		11.2%		
1/2"	12.50	68.0%	68.0%			#170	0.090		10.5%		
3/8"	9.50	64.5%	64.5%			#200	0.075	9.8%	9.8%		
1/4"	6.30		60.6%

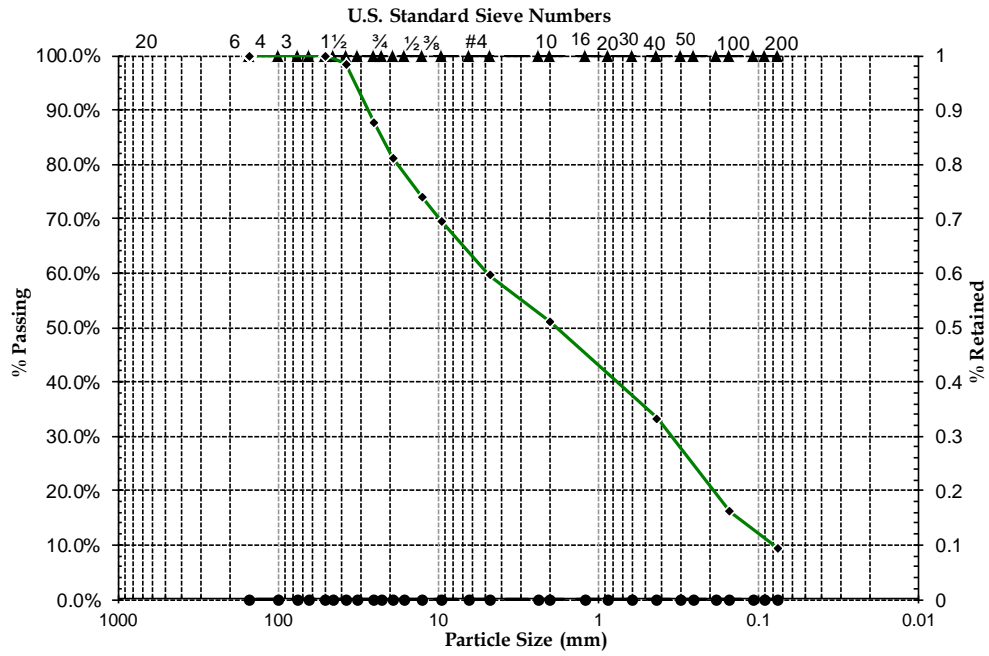
Date Received: 5/12/18	Sample Description: TH-6 - 3' BSG	Source: TH-6 - 3' BSG	Unified Soils Classification System: SP-SM, Poorly graded Sand with Silt and Gravel
Project: 182XX 213th Ave Ct E	Location: TH-6 - 3' BSG	Sample #: 18-0026D	Specifications: No Specs

Sample Meets Specs ? n/a
% Gravel: 40.4%
% Sand: 50.2%
% Fines: 9.4%
D ₍₁₀₎ = 0.08 mm
D ₍₃₀₎ = 0.37 mm
D ₍₆₀₎ = 4.95 mm
D ₍₉₀₎ = 19.89 mm
Curvature Coef, C _c : 0.34
Uniformity Coef, C _u : 60.73
Fineness Modulus: 4.20
Dust Ratio (# 200/# 40): 0.28
Sand/Silt ratio (# 10/# 200): 5.4
Sand Equivalent: N/A
Fracture count (Sgl/Dbf): N/A

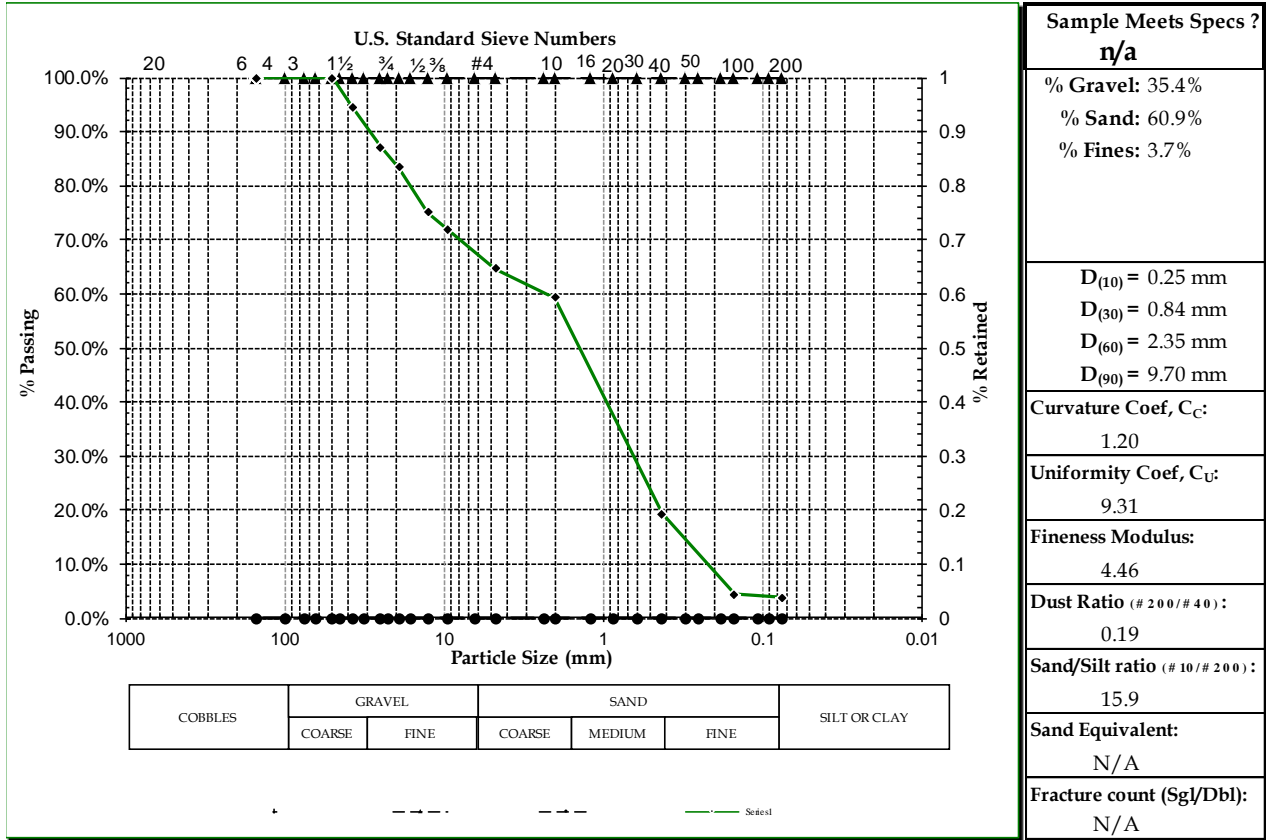
Date Received: 5/12/18	Sample Description: TH-7 - 2' BSG	Source: TH-7 - 2' BSG	Unified Soils Classification System: SW, Well-graded Sand with Gravel
Project: 182XX 213th Ave Ct E	Location: TH-7 - 2' BSG	Sample #: 18-0026F	Specifications: No Specs

Actual		Interpolated		Actual		Interpolated			
Coarse Aggregate		Cumulative	Cumulative	Fine Aggregate		Cumulative	Cumulative		
Sieve Size	Percent	Percent	Specs	Specs	Sieve Size	Percent	Percent	Specs	Specs
US	Metric	Passing	Max	Min	US	Passing	Passing	Max	Min
6.00"	150.00	100.0%			#4	64.6%	64.6%		
4.00"	100.00	100.0%			#8		60.0%		
3.00"	75.00	100.0%			#10	59.3%	59.3%		
2.50"	63.00	100.0%			#16		38.5%		
2.00"	50.00	100.0%			#20		30.1%		
1.75"	45.00		97.8%		#30		23.8%		
1.50"	37.50	94.5%	94.5%		#40	19.3%	19.3%		
1.25"	31.50		90.9%		#50		12.6%		
1.00"	25.00	87.1%	87.1%		#60		9.9%		
7/8"	22.40		85.5%		#80		6.1%		
3/4"	19.00	83.4%	83.4%		#100	4.4%	4.4%		
5/8"	16.00		79.6%		#140		4.0%		
1/2"	12.50	75.1%	75.1%		#170		3.9%		
3/8"	9.50	71.9%	71.9%		#200	3.7%	3.7%		
1/4"	6.30		67.0%

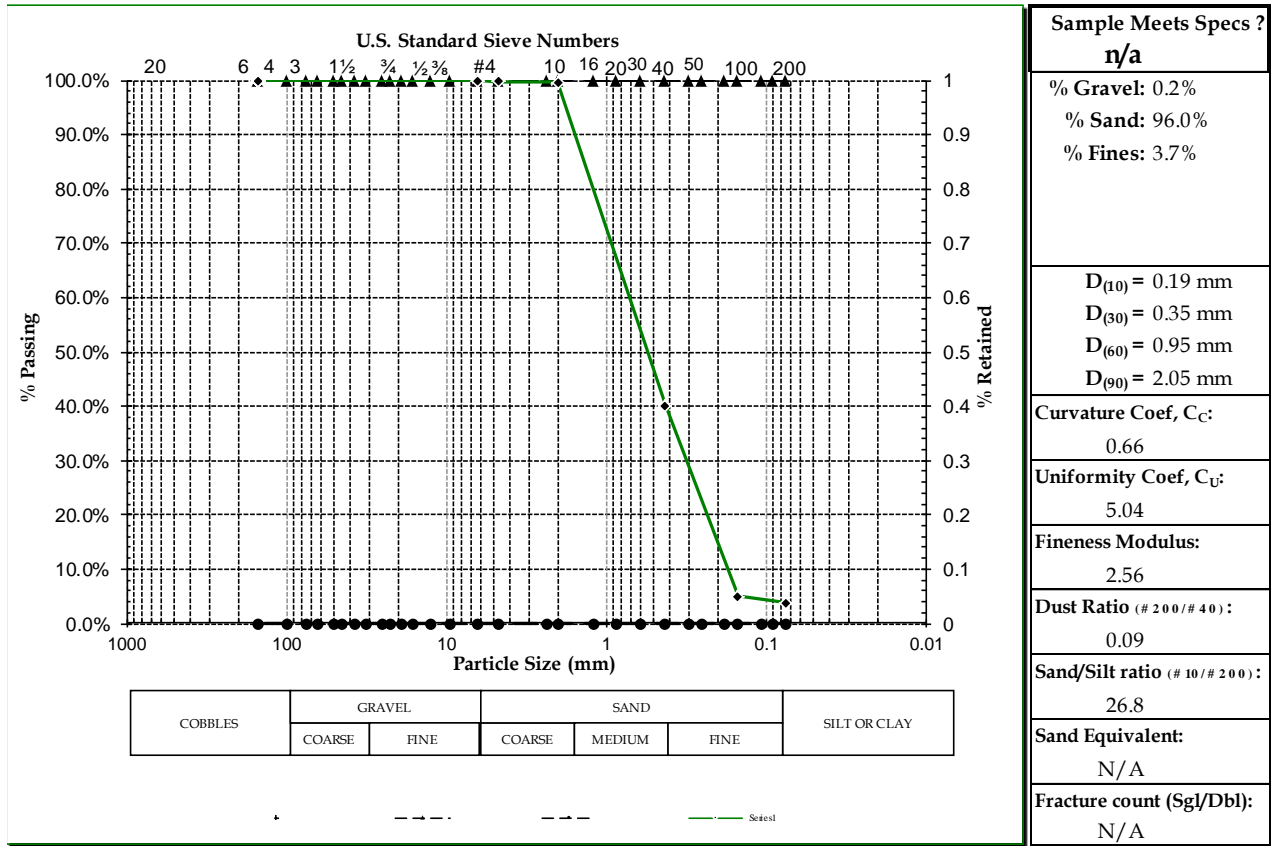
Date Received: 5/12/18	Sample Description: TH-7 - 5' BSG	Source: TH-7 - 5' BSG	Unified Soils Classification System: SP, Poorly graded Sand
Project: 182XX 213th Ave Ct E	Location: TH-7 - 5' BSG	Sample #: 18-0026E	Specifications: No Specs

Actual		Interpolated				Actual		Interpolated			
Coarse Aggregate		Cumulative		Cumulative		Fine Aggregate		Cumulative		Cumulative	
Sieve Size	Percent	Percent	Specs	Specs	Sieve Size	Percent	Percent	Specs	Specs		
US	Metric	Passing	Passing	Max	Min	US	Metric	Passing	Passing	Max	Min
6.00"	150.00		100.0%			#4	4.75	99.8%	99.8%		
4.00"	100.00		100.0%			#8	2.360		99.6%		
3.00"	75.00		100.0%			#10	2.000	99.6%	99.6%		
2.50"	63.00		100.0%			#16	1.180		68.6%		
2.00"	50.00		100.0%			#20	0.850		56.1%		
1.75"	45.00		100.0%			#30	0.600		46.7%		
1.50"	37.50		100.0%			#40	0.425	40.1%	40.1%		
1.25"	31.50		100.0%			#50	0.300		24.2%		
1.00"	25.00		100.0%			#60	0.250		17.8%		
7/8"	22.40		100.0%			#80	0.180		8.9%		
3/4"	19.00		100.0%			#100	0.150	5.0%	5.0%		
5/8"	16.00		100.0%			#140	0.106		4.3%		
1/2"	12.50		100.0%			#170	0.090		4.0%		
3/8"	9.50		100.0%			#200	0.075	3.7%	3.7%		
1/4"	6.30	100.0%	100.0%

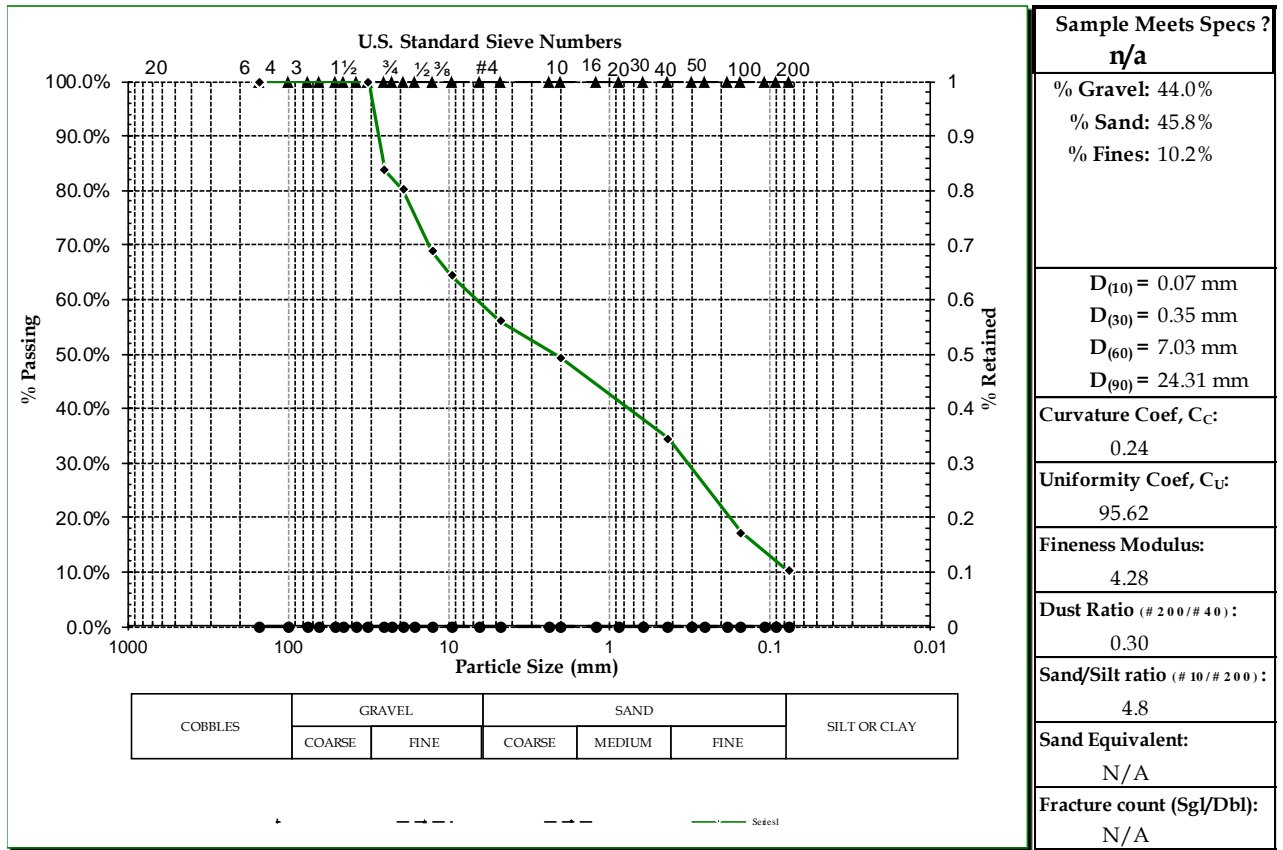
Date Received: 5/12/18	Sample Description: TH- 8 - 5' BSG	Source: TH- 8 - 5' BSG	Unified Soils Classification System: SP-SM, Poorly graded Sand with Silt and Gravel
Project: 182XX 213th Ave Ct E	Location: TH- 8 - 5' BSG	Sample # 18-0026G	Specifications: No Specs

Sample Meets Specs ? n/a
% Gravel: 44.0%
% Sand: 45.8%
% Fines: 10.2%
D ₍₁₀₎ = 0.07 mm
D ₍₃₀₎ = 0.35 mm
D ₍₆₀₎ = 7.03 mm
D ₍₉₀₎ = 24.31 mm
Curvature Coef, C _c : 0.24
Uniformity Coef, C _u : 95.62
Fineness Modulus: 4.28
Dust Ratio (# 200/# 40): 0.30
Sand/Silt ratio (# 10/# 200): 4.8
Sand Equivalent: N/A
Fracture count (Sgl/Dbf): N/A

Coarse Aggregate		Actual Cumulative	Interpolated Cumulative	Specs		Fine Aggregate		Actual Cumulative	Interpolated Cumulative	Specs	
Sieve Size	Metric	Percent Passing	Percent Passing	Max	Min	Sieve Size	Metric	Percent Passing	Percent Passing	Max	Min
6.00"	150.00		100.0%			#4	4.75	56.0%	56.0%		
4.00"	100.00		100.0%			#8	2.360		50.2%		
3.00"	75.00		100.0%			#10	2.000	49.3%	49.3%		
2.50"	63.00		100.0%			#16	1.180		41.6%		
2.00"	50.00		100.0%			#20	0.850		38.5%		
1.75"	45.00		100.0%			#30	0.600		36.1%		
1.50"	37.50		100.0%			#40	0.425	34.4%	34.4%		
1.25"	31.50	100.0%	100.0%			#50	0.300		26.6%		
1.00"	25.00	83.7%	83.7%			#60	0.250		23.5%		
7/8"	22.40		82.2%			#80	0.180		19.1%		
3/4"	19.00	80.2%	80.2%			#100	0.150	17.2%	17.2%		
5/8"	16.00		74.9%			#140	0.106		13.1%		
1/2"	12.50	68.8%	68.8%			#170	0.090		11.6%		
3/8"	9.50	64.3%	64.3%			#200	0.075	10.2%	10.2%		
1/4"	6.30		58.7%

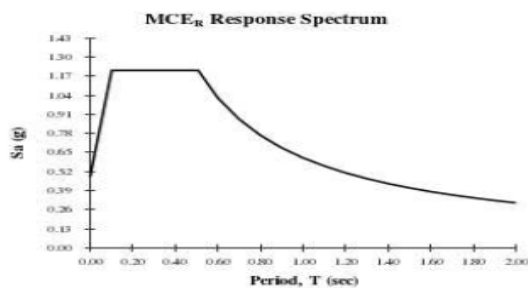
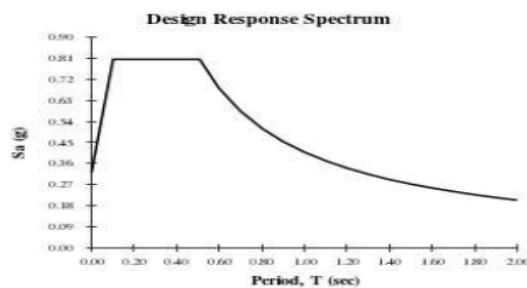
USGS-Provided Output

$S_S = 1.208 \text{ g}$	$S_{MS} = 1.208 \text{ g}$	$S_{DS} = 0.805 \text{ g}$
$S_1 = 0.456 \text{ g}$	$S_{M1} = 0.613 \text{ g}$	$S_{D1} = 0.409 \text{ g}$

For information on how the S_S and S_1 values above have been calculated from probabilistic (risk-targeted) and deterministic ground motions in the direction of maximum horizontal response, please return to the application and select the “2009 NEHRP” building code reference document.

$S_S = 1.208 \text{ g}$	$S_{MS} = 1.208 \text{ g}$	$S_{DS} = 0.805 \text{ g}$
$S_1 = 0.456 \text{ g}$	$S_{M1} = 0.613 \text{ g}$	$S_{D1} = 0.409 \text{ g}$
